COUNTY OF SANTA CRUZ

HISTORIC RESOURCES COMMISSION PLANNING DEPARTMENT

HISTORIC RESOURCE PRESERVATION PLAN REVIEW

Applicant:Heidi Spicer
Owner:Ayshe Tuncer and Mike Anderson
APN:041-021-41
Situs:8057 Valencia St., Aptos, CA
Location:The residence is located on the north side of Valencia St. approximately 200 feet east of Trout Gulch Rd.
Historic Name: None
Rating:..... NR3

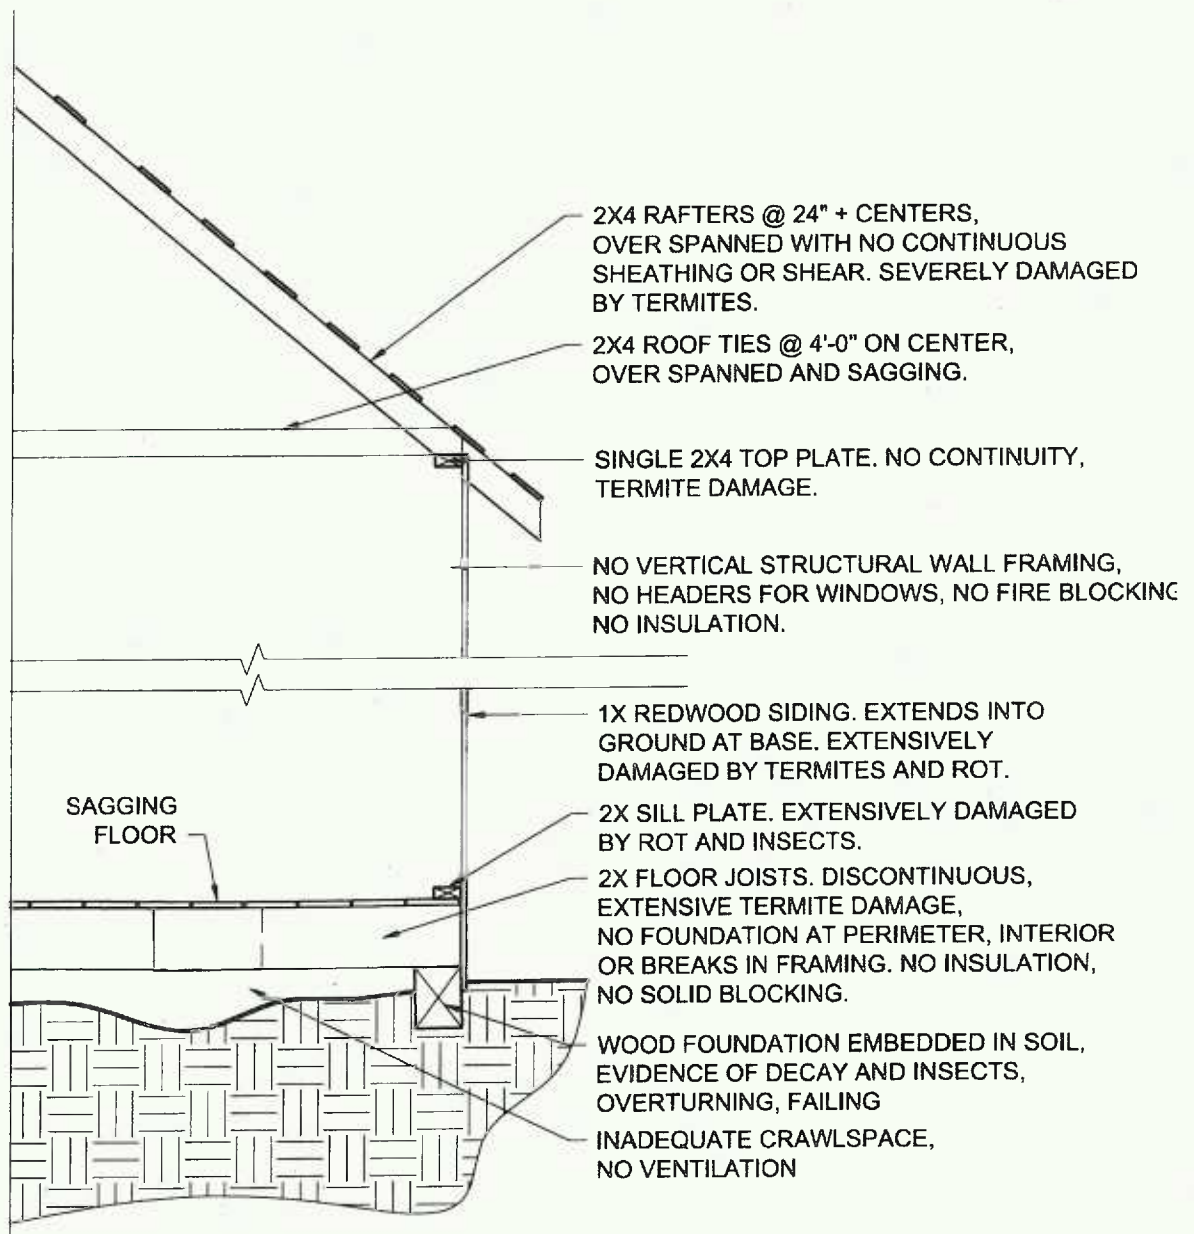
FIGURE A

Figure A SKEC shows the structure's existing construction. There is no wall framing. The top plate is a single member only with nothing to keep gaps from opening up where it is discontinuous. There are several basic building components missing, including wall framing,

fire blocking, adequate nailing, structural siding, foundation, etc. The components that are in place are severely damaged without enough material left to nail through and to other parts to stitch it together in a meaningful way structurally.

AS-BUILT CONDITION OF EXISTING STRUCTURE

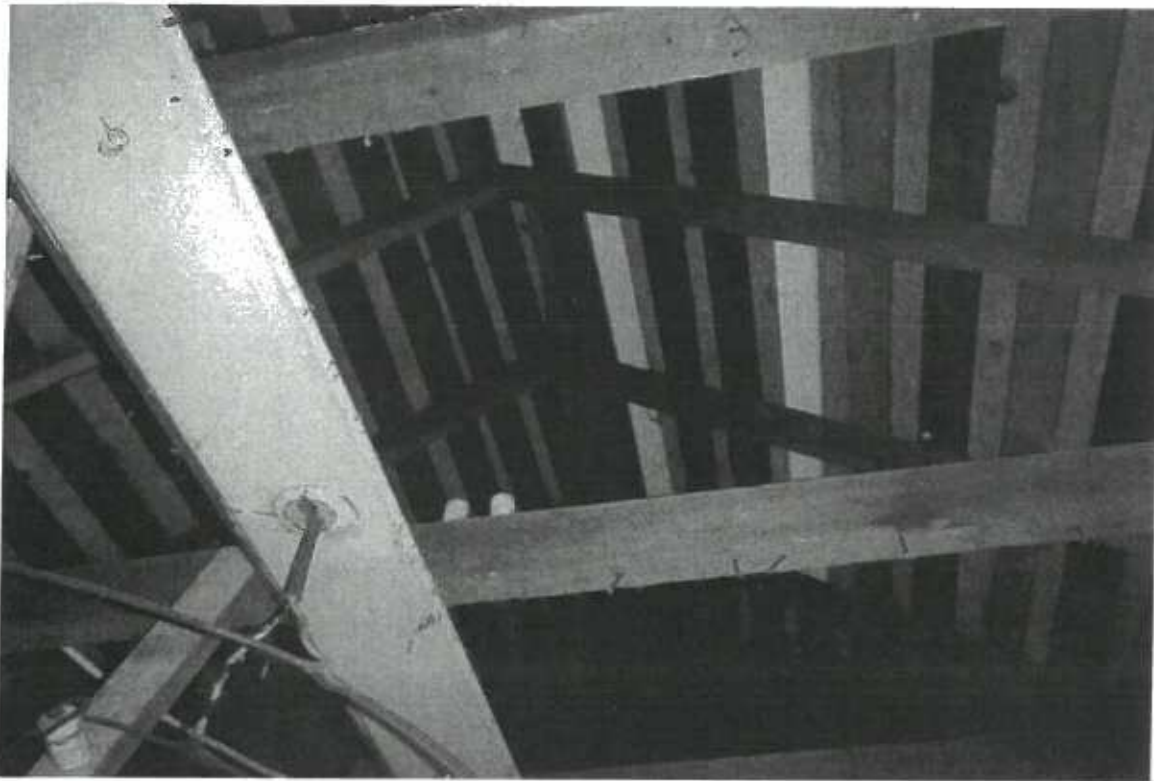
Figure 1. Roof framing, no ridge support, solid blocking

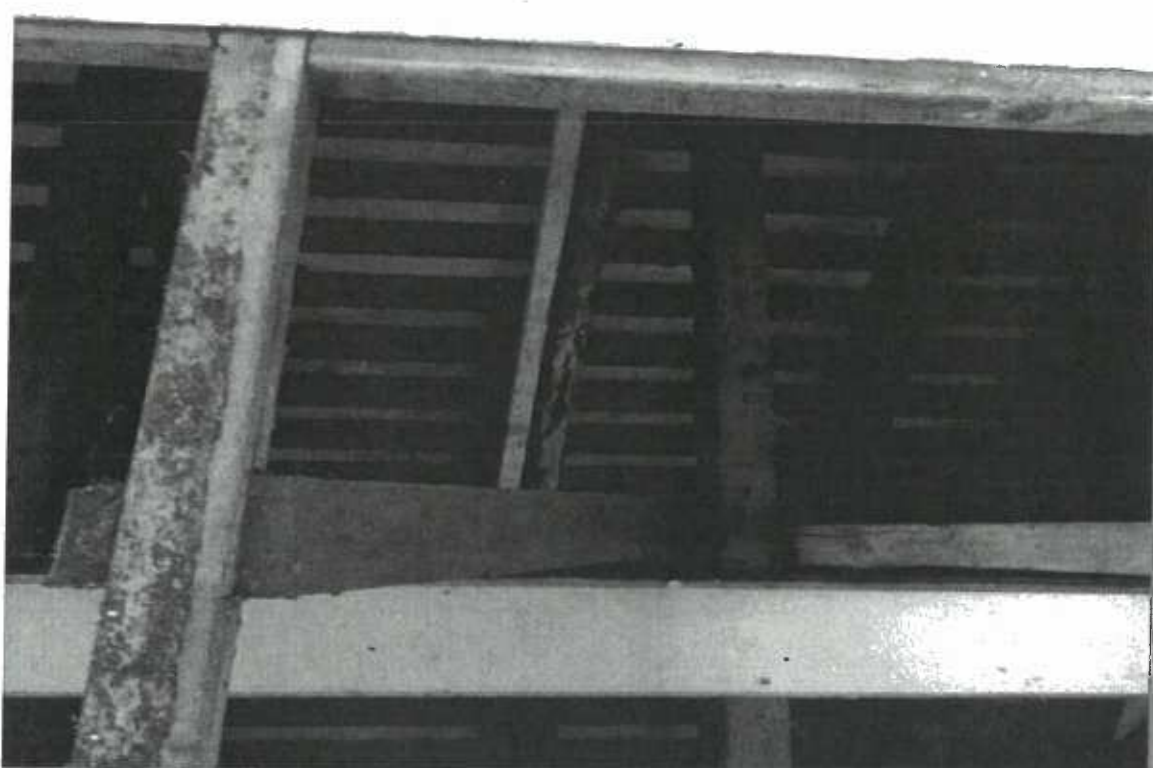
Figure 2. Heavy Termite infestation and damage at rafters

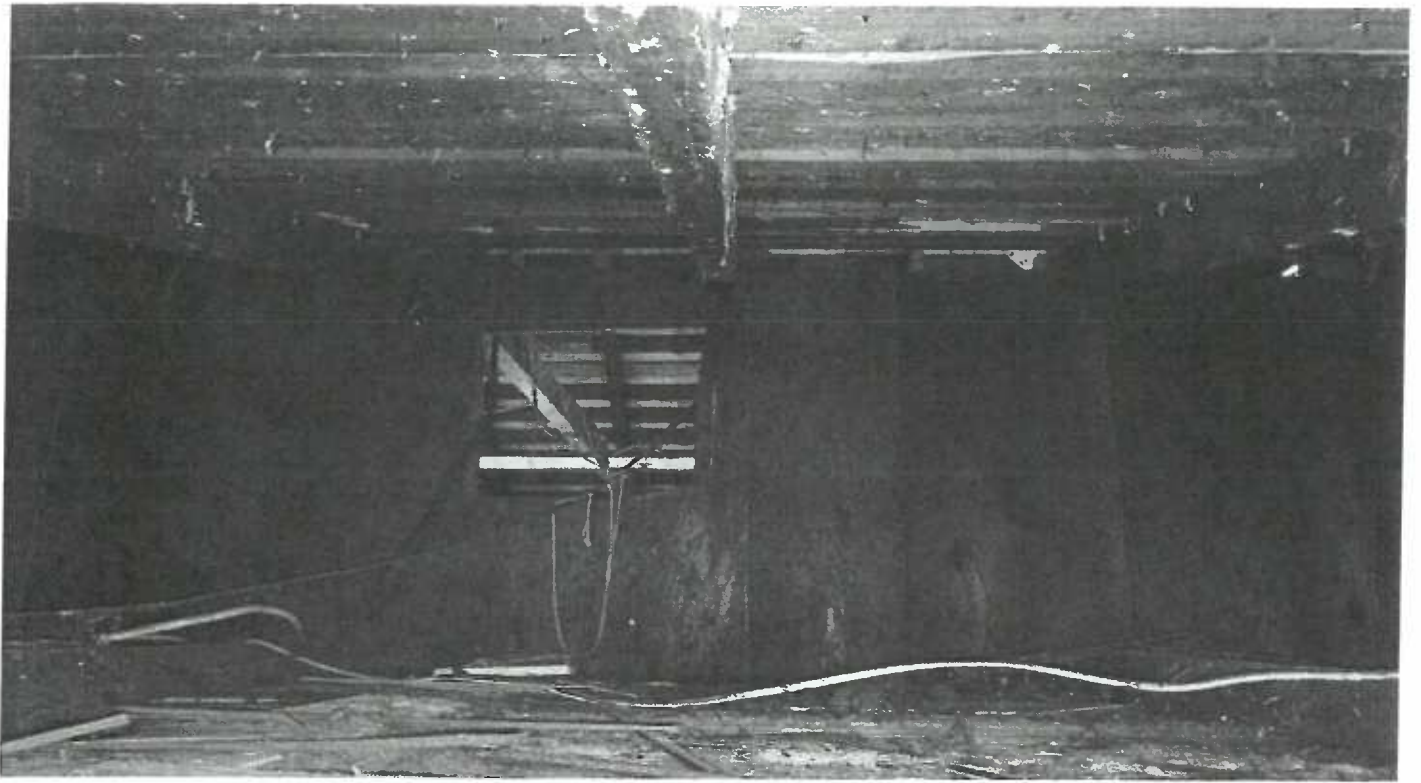
Roof framing in the middle third of the building consists of 2x4 rafters spaced at 24 inches on center. Ceiling joists are 2x3 redwood at approximately 48" on center. Roofing consists of built-up asphaltic roll roofing. The rafters and ceiling joists are significantly undersized for the span and are sagging in the center. Evidence of recent efforts to correct this is inadequate and improperly constructed. There is evidence of extensive termite damage and infestation throughout the attic (Figure 3).

Figure 3. Heavy termite infestation and damage in rafters, no framing at lines of bearing.

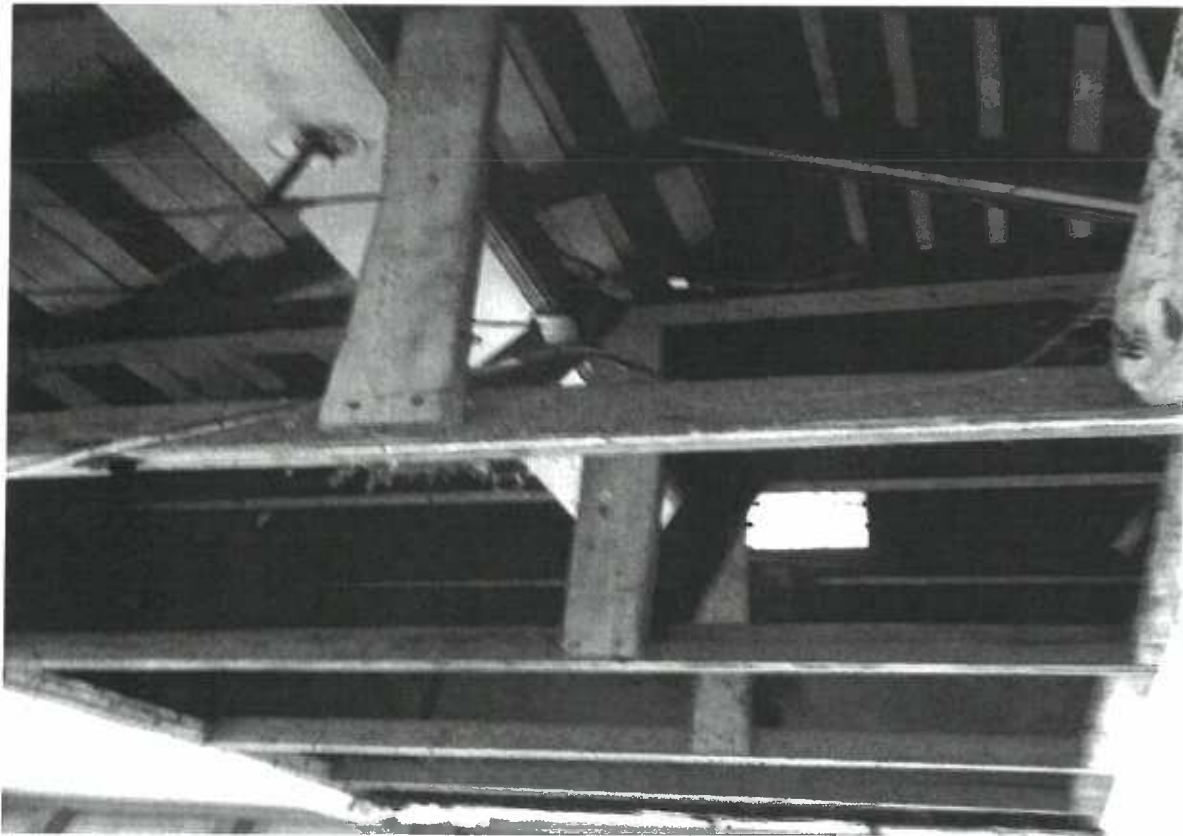
Figure 4. No wall framing at lines of bearing

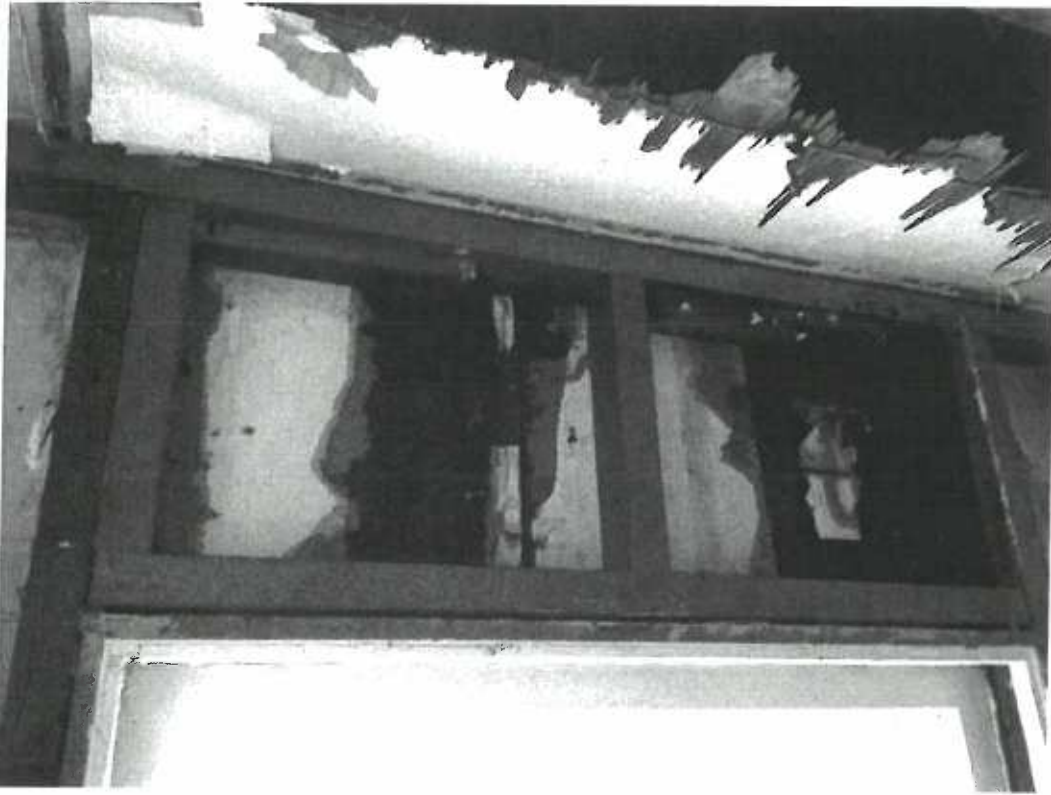
Figure 7. Place holder Sub-standard door and window framing

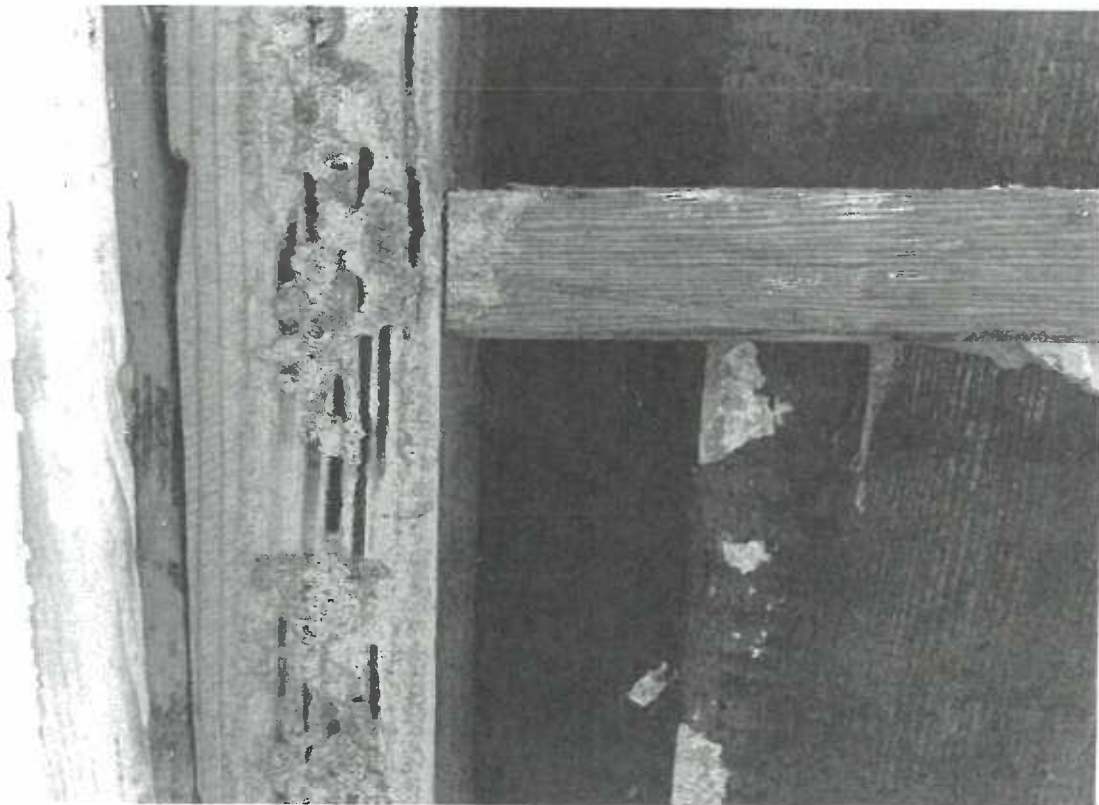
Figure 8. Heavy termite damage and infestation at wind/door openings

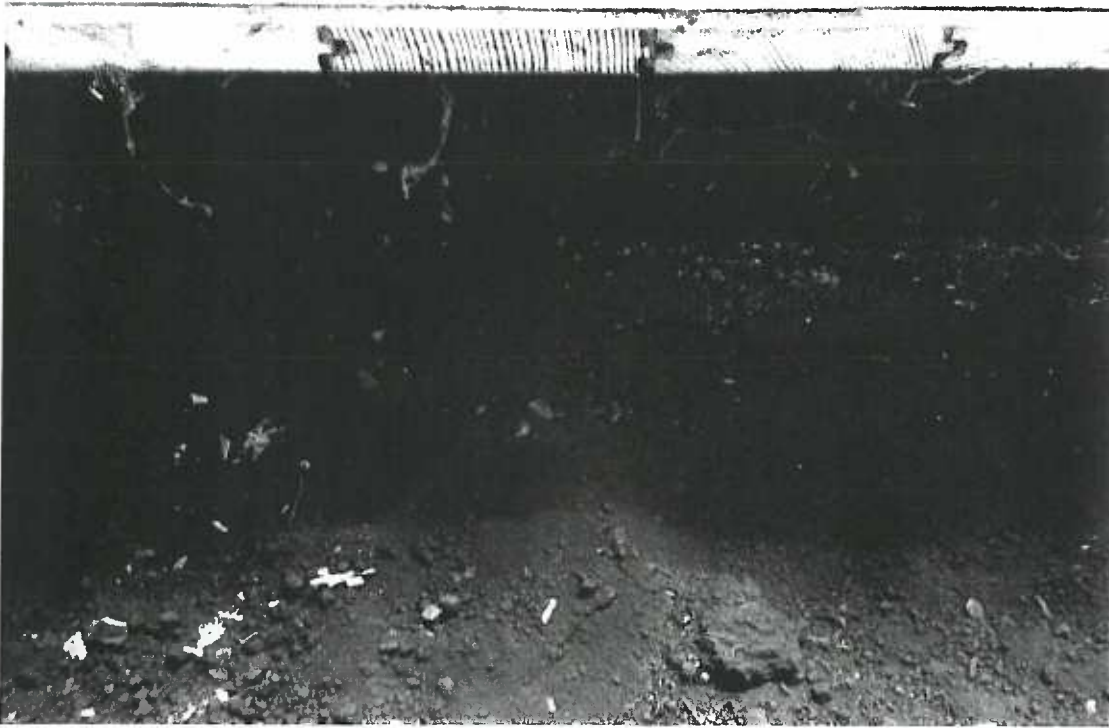
The original foundation appears to consist of a perimeter redwood mudsill directly into exposed native soils. The mudsill is completely embedded into soil in several locations (Figure 9). The floors consist of 1x6 tongue and groove decking on 2x6 floor joists at approximately 24" spacing. The decking shows evidence of heavy infestation in places by termites and other wood boring insects (Figures 12&13). The floor joists are cut and discontinuous in places (Figure 10), exhibiting extensive damage from termite infestation (Figure 11) and are dramatically 'crowned', sloping to the perimeter. Intermittent 2x4 posts, likely introduced in an attempt to correct cut, sagging and 'crowned' joists bear directly on soil (Figure 14).

Figure 9. Mudsill completely embedded into soil

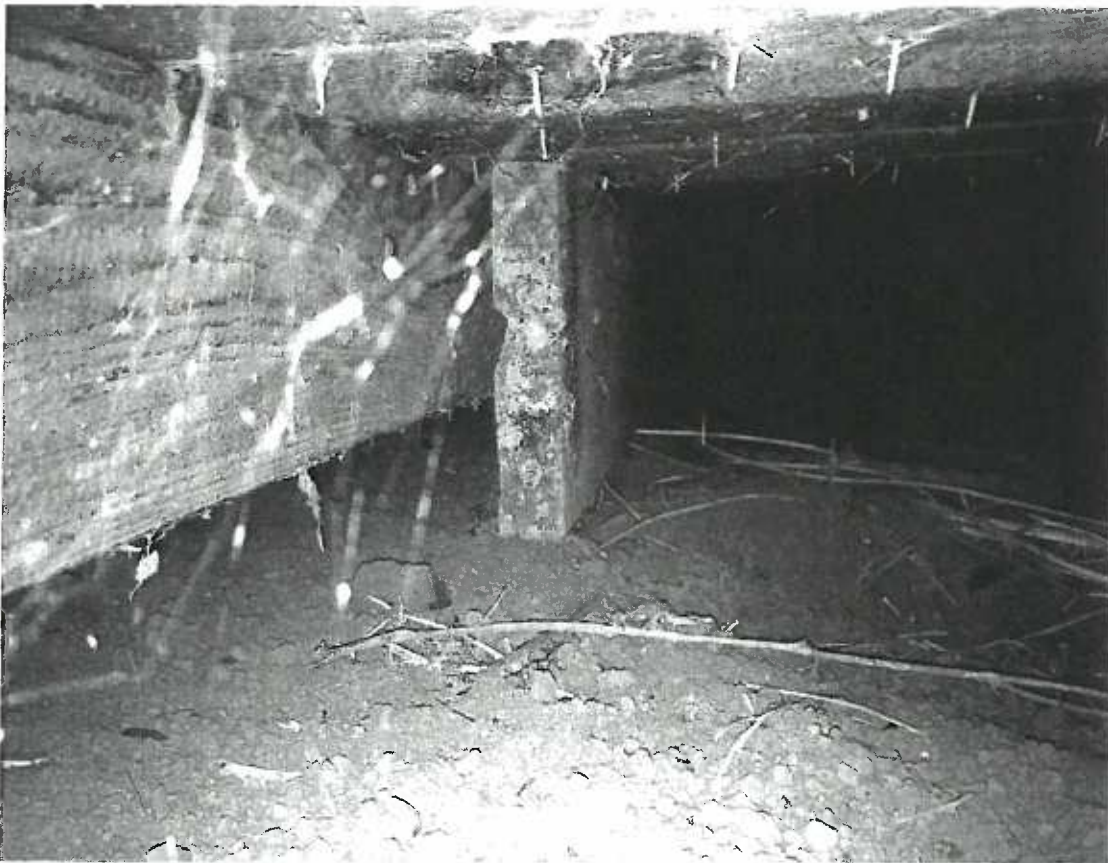
Figure 10. Discontinuous floor joists w/ no support

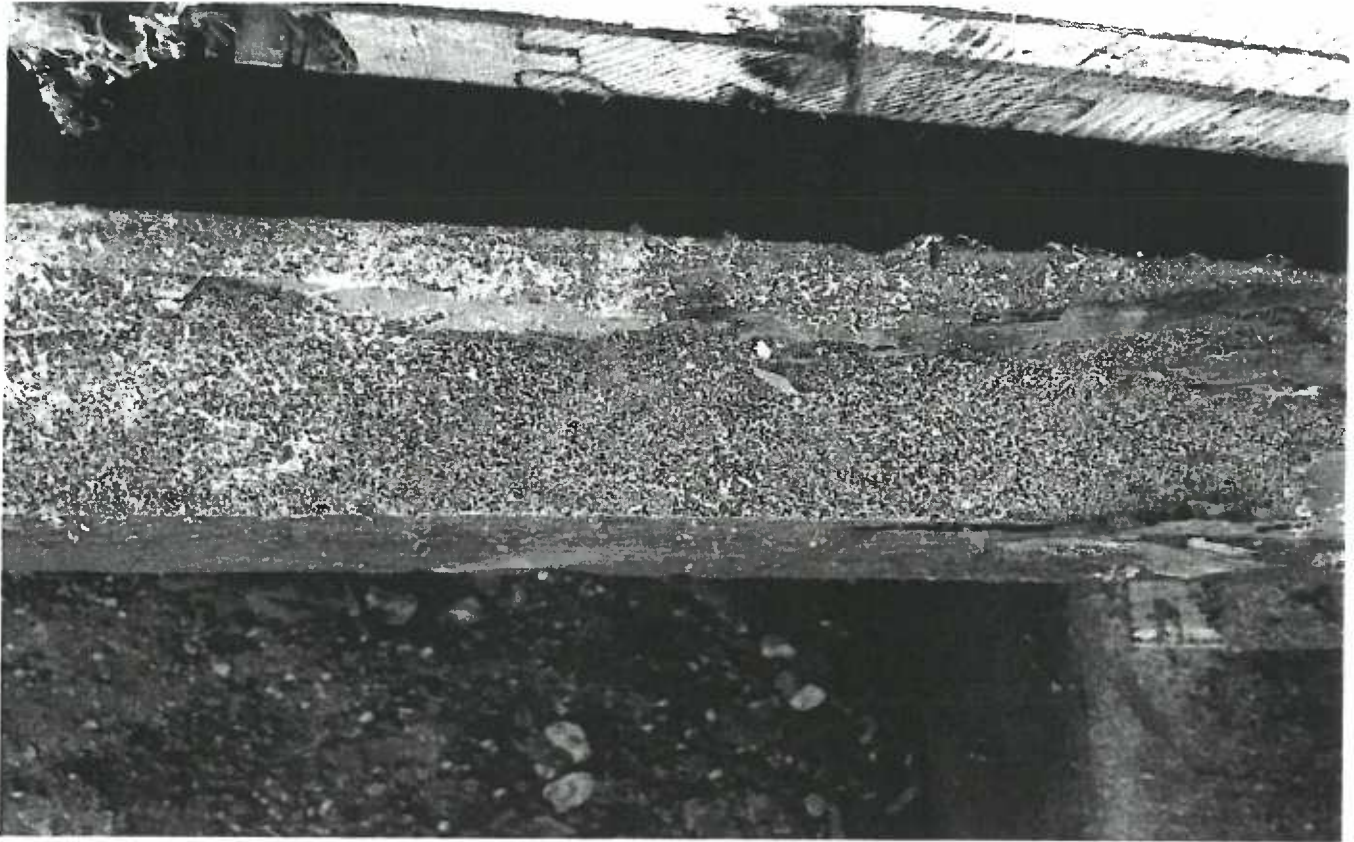
Figure 11. Heavy termite infestation and damage at floor joists

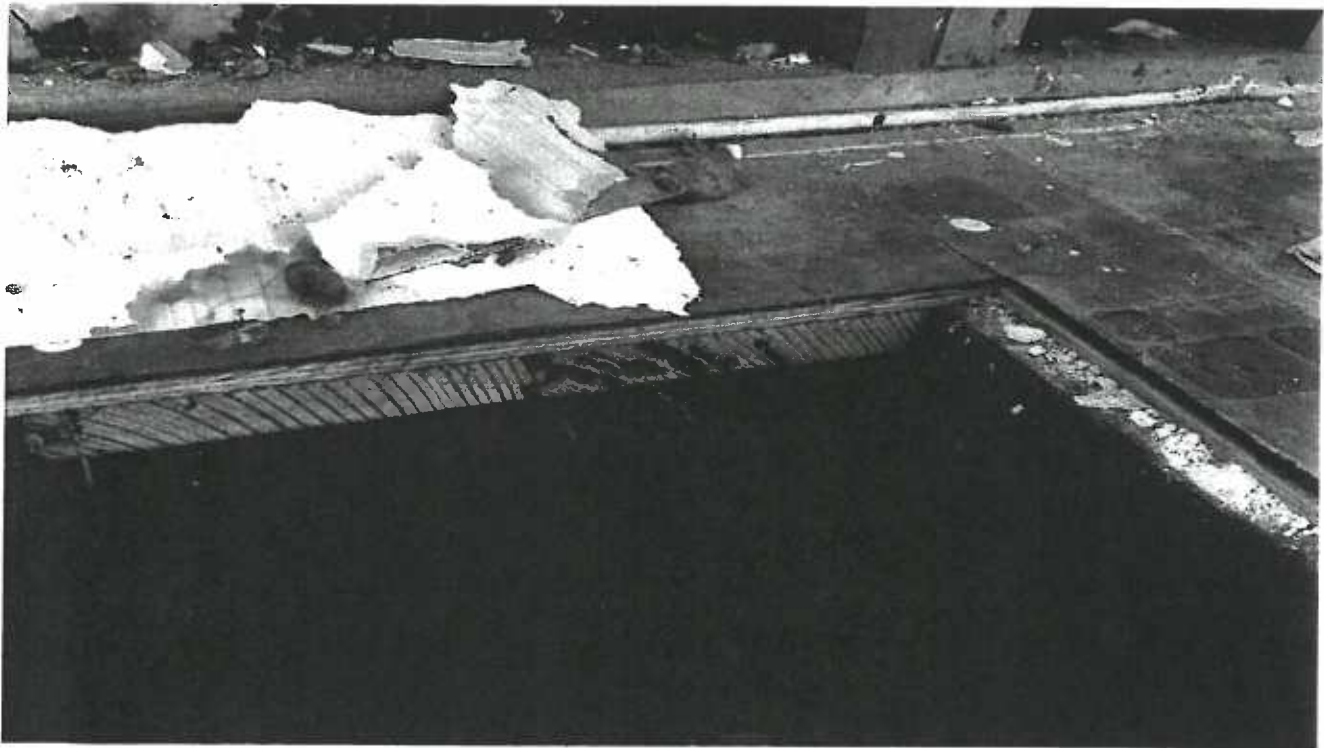
Figure 12. Heavy termite infestation and damage at floor deck

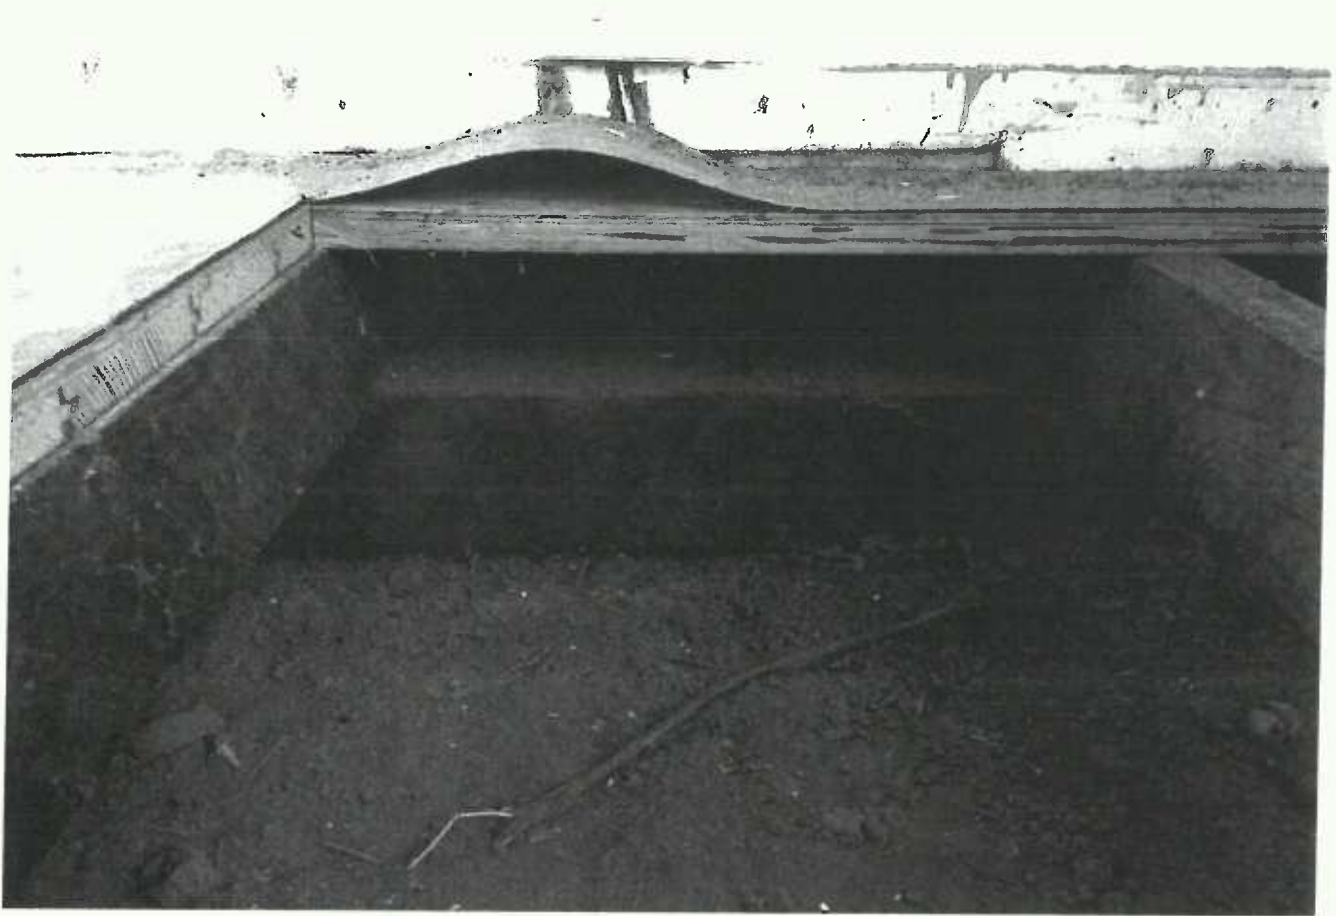
Figure 13. Heavy termite infestation and damage at floor deck

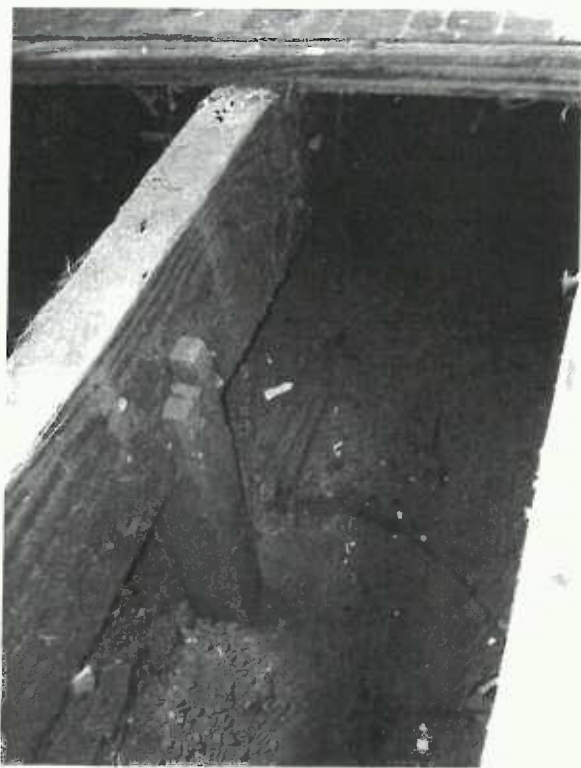
Figure 14. Posts bearing on soil alone

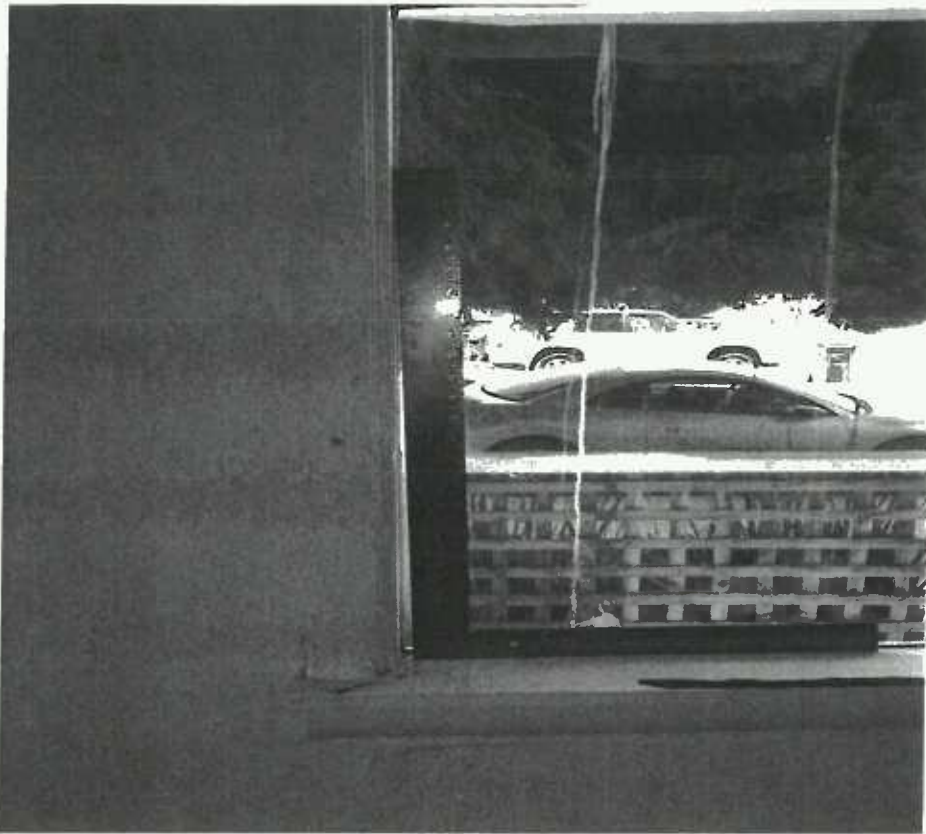
Since there is no wall framing or continuous top plate present, it is impossible to create any lateral bracing, which leaves the structure completely vulnerable to catastrophic failure by racking, twisting, and collapse. Evidence of the structural failure of the walls by 'racking' is indicated in photographs showing that the walls have already shifted significantly with the front wall of the structure leaning forward and toward the Southwest corner. Figure 15 shows a 24" framing angle with the framing out of plumb by 1/2" over 24", a significant deviation from plumb bearing when considering the significant roof load above.

Figure 15. Front wall showing significant racking/shift towards SW corner

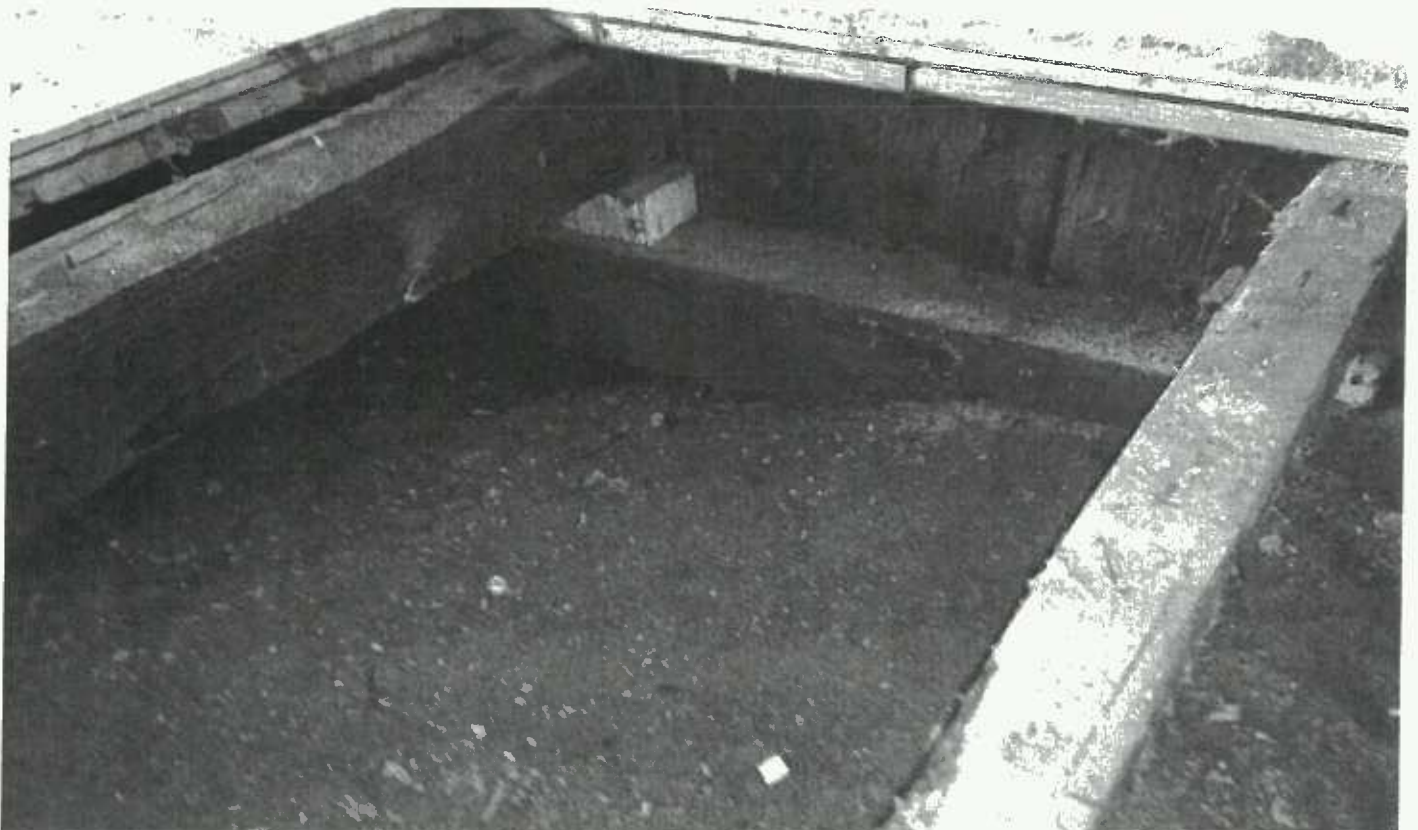
The 1x6 tongue and groove floor deck does not provide any lateral bracing in the floor plane. There is no solid blocking between floor joists (Figure 16). The roof rafters with 1x 'skip sheathing' (intermittent 1x boards laid across the 2x4 rafters) do not provide any lateral bracing in the roof plane either. There is no solid blocking between rafters to resist overturning and failure.

Figure 16. No solid blocking between floor joists

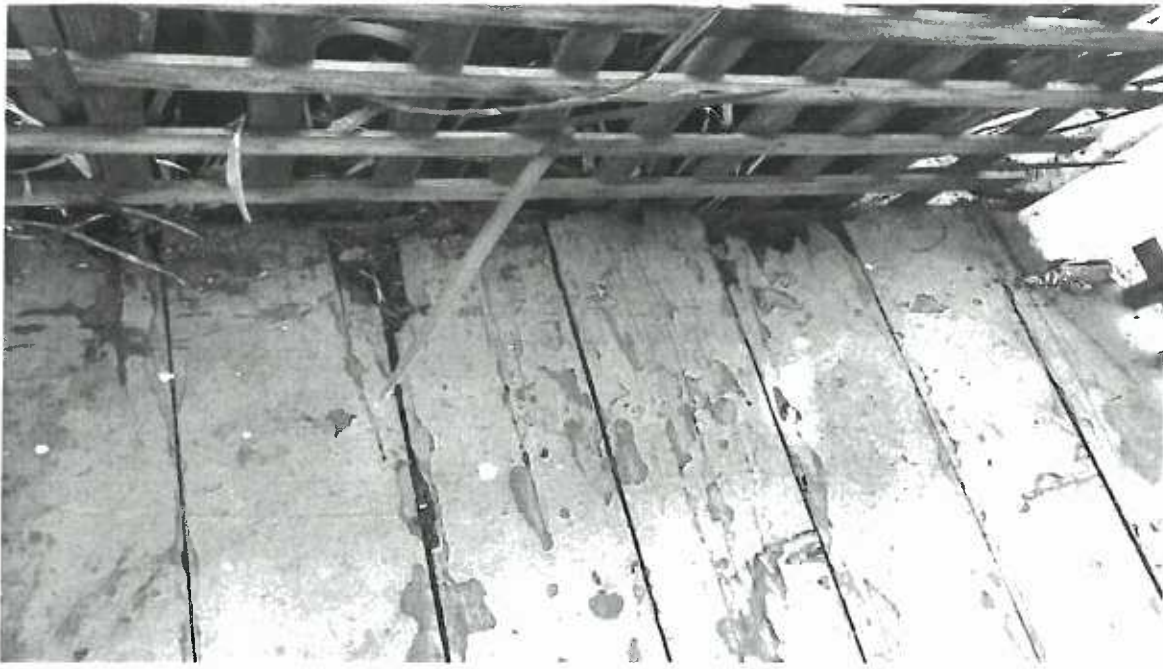
The front porch deck shows heavy damage (Figure 17) from rot due to support members bearing directly on soils and in contact with the concrete front steps, and sags significantly towards the street. There appears to be no foundation under the unrestrained 4x4 posts carrying the porch roof and posts do not even continue to the soil (Figure 18). The remaining deck framing members show extensive rot and damage. The guardrail appears to be a recent installation comprised of a single 2x4 rail spanning between the posts with lightweight garden trellis panels as infill. This does not appear to be compliant with current building codes and accepted construction practice.

Figure 17. Porch deck shows heavy damage

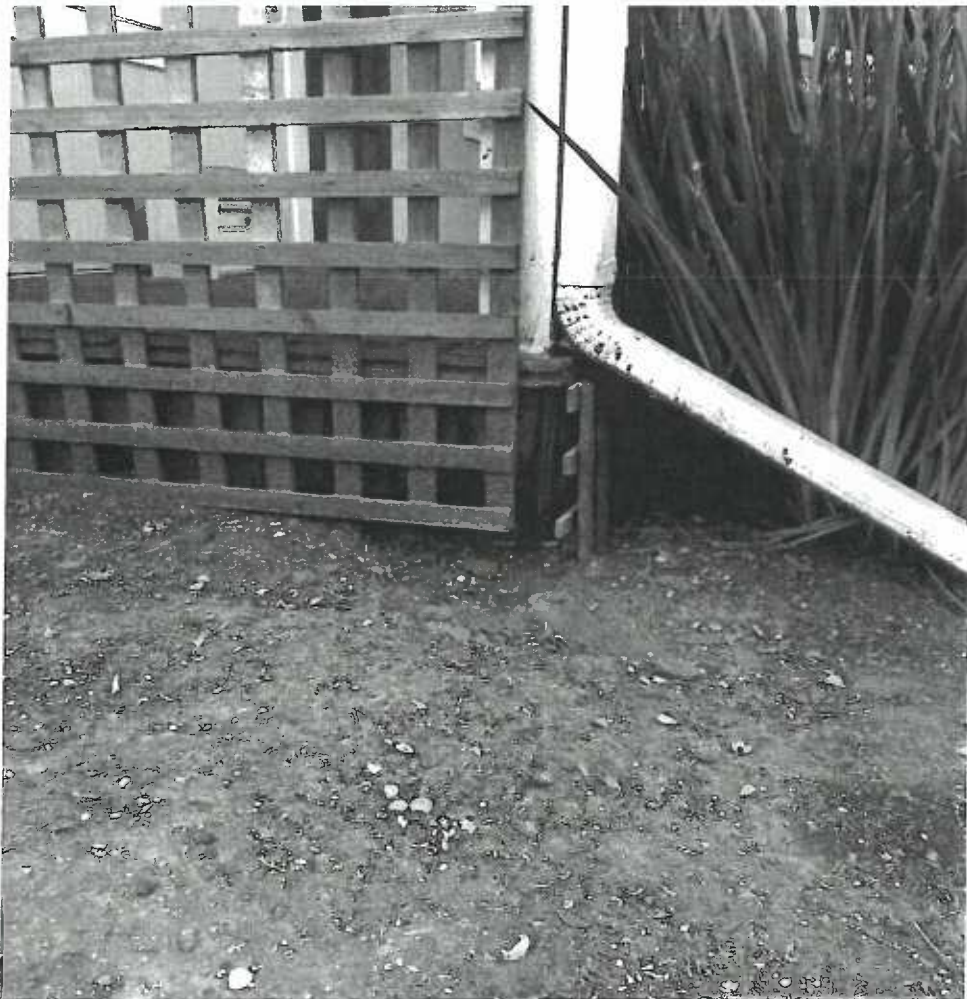
Figure 18. No bearing at porch posts. Extensive rot of remaining under deck members.
