Documenting Condition of Historic Resources (Goal 3B)

Agenda item 9C

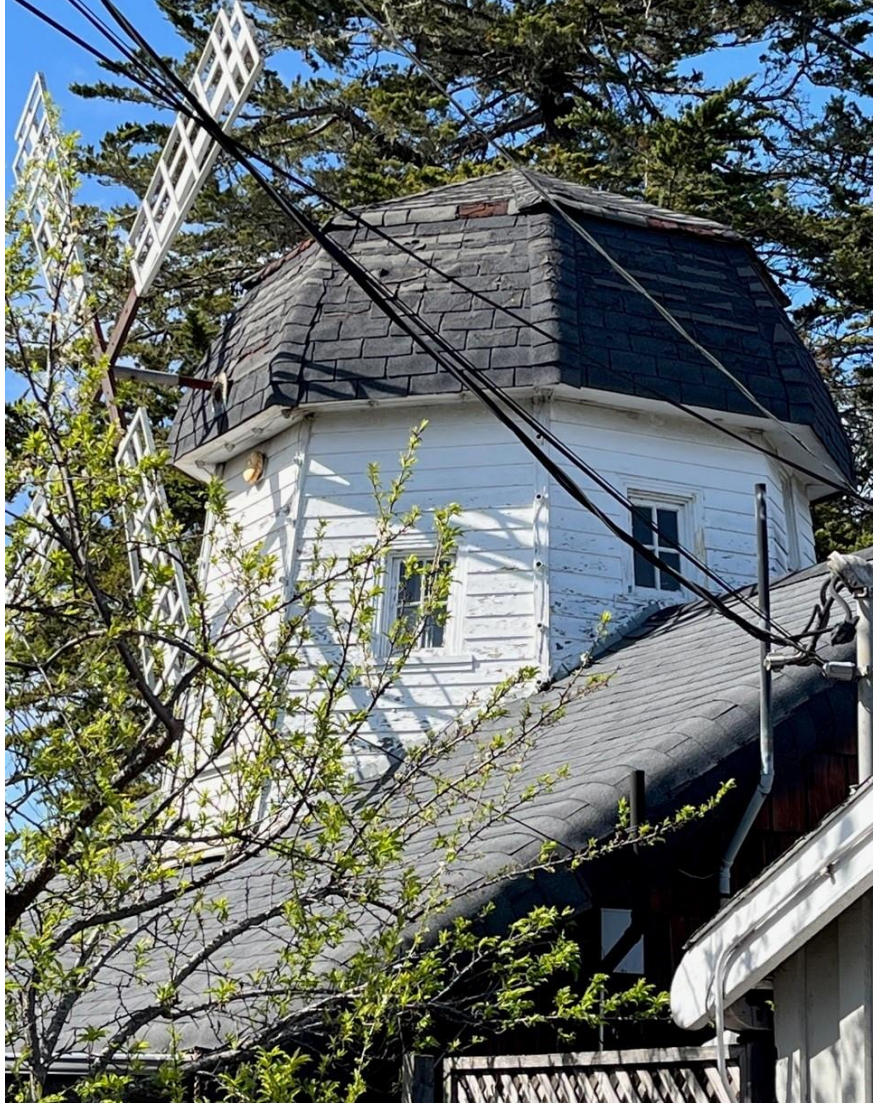
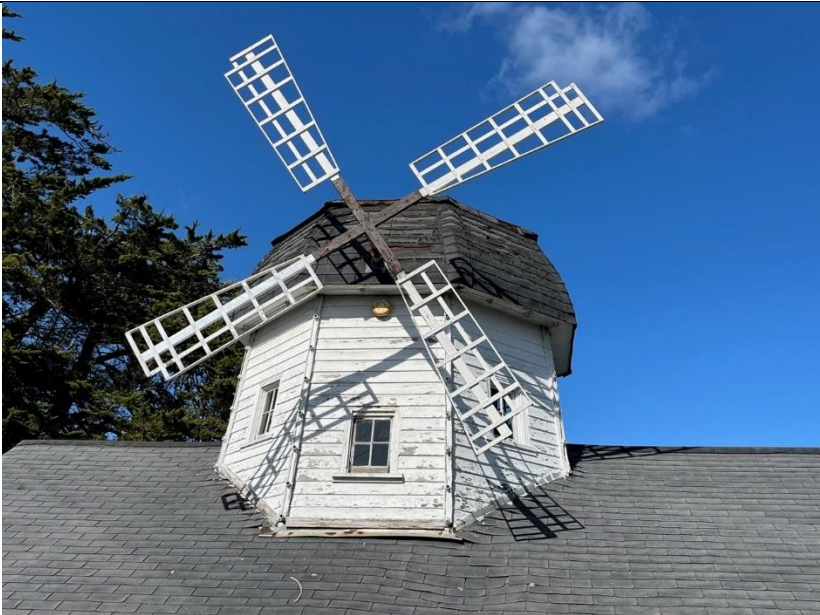
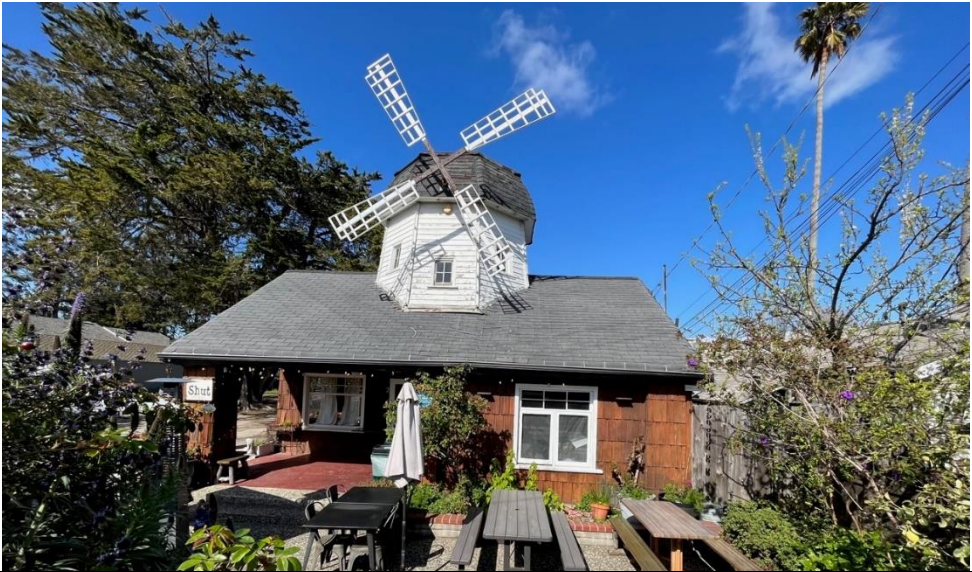
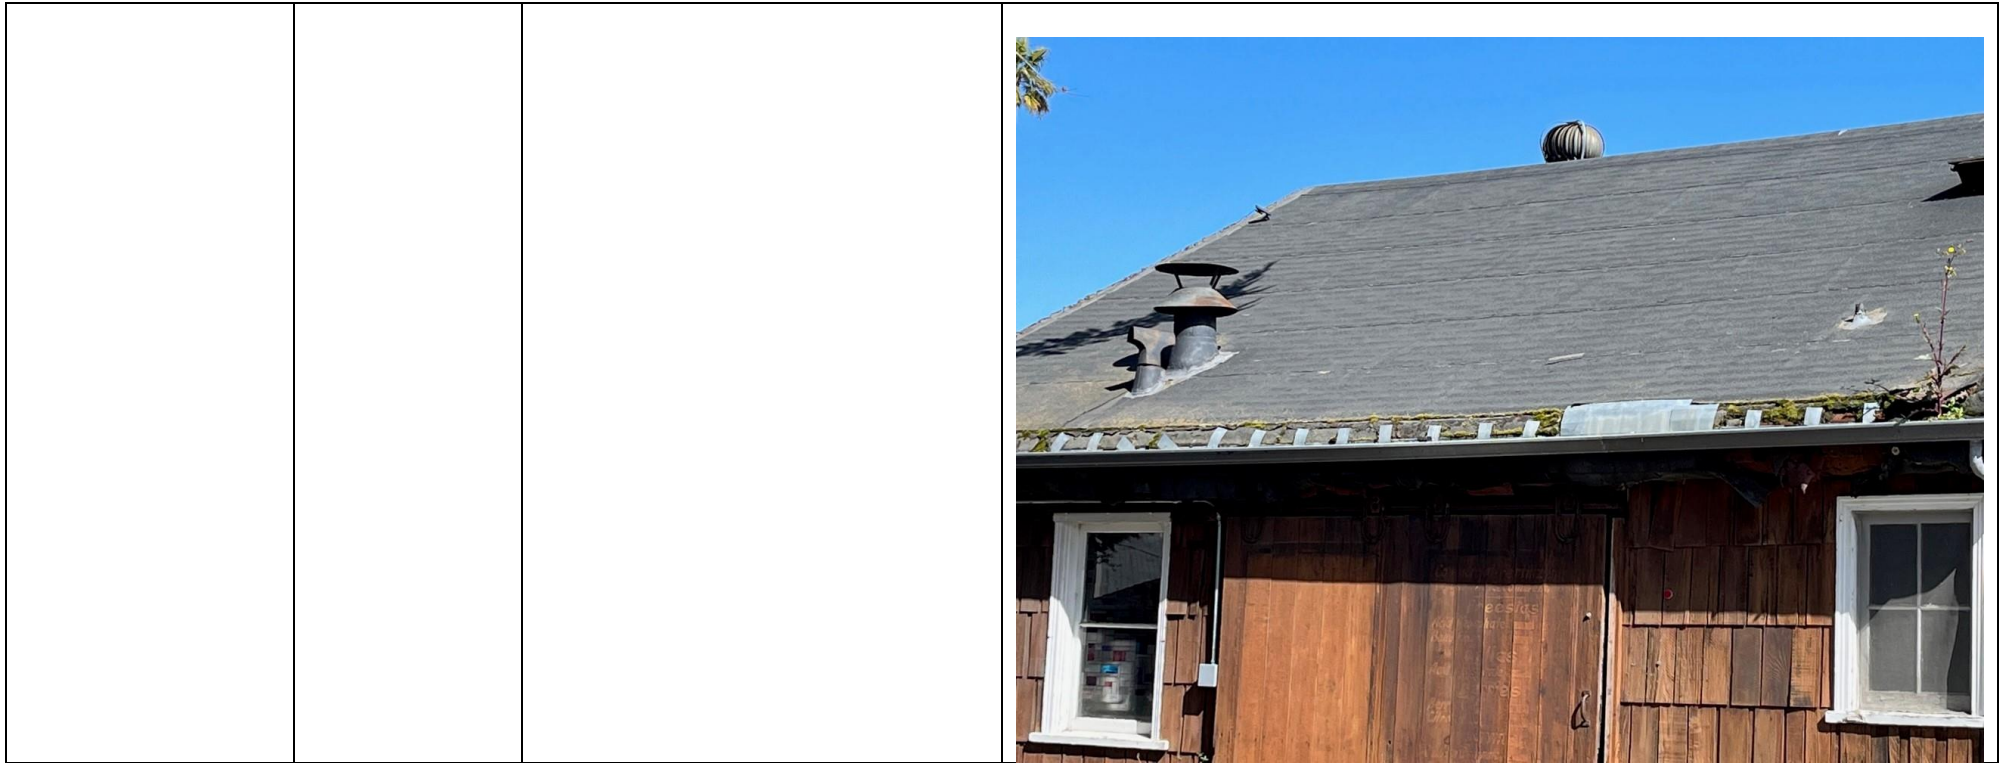
Address and Parcel Number/ Historic Name	Documenter/ Date	Condition of structure	Photos
<p>APN 027-211-13 21231 East Cliff Dr., Santa Cruz</p> <p>Buckhart's Candies</p>	<p>A. Murphy 3/23/23</p>	<p>Overall condition 3-4: Deferred maintenance may lead to structural problems and compromise the building:</p> <ol style="list-style-type: none">1. Roofing is in poor condition, with tiles showing damage. Lichen on tiles, weeds growing in roof gutter.2. Paint on windows and trim is in poor condition, with potential dry rot on window frames.3. Roof appears to be sagging in some areas.
