Mr. Conti Leung
CKL-Construction, Inc.
500 Cathedral Drive #2216
Aptos, CA 95001-2216
Re: 101 Esplanade -Fire Damage
101 Esplanade
Aptos, CA 95003

101 Esplanade -Fire Damage

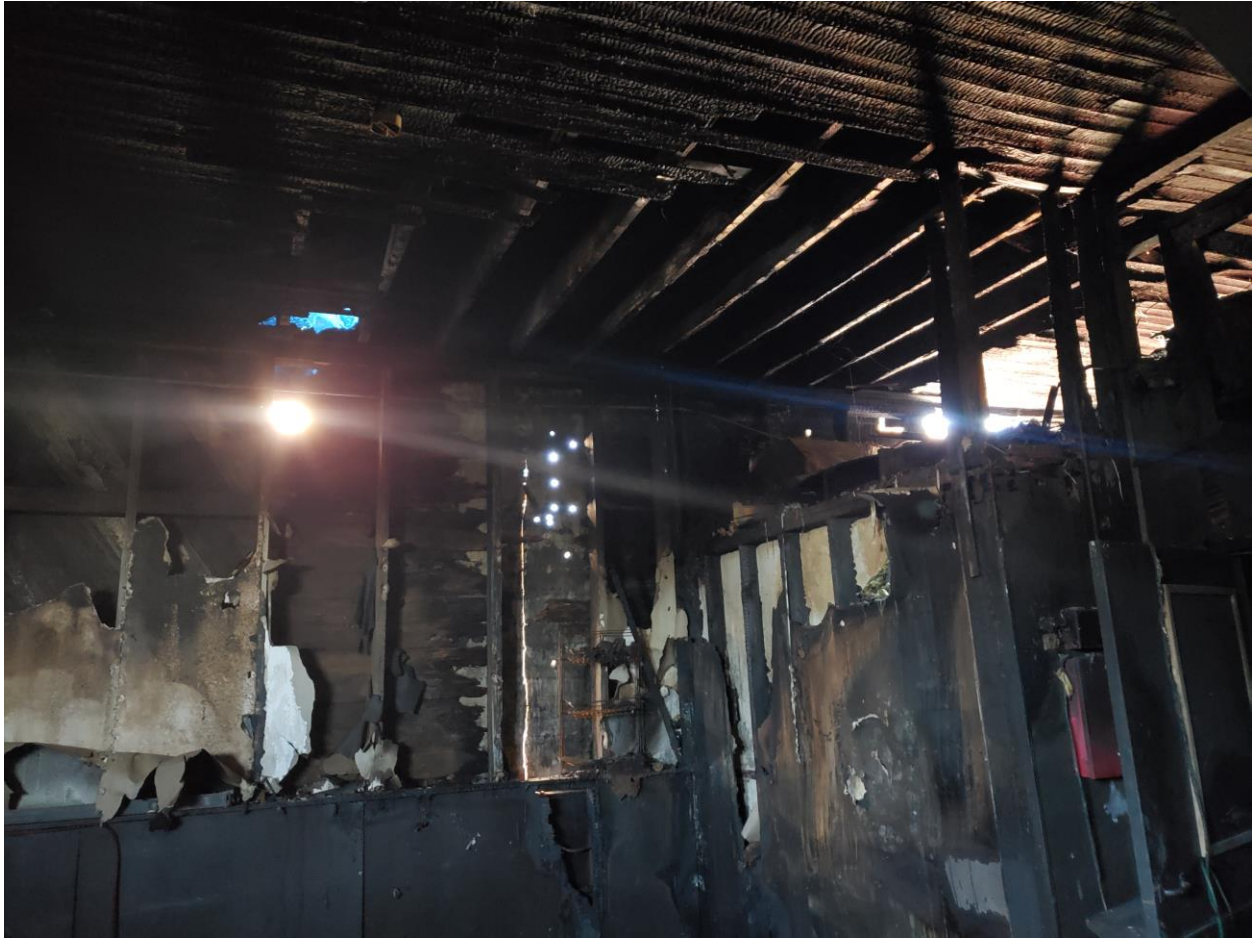
The 2nd floor joists/top plates have been severely damaged. These joists have lost its load carrying capacity and lateral supports for the walls have been compromised. Interior wall have been damage and lost its load carrying capacity.

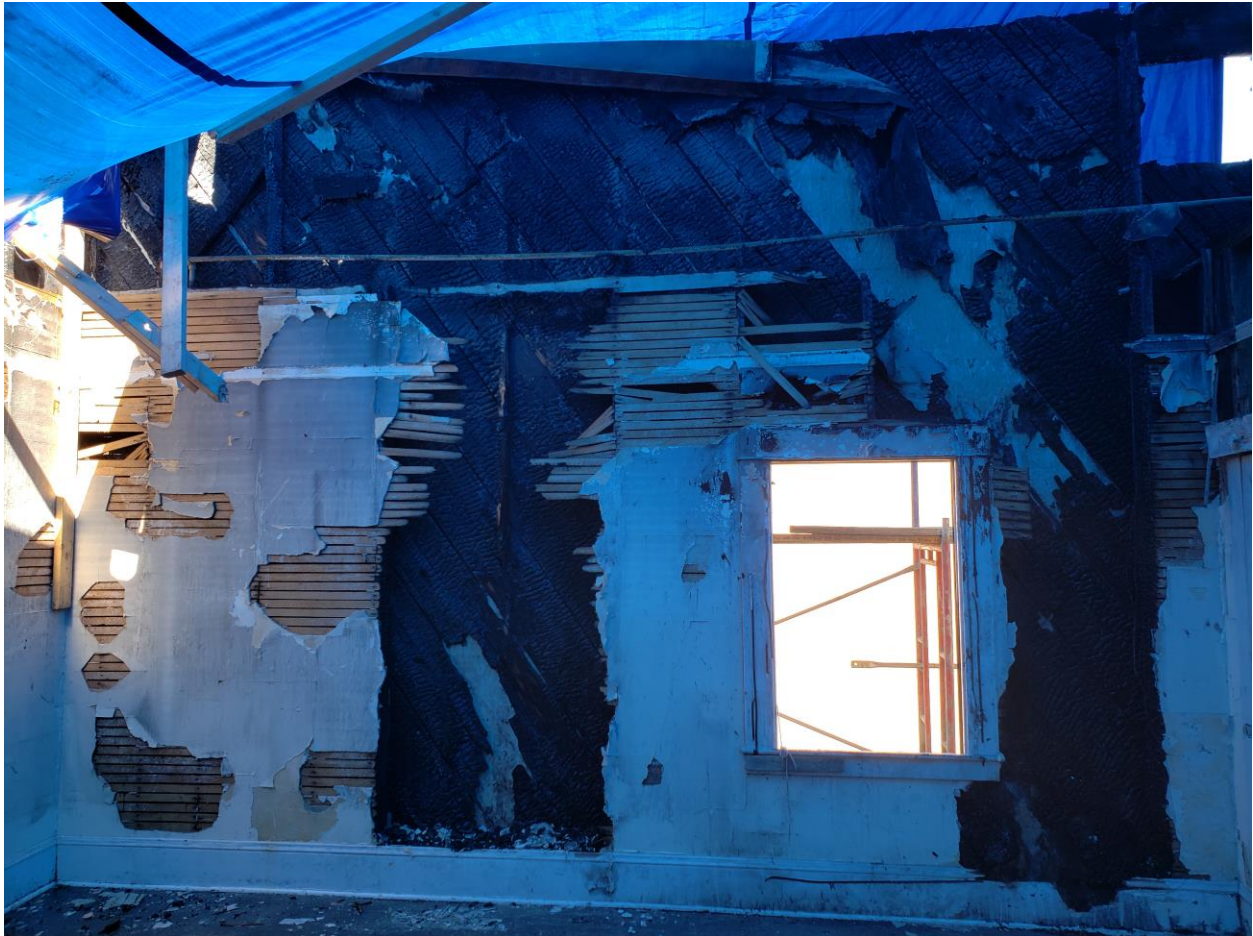
2nd Floor stud walls have been destroyed. The fire travel below and sole plates and into the joist and top plates below. The gravity loading carrying capacity lateral supports of the wall have been compromised.

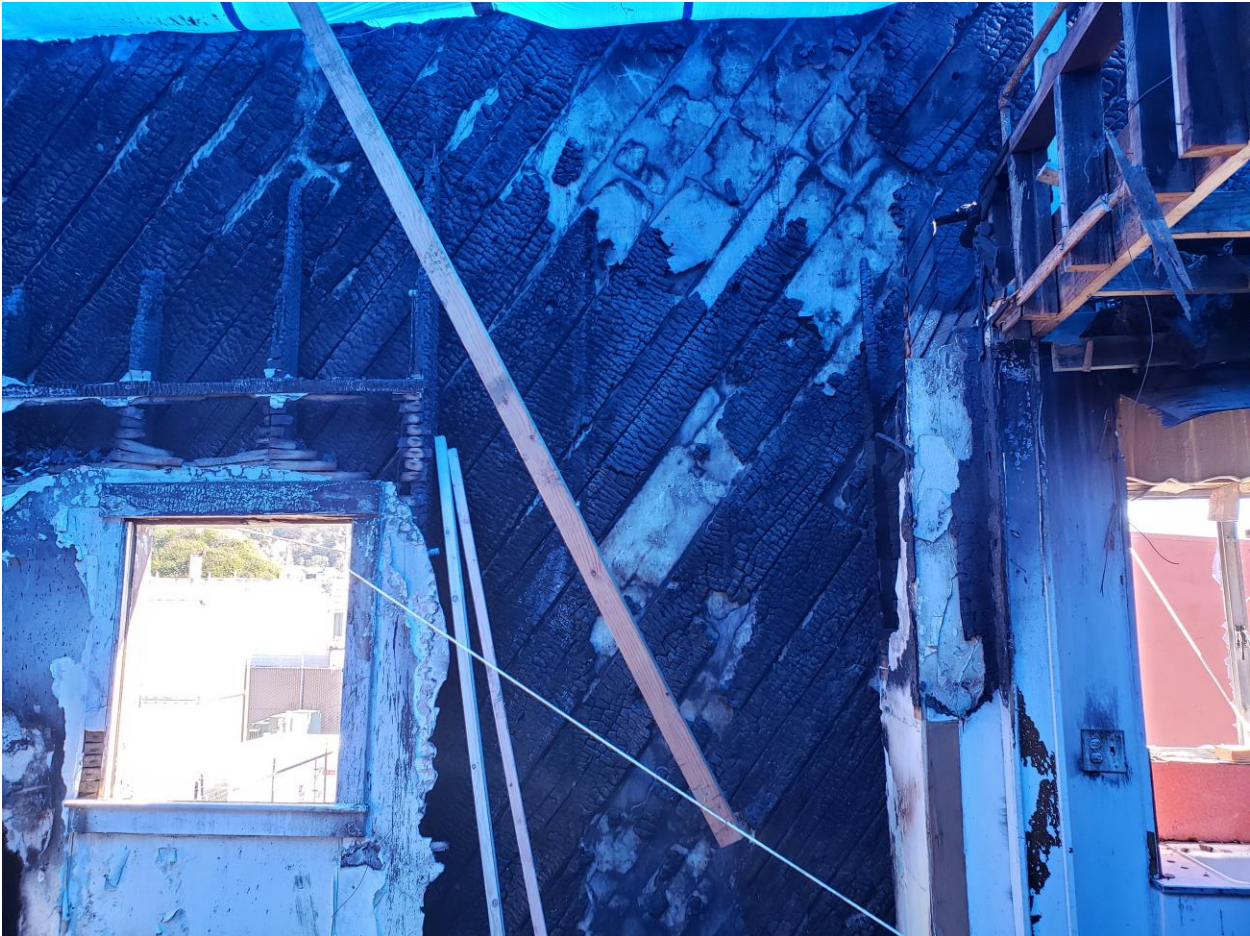
2nd Floor stud walls have been destroyed. There's no gravity or lateral support for the walls.

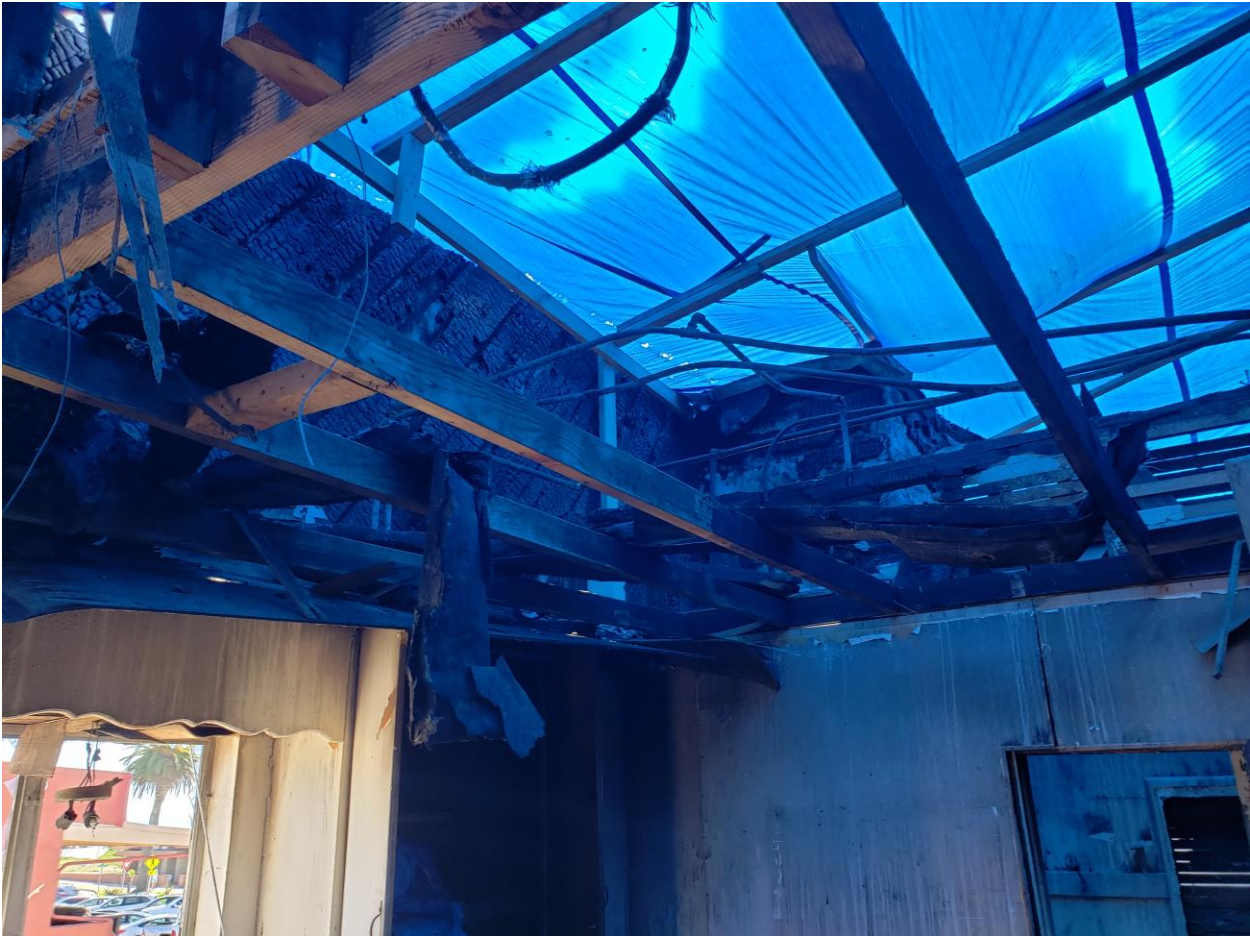
The roof have been completely destroyed by the fire. There's no lateral support for the walls.
