# Staff Report to the Zoning Administrator

Applicant: County of Santa Cruz, DPW Owner: County of Santa Cruz, Department of Public Works APN: No Situs, work within the public rightof-way (except a small portion of work within APN 032-251-01) **Agenda Date:** 10/1/04 **Agenda Item #:** 8

**Project Description:** Proposal to repair four crib walls in emergency failing condition through installation of soil nails, primary and secondary shotcrete facing, and finish facing with sculpting and staining (total 300 linear feet); temporarily removing and replacing portions of a stairway as needed to accomplish the work; and approximately 733 cubic yards of grading.

Location: Southeast side of East Cliff Drive between 33<sup>rd</sup> Avenue and 36<sup>th</sup> Avenue

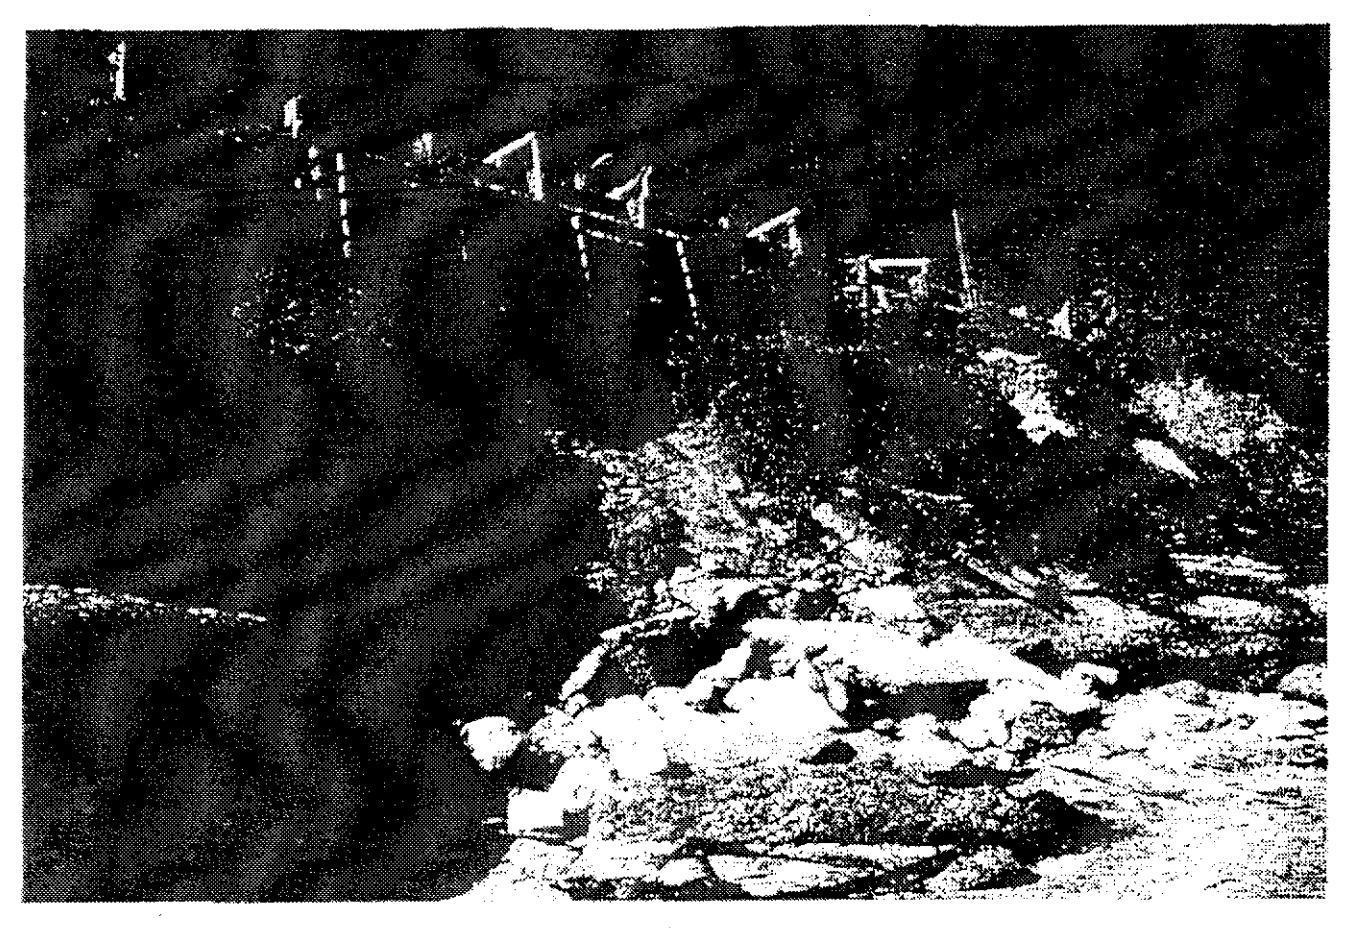
Wall # 2

Wall 2 is the only crib wall along the bluff founded entirely on terrace deposits. Erosion of the terrace deposits has undermined the central portion of the wall, resulting in the complete loss of infill in one section of the crib wall. Consequently, a vertical shaft **has** formed and daylights in the overlying asphalt concrete. The lower crib elements have ruptured where the wall is undermined, effectively eliminating much of the bluff support in **this** area, and putting the wall in danger of immediate collapse.

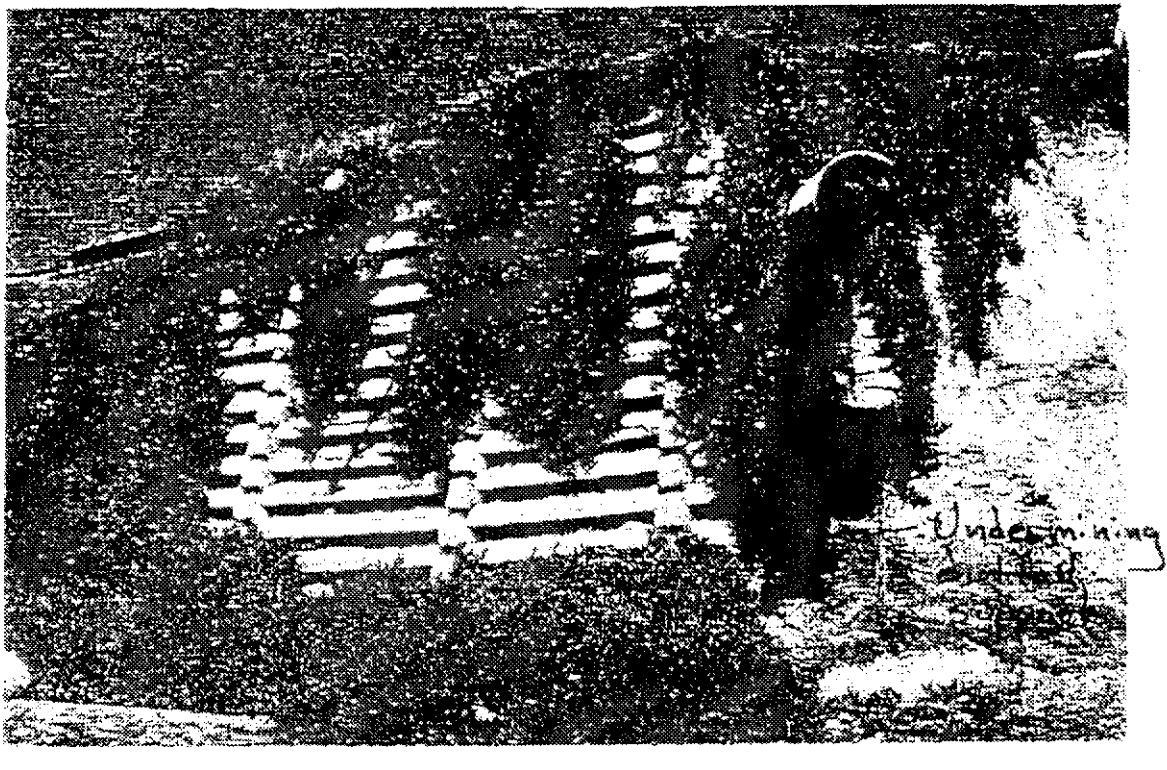
Wall #3

Wall 3 exhibits moderate structural distress, apparently due to corrosion within the fascia, although only the undermined concrete support for the adjacent outfall pipe appears to be in danger of collapse.

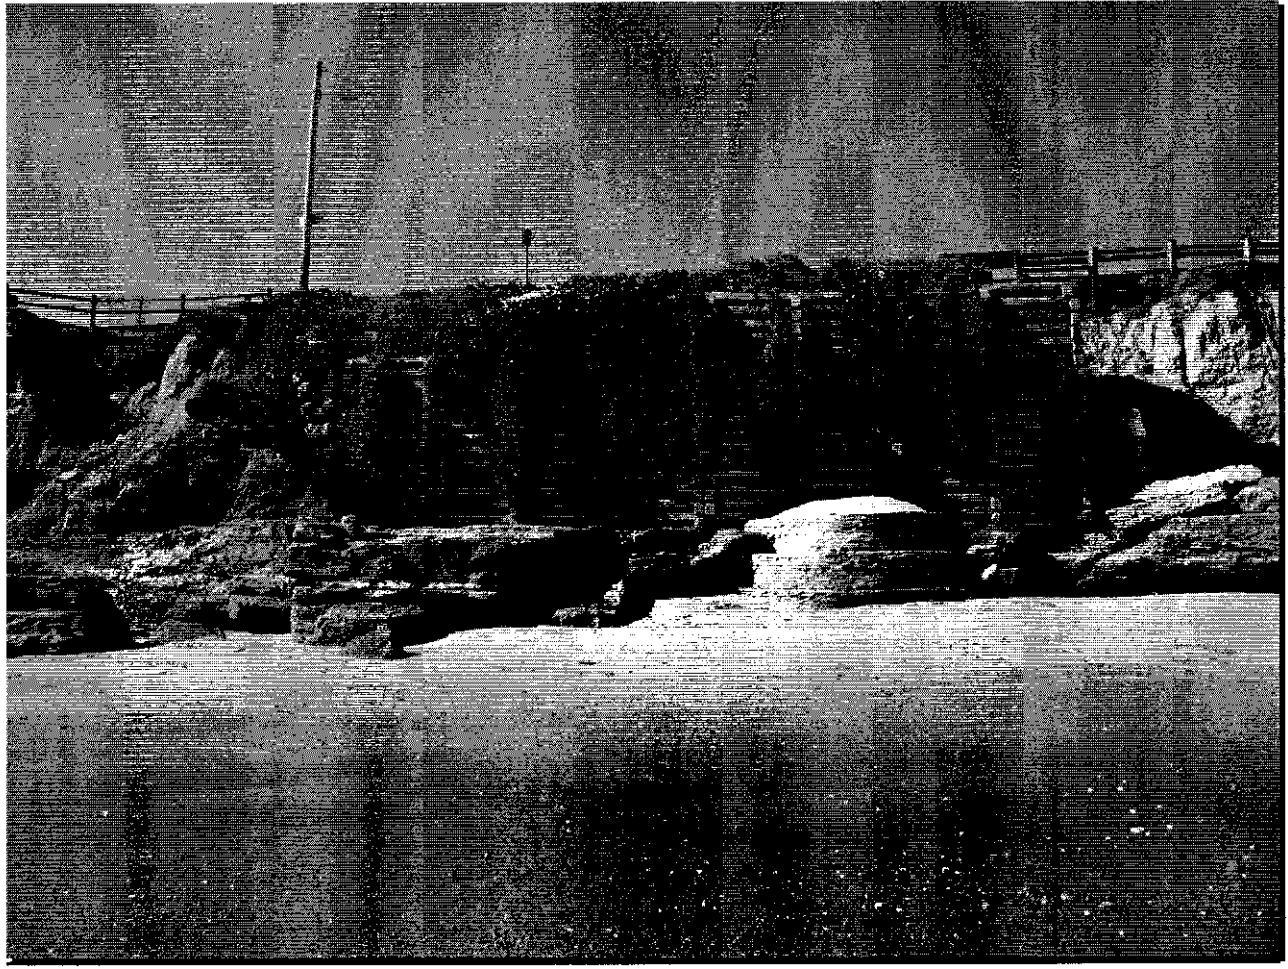
### **CRIB WALL #1** (33<sup>rd</sup> Avenue) (fig.1)

STA 0+69.25 /12.467m R to STA 0+79.61 /10.991m R Length = 52 feet (8 crib sections @ 6.5 feet) Height = 18 feet (18 crib sections @ 1 foot) Depth = 6.5 feet into slope Batter = 1:19 Elevation difference from roadway to top of wall = about 4 feet below Elevation difference from bottom of wall to purisima shelf = 0 feet

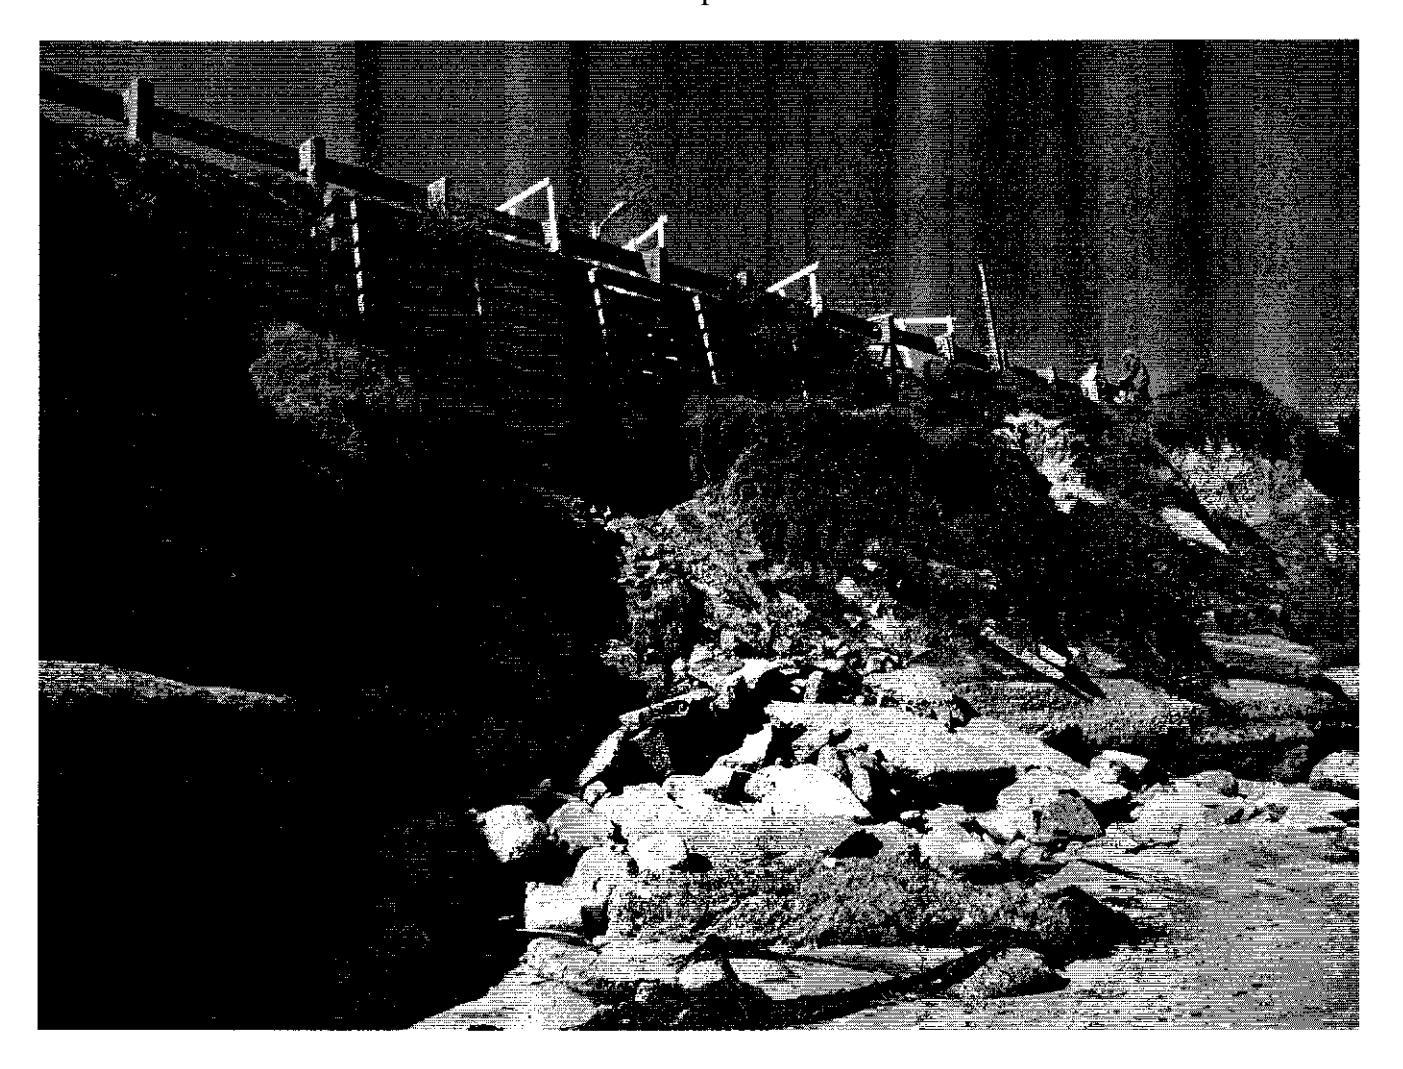
#### STA 1+10.42 / 8.506m R to STA 1+26.15 / 8.17m R

Western portion Length = 18 feet Height = 7 feet Depth = 6.5 feet into slope No Batter Elevation difference from roadway = 2 feet below Elevation difference from purisima shelf = 15.3 feet above purisima Eastern portion Length = 33 feet (5 crib section @ 6.6 feet) Height = 9 feet Depth = 6.5 feet Batter = 1:6 Elevation difference from roadway to top of wall = about 0.3 feet below Elevation difference from bottom of wall to purisima shelf = **14** feet above

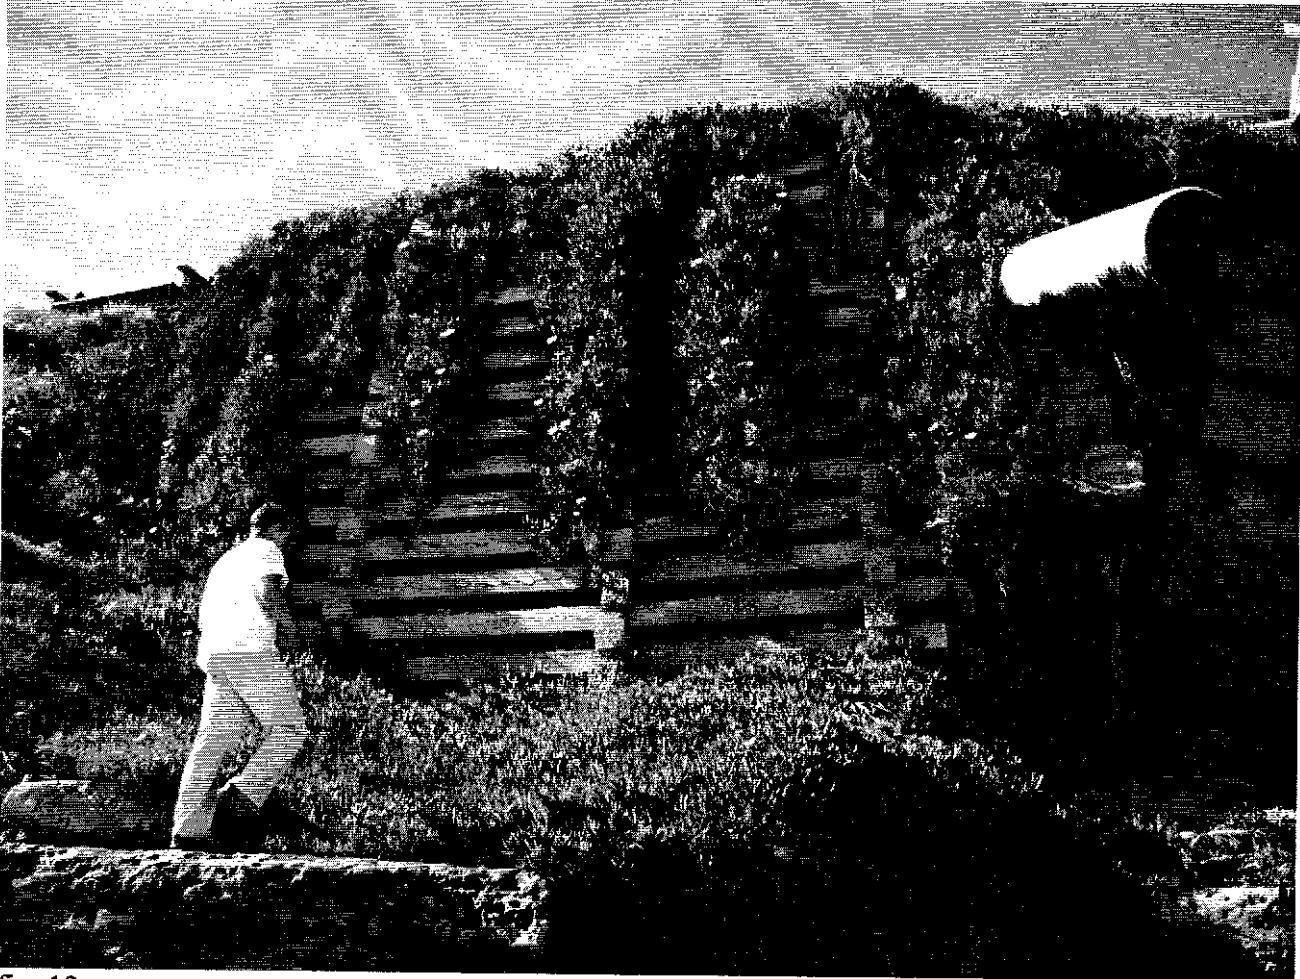
#### STA 2+47.91 / 10.648m R to STA 2+53.58 / 10.357m R

Length = 18 feet (3 crib sections @ 6 feet) Height = 15 feet (15 crib sections @ 1 foot) Depth = 6.5 feet (1 crib section) into slope Batter = 1:6 Elevation difference from roadway to top of wall = about 3 feet below Elevation difference from bottom of wall to purisima shelf = 2 feet

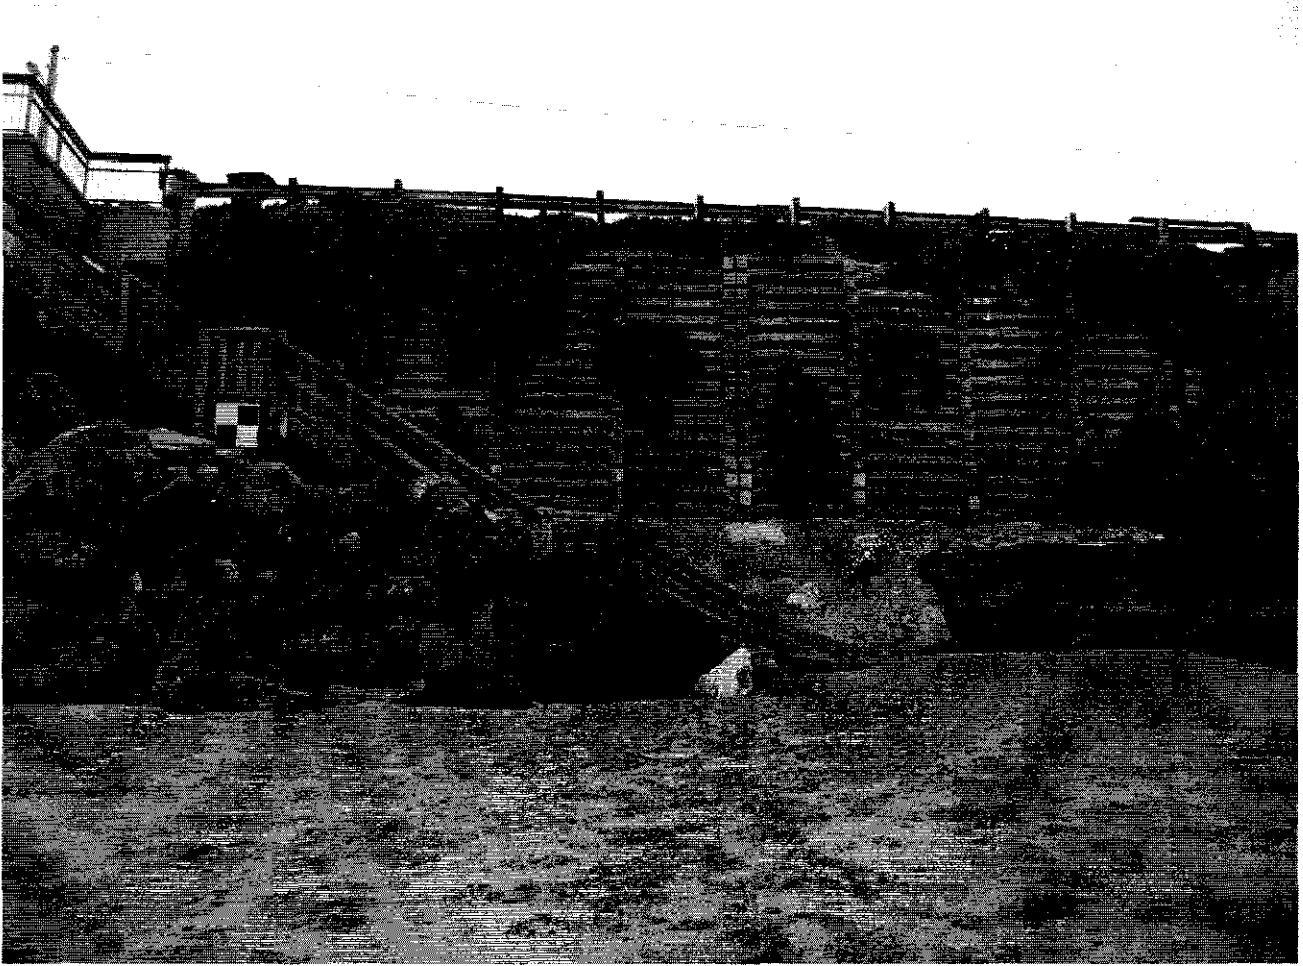
#### STA 3+09.58 / 10.641m R to STA 3+25.43 / 10.943m R

Length = 52 feet (8 crib sections @ 6.5 feet) Height = 16 feet (16 crib sections @ 1 foot) Depth = 6.5 feet (1 crib section) into slope Batter = 1:25 Elevation difference from roadway to top of wall = about 3.2 feet Elevation difference from bottom of wall to purisima shelf = 0 feet

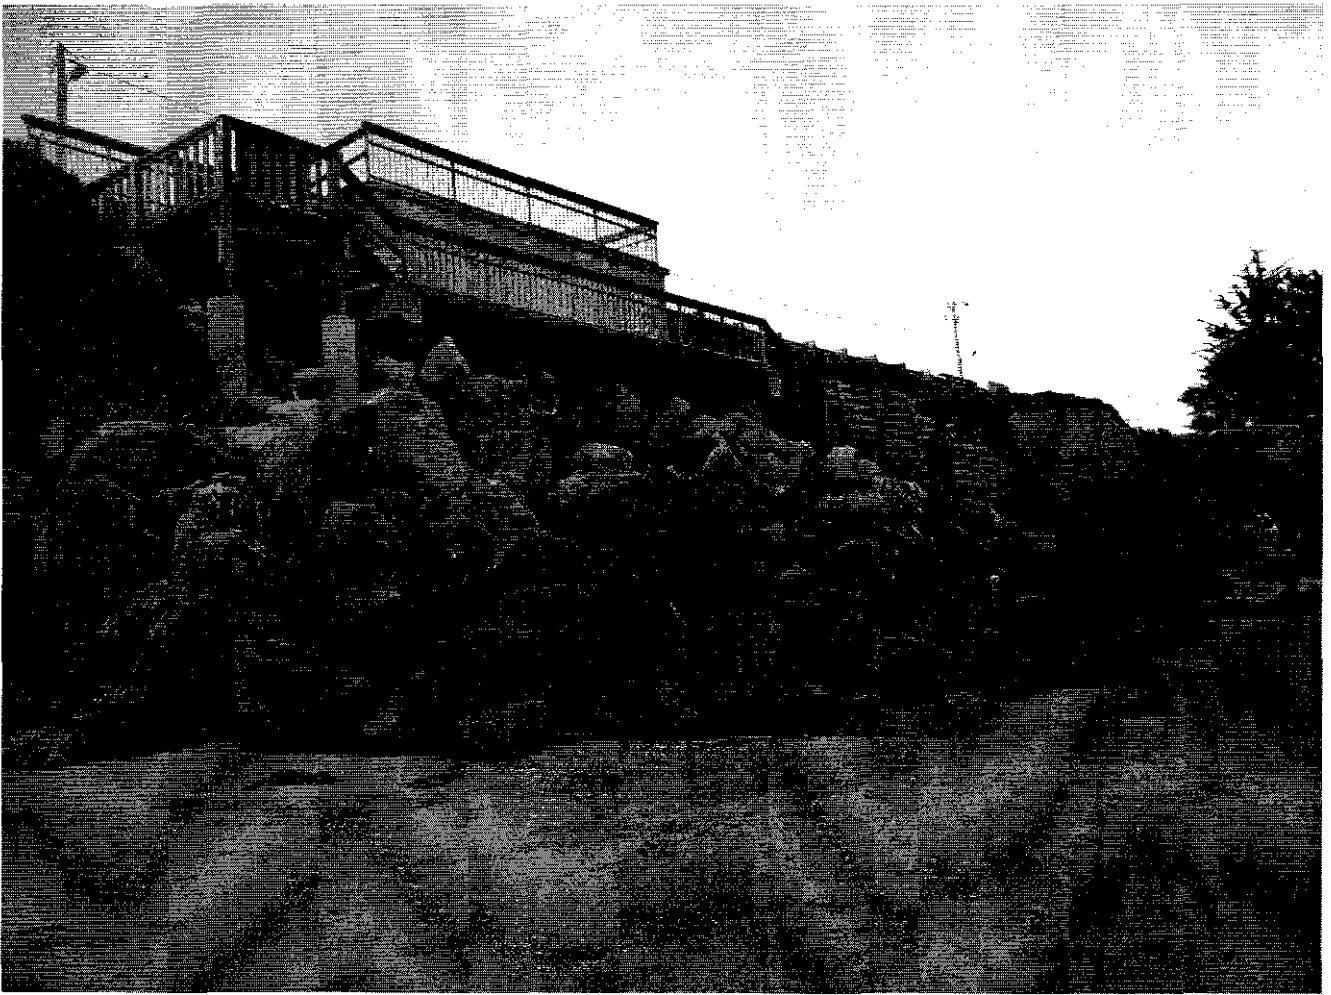
fig. 14

Building footprint =  $27.4 \times 11.4$  feet Concrete slab =  $34.3 \times 8.5$  feet Elevation difference from roadway to top of building = **1.3** feet Elevation difference from bottom of building to purisima shelf approx. = 12 feet
