NOTICE OF ENVIRONMENTAL REVIEW PERIOD SANTA CRUZ COUNTY

APPLICATION NO.: 07-0379

This proposal is to install a crib wall to stabilize the roadway embankment and to repair any road damage that occurred during the 2005-2006 storm season. The project is located in Soquel on North Main Street, approximately 0.8 mile from the intersection with Soquel Drive. The project requires a Riparian Exception and Preliminary Grading Approval.

Soquel Creek Roadway Embankment Repairs

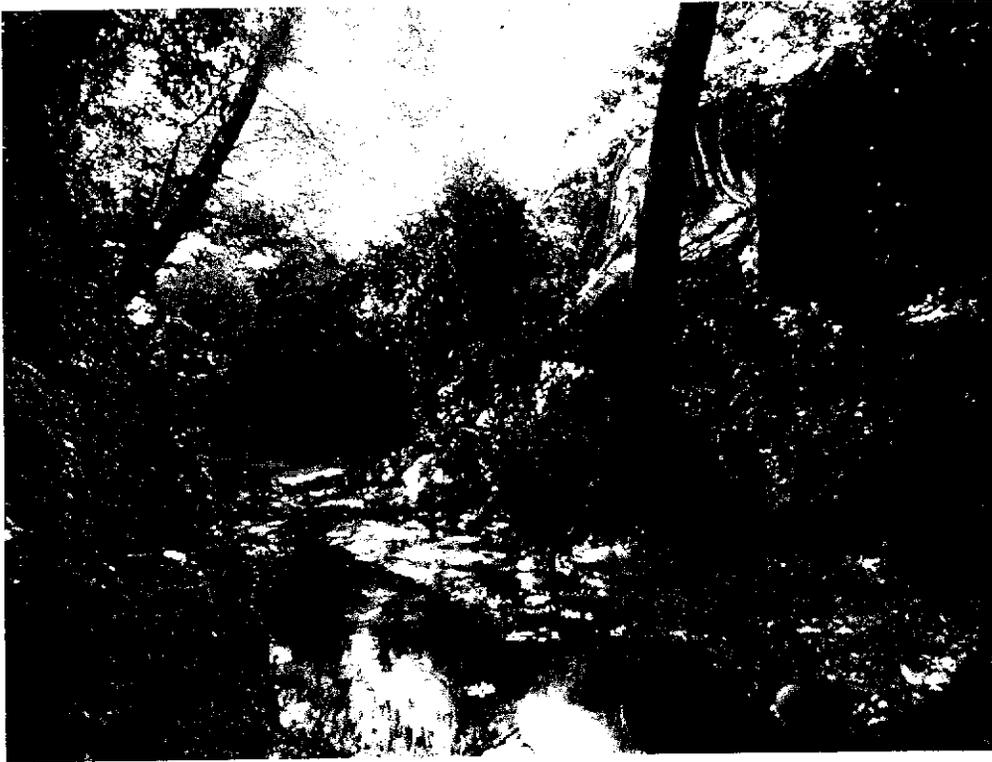
Photograph 3. County Action Area. View of slide and riparian corridor of Bates Creek looking downstream.

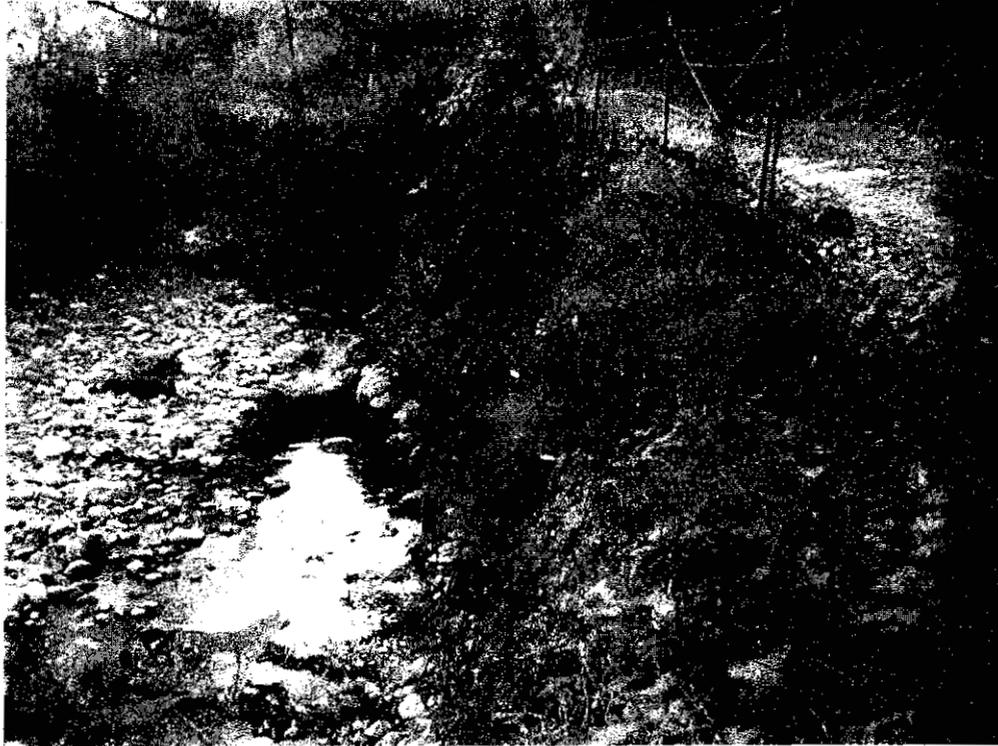
Photograph 5. State Action Area (P.W. #2619). View of creekbank/roadway embankment failure on Hihn's Mill Road adjacent to the East Branch of Soquel Creek.

Damage to the State action area occurred when high stormwaters in the East Branch of Soquel Creek caused the failure of the creek bank below the north side of Hihn's Mill Road in the Soquel Demonstration State Forest. The failed creek bank exposed layers of alluvial substrate, road fill, and road rock. This loss of substrate produced tension cracks along the outer edge of the road on top of the stream bank undermining the stability of the road and making it susceptible to further damage during future high flow events.

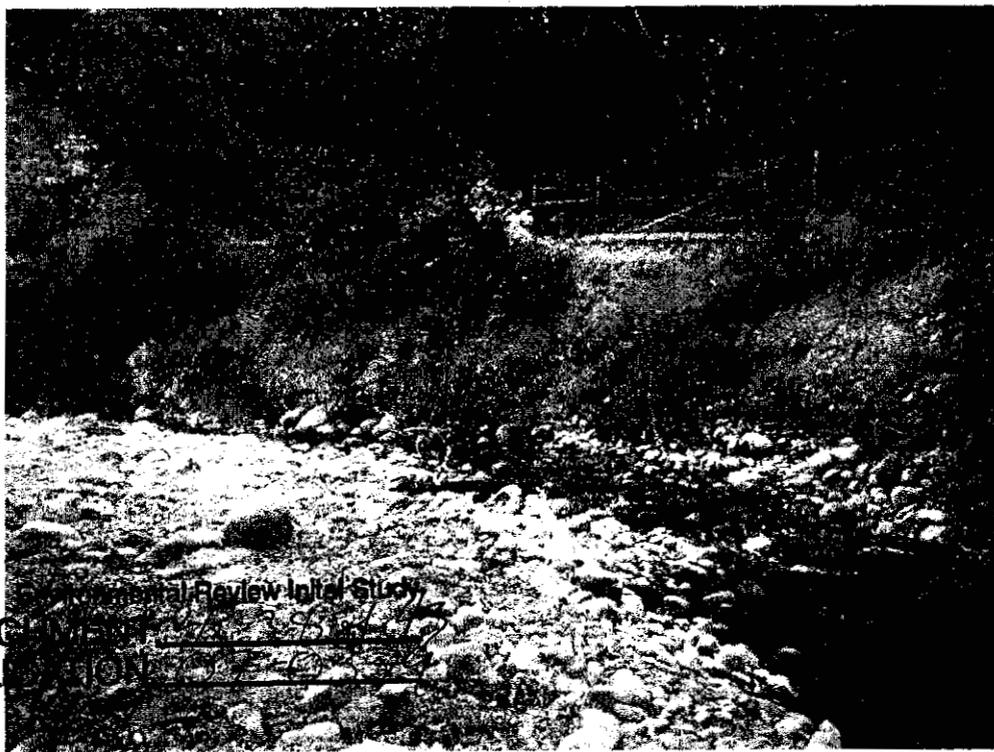
Photograph 6. State Action Area. View of creekbank/roadway embankment failure from creekbed showing exposed alluvial substrate and road fill material.

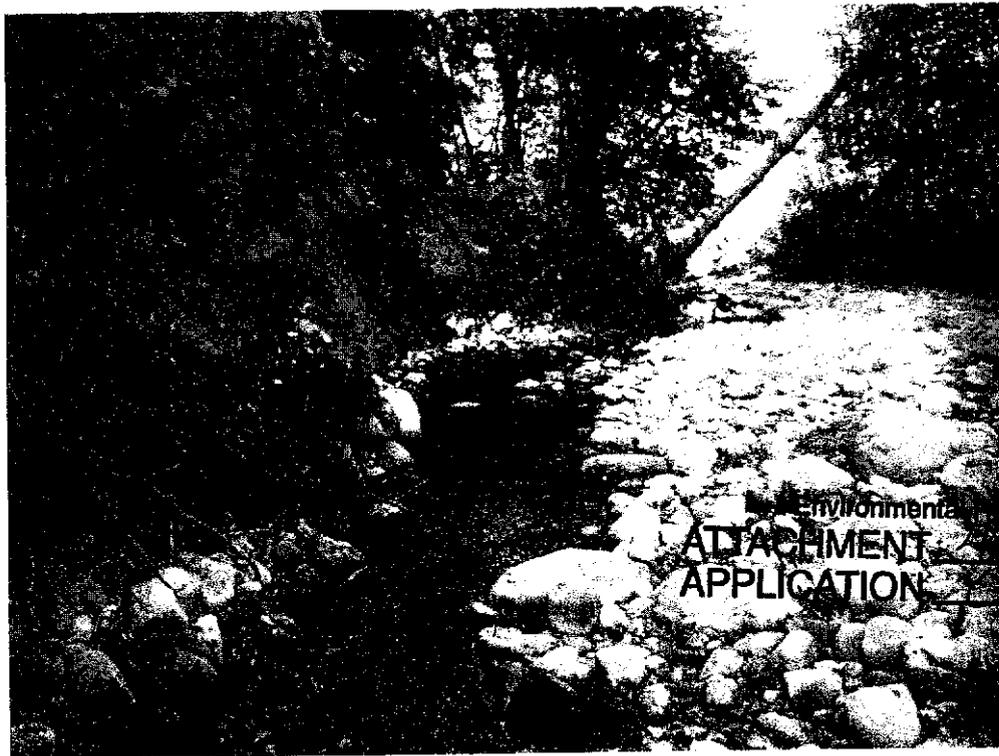
Photograph 8. State Action Area. View looking downstream showing slide area and active channel of creek.

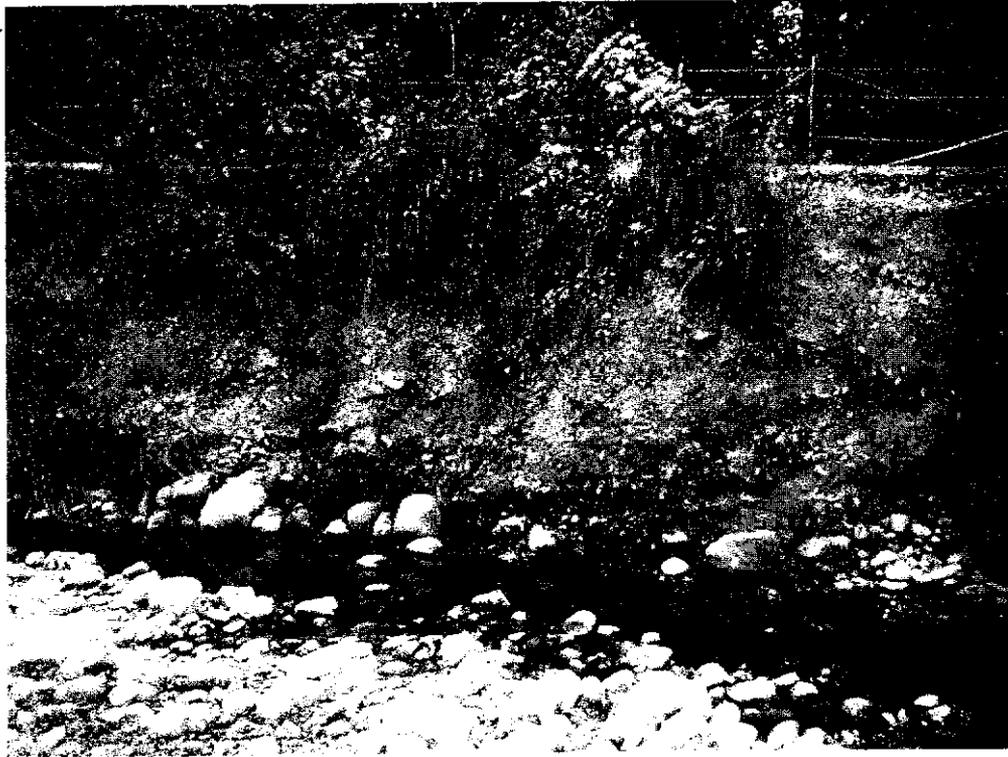
Photograph 9. State Action Area. View of failed creekbank/roadway embankment below Hihn's Mill Road showing alluvial substrate and remaining patches of riparian vegetation on upper part of bank.

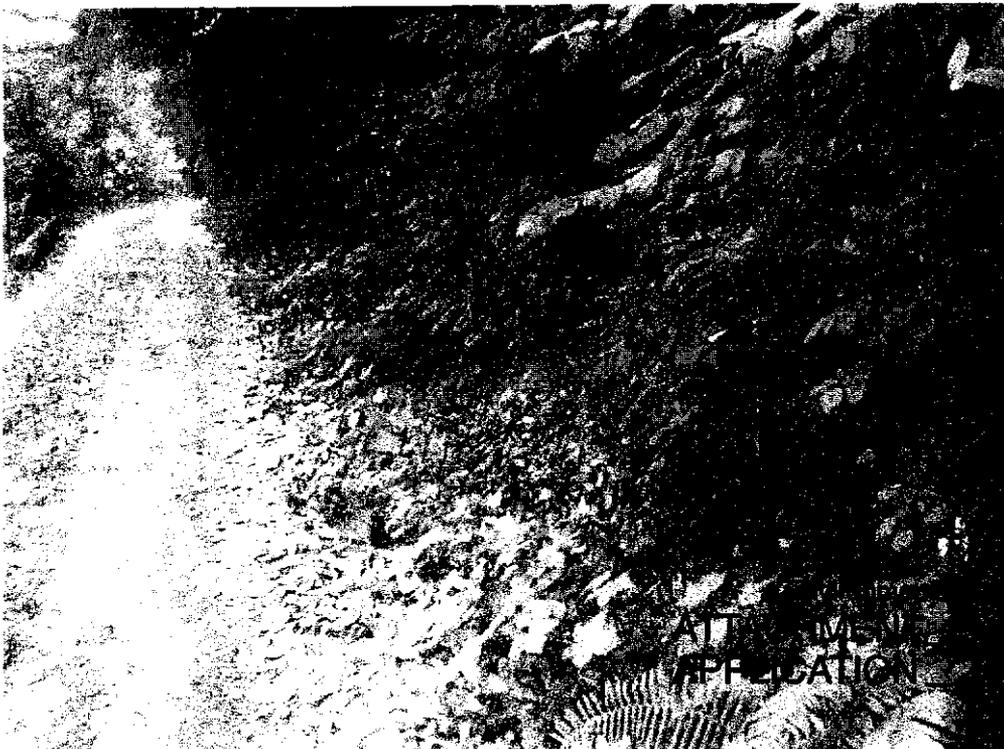
Photograph 12. State Action Area. Cut bank side of Hihn's Mill Road where vegetation will be removed to widen roadway.

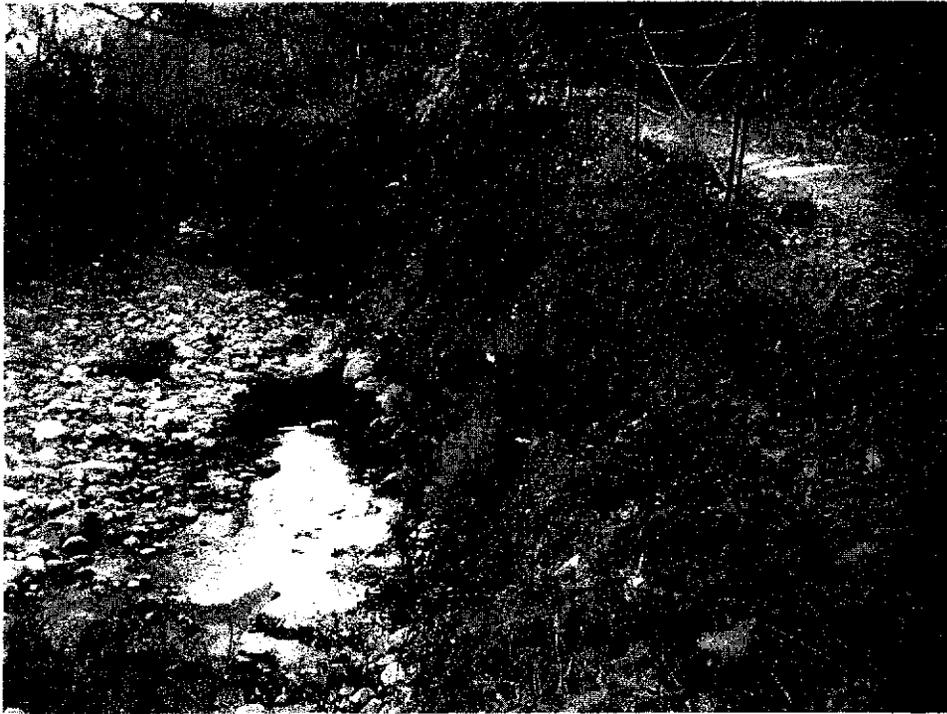
Photograph 5. State Action Area (P.W. #2619). View of creekbank roadway embankment failure on Hihn's Mill Road adjacent to the East Branch of Soquel Creek.

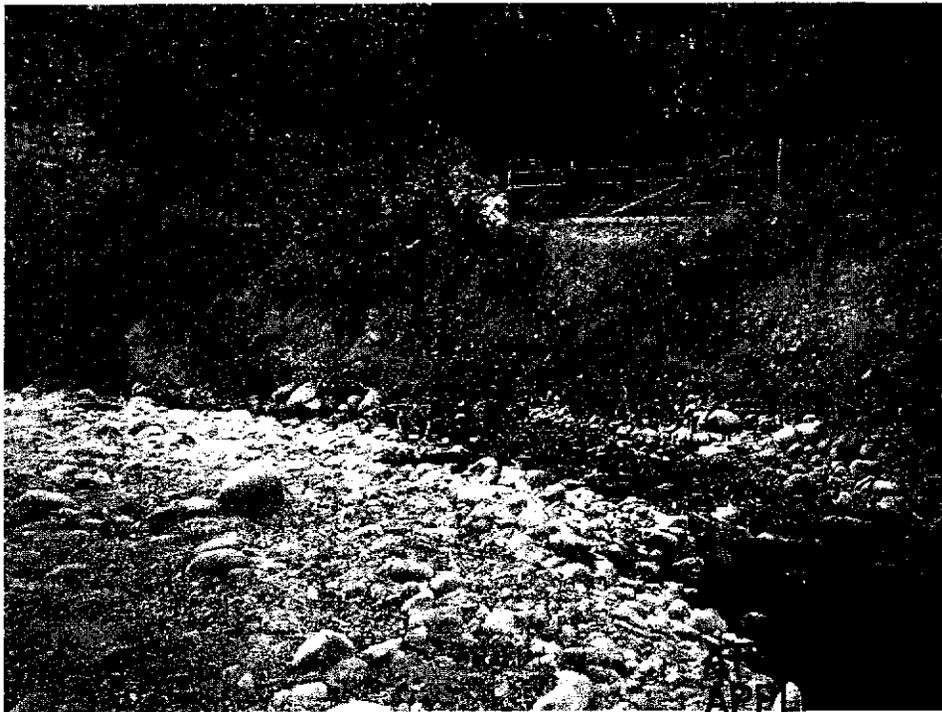
Photograph 6 State Action Area. View of creekbank roadway embankment failure from creekbed showing exposed alluvial substrate and road fill material.

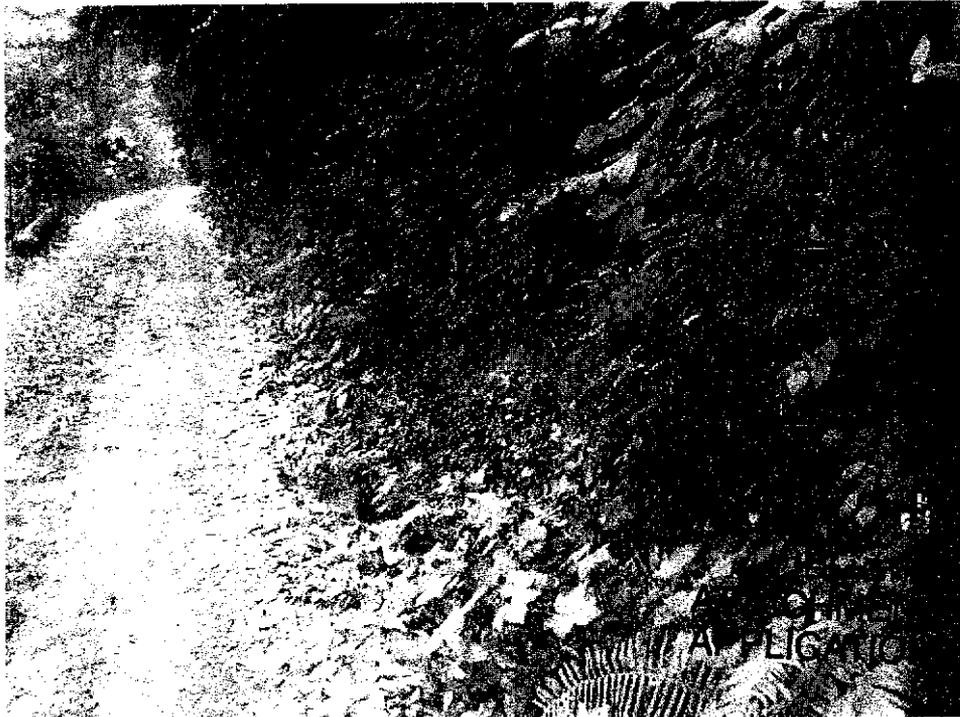
Photograph 12 State Action Area. Cut hank side of Hihn's Mill Road where vegetation will be removed to widen roadway.
