# COUNTY OF SANTA CRUZ

### APPLICATION FOR DEMOLITION OF THE APTOS FIRE HOUSE/ VFW HALL

**Documentation Report**  
**The Former Aptos Firehouse/VFW Hall**  
**8037 Soquel Drive**  
**Aptos, Santa Cruz County, California**  
**Supplement to an**  
**Application for Demolition**

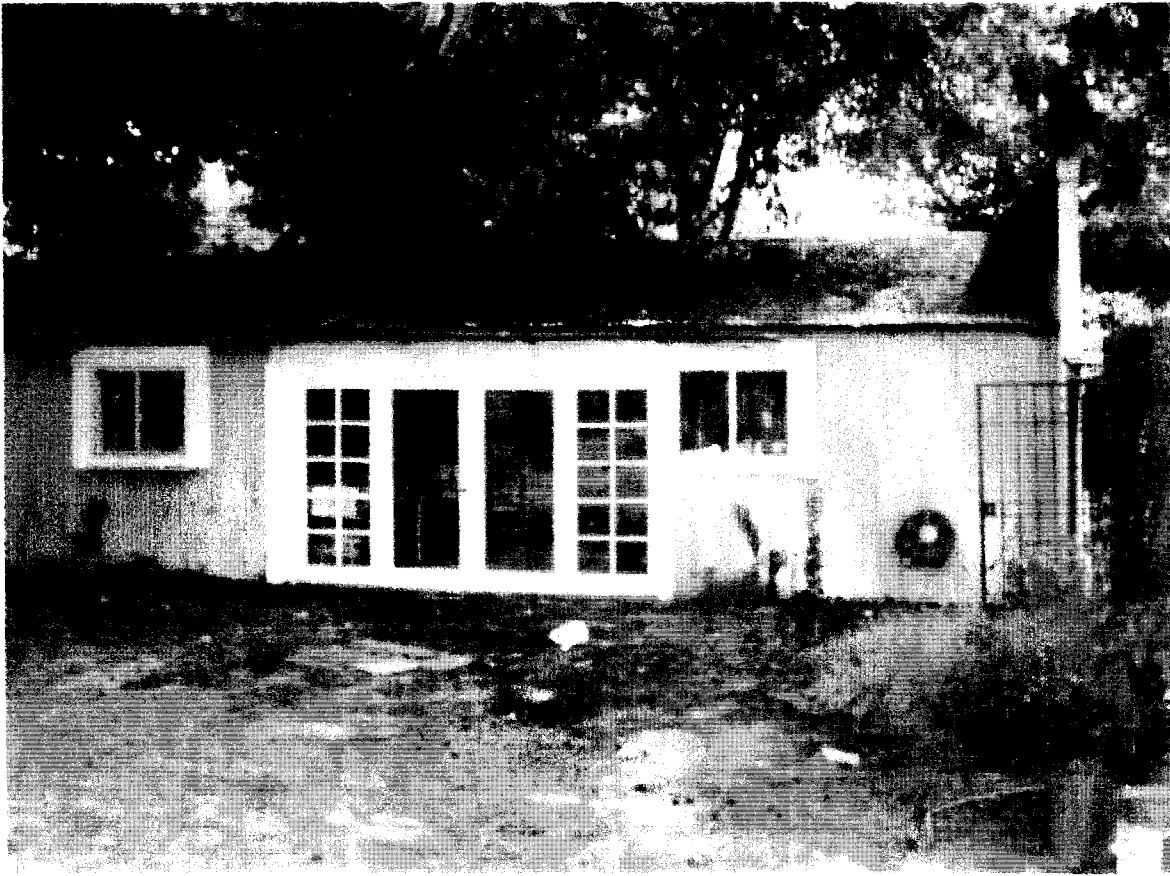
Note: mix of materials, wood to corrugated metal, replaced or created windows, double doors. The doors and windows are contemporary.
