# **Phase I Environmental Site Assessment**

DeFrees/Wagner Property  
3800 Portola Drive  
APNs 032-092-01 & 032-092-05  
Santa Cruz, California

December 4, 2013

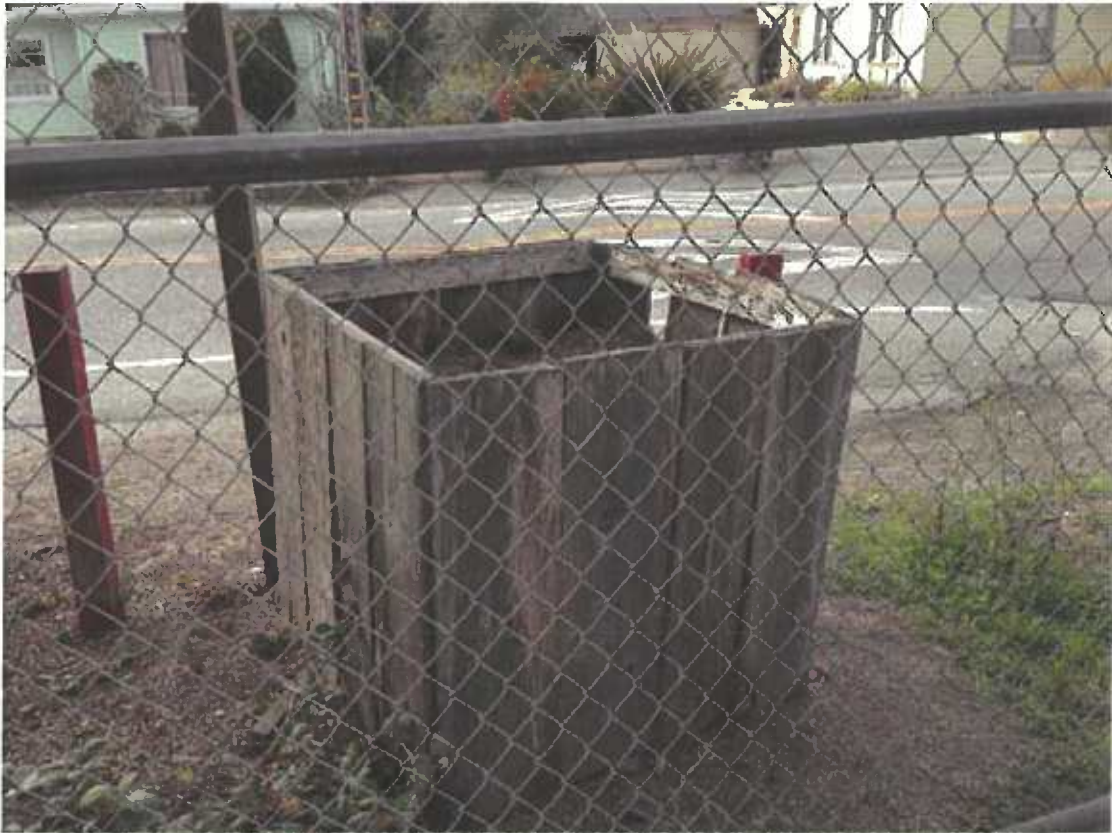
There were no ASTs observed on the Property. According to the SCCEH-maintained HMMP file for Big Creek Lumber, a 288-gallon propane tank had been present in the southwest corner of the Property. The propane was reportedly used for fueling the forklifts used in the lumber business.

**BOX PLANTER IN FORMER LOCATION OF PROPANE TANK ON SOUTHWEST PROPERTY CORNER**

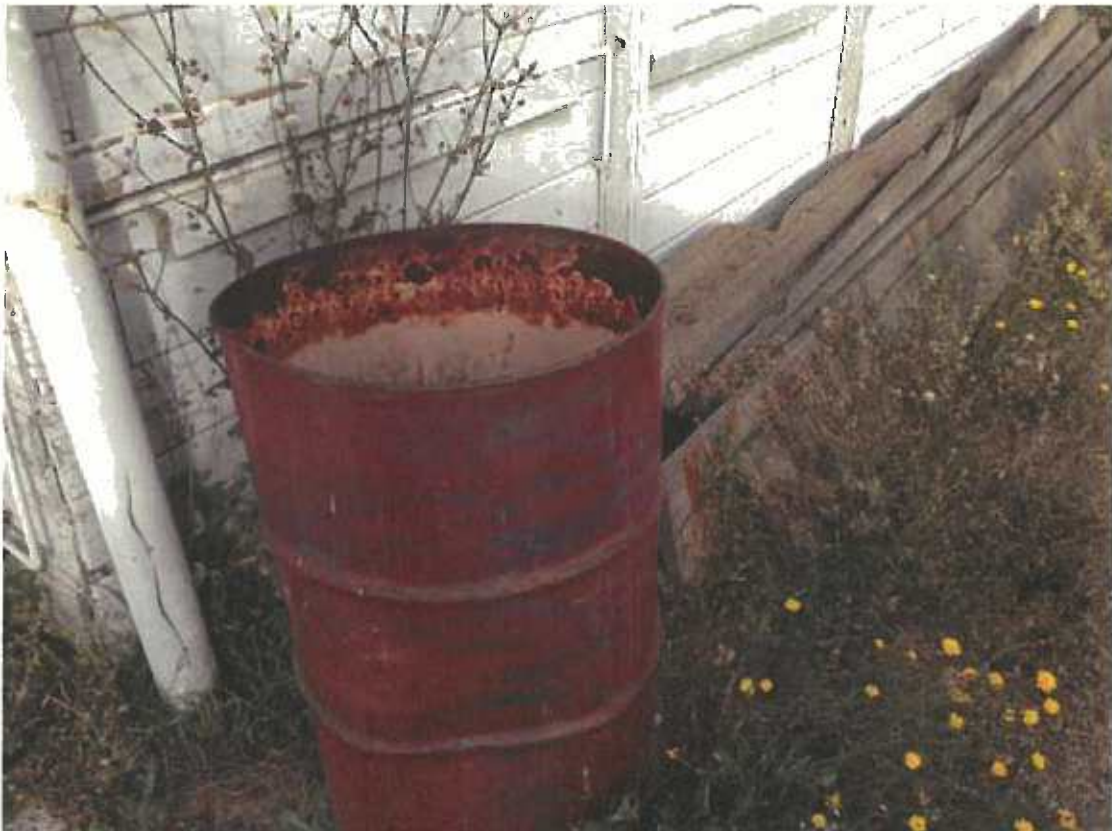
**EMPTY 55-GALLON STEEL DRUM AT SOUTHWEST CORNER OF BUILDING**

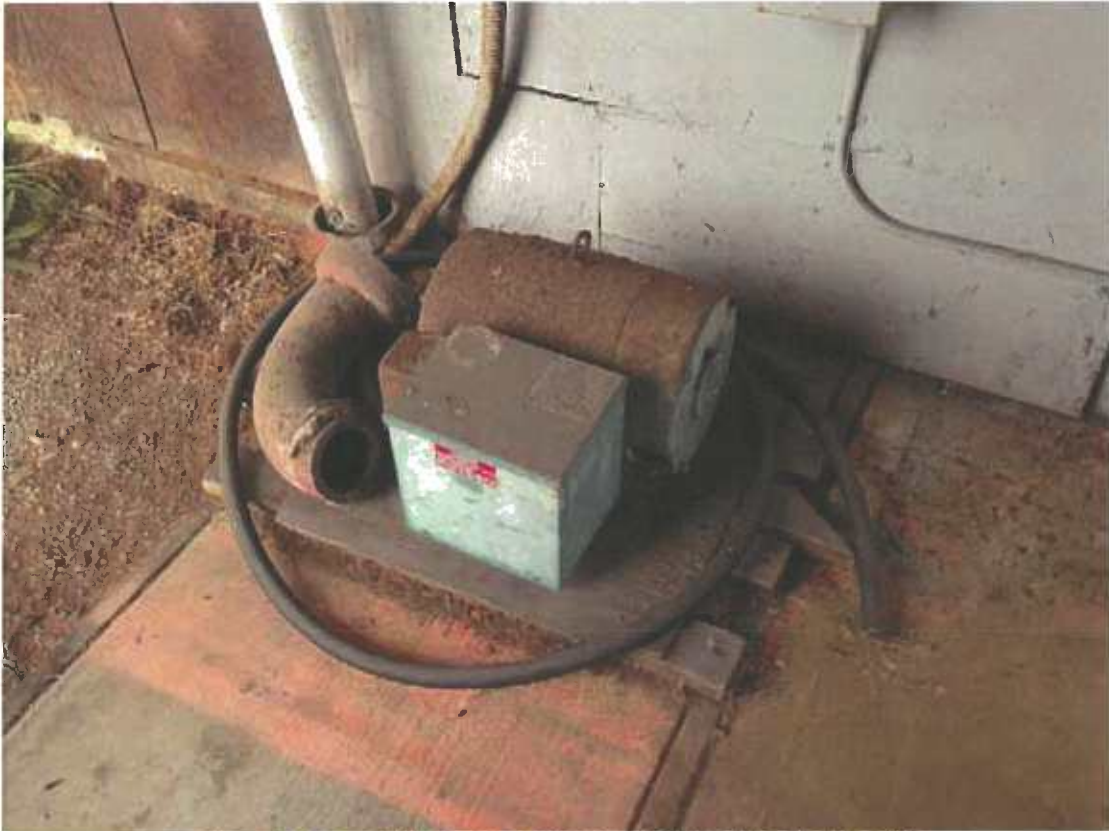
A pad-mounted rotary phase generator was observed on the Property adjacent to the west exterior wall of the building.

ROTARY PHASE GENERATOR ADJACENT TO WEST SIDE OF BUILDING

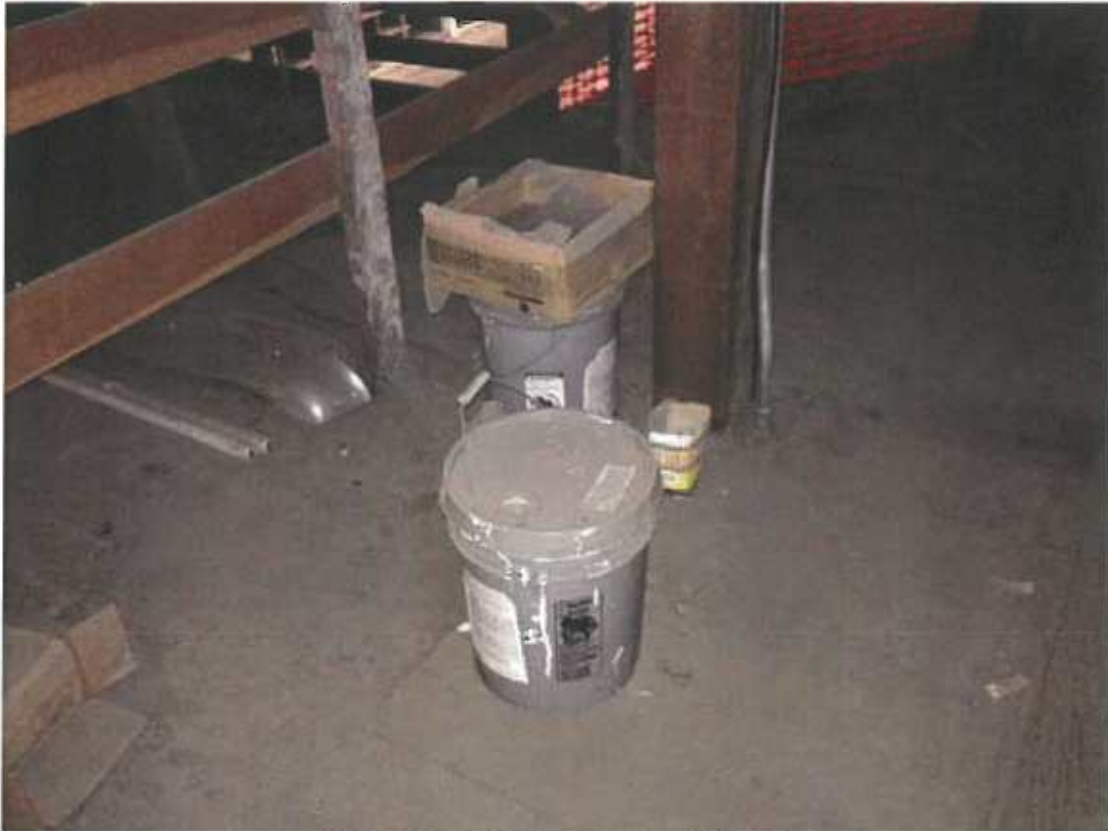
Other than minimal amounts of interior and/or exterior paints and cleaning supplies, hazardous substances were not observed on the Property at the time of the Property inspection. All containers of cleaning supplies and paints appeared to be intact and in good condition.

**PAINT BUCKETS STORED ON MEZZANINE LEVEL**

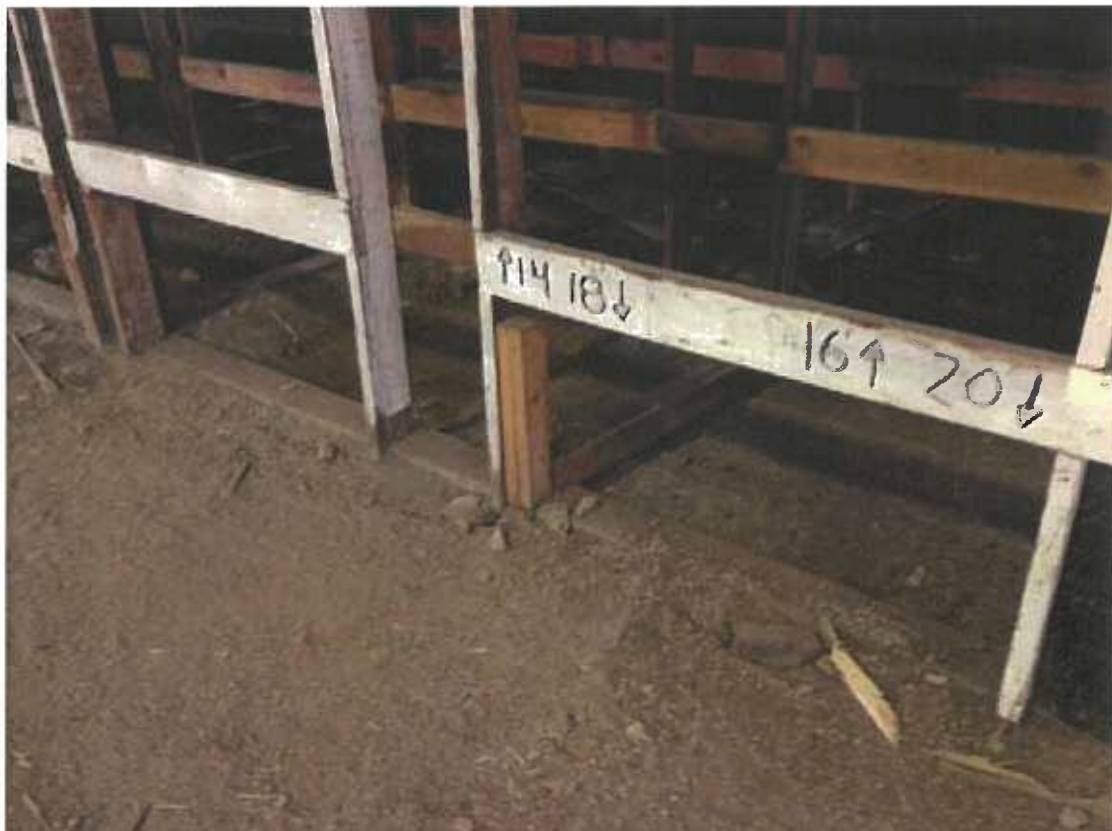
**LUMBER STORAGE RACKS CONSTRUCTED ON BARE SOIL**

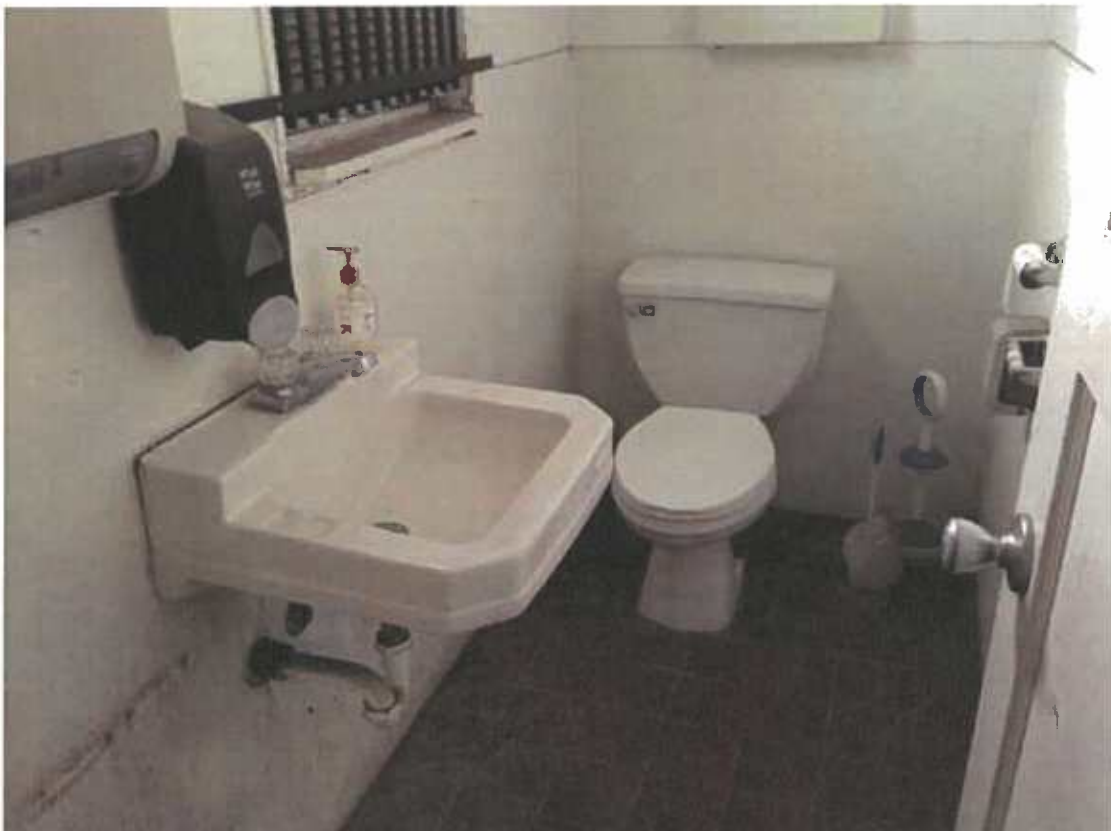
Other than minor surface staining from water in the restroom, and evidence of water leakage from an ice machine used by a former tenant, RRM did not observe any spills, leaks, corrosion or odors that could indicate the presence of hazardous materials, during the Property inspection.

**RESTROOM IN SOUTHWEST CORNER OF BUILDING**
