## Staff Report to the Planning Commission

Application Number: **08-0106**

**Project Description:** The project proposes to re-contour, install drainage improvements, and revegetate approximately 600 feet of an unnamed ephemeral drainage that drains a large portion of the Santa Cruz Gardens subdivision. The project is designed to repair severe bed and bank erosion, prevent future erosion, provide some detention, and establish native riparian vegetation along the impacted drainage corridor. Several gabion drop structures would be constructed within the drainage corridor to allow for backfilling, re-contouring, and storm water detention that would enable the establishment of native riparian vegetation along the currently eroded drainage. A gabion energy dissipater would also be constructed at the downstream end of the project area to reduce the velocity of storm water flows in an effort to eliminate downstream erosion.

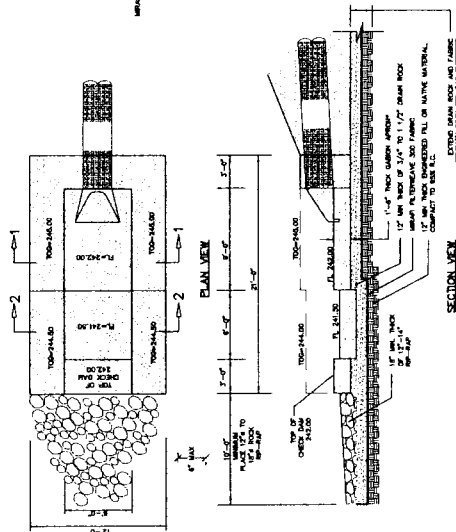
1 GABION APRON ENERGY DISSIPATER-A

NOTE: ALL ELEVATIONS ARE TO THE TOP OF THE GABION APRON.

The two gabion riprap apron energy dissipaters with gabion check dams would be constructed approximately 100 feet apart to dissipate runoff at the outlet. The first energy dissipater would handle up to a 10-year storm event. Excess runoff over a 10-year would be routed down to the second energy dissipater. The second gabion apron energy dissipater would be sized to handle both high and low flow events and to further reduce the peak flow velocity from 21.9 ft/sec to 3.9 ft/sec for a 100-year storm event at the outfall (See Attachment 4).

Two gabion riprap apron energy dissipaters with a gabion check dams shall be constructed to dissipate the runoff at the outlet. These two energy dissipaters are to be constructed about 100 ft apart. The first energy dissipater will handle up to a 10 year storm event. Excess runoff over 10-year event will be routed down to the second energy dissipater. The second gabion apron energy dissipater was sized to handle both high and low flow events and to further reduce the peak flow velocity from 21.9 fps to 3.9 fps for a 100-year storm event at the outfall.

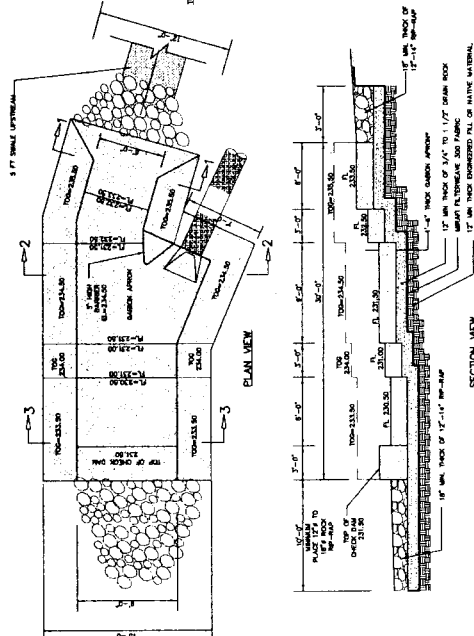
2 GABION APRON ENERGY DISSIPATER-B

NOTE: ALL ELEVATIONS ARE TO THE TOP OF THE GABION APRON.
