## Staff Report to the Zoning Administrator

Application Number: **121040**

**PROJECT TITLE:** Scotts Creek Streambank Stabilization Project

**Scotts Creek Railroad Bridge Emergency Sheet Pile Project Monitoring Report**  
**USACE RGP File Number 2010-00407S**  
**February 26, 2011**  
*County Version*

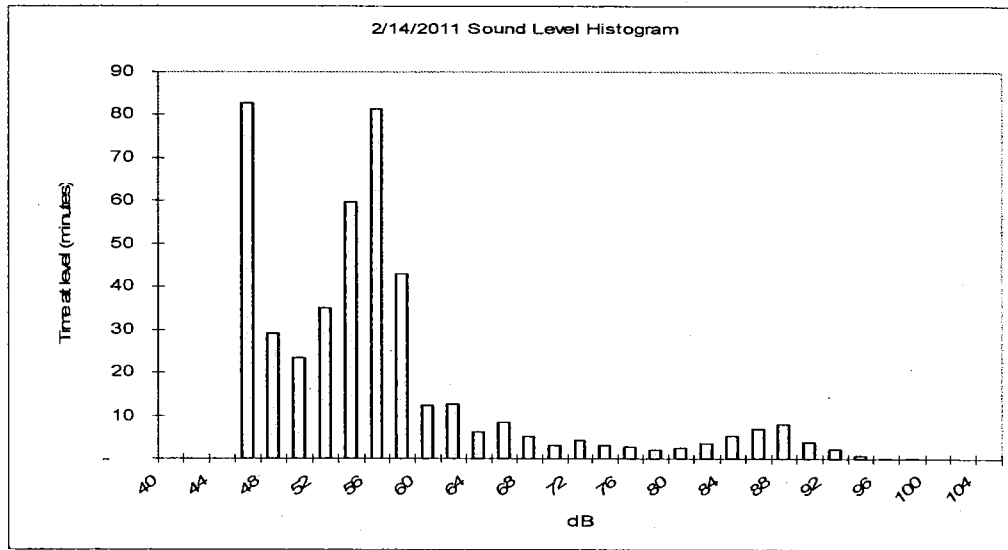
Figure 7. Frequency histogram of sound levels from 2/14/2011.
