CALIFORNIA ENVIRONMENTAL QUALITY ACT (CEQA) INITIAL STUDY/ENVIRONMENTAL CHECKLIST

**Application
Number:** 171089

Project Name: San Vicente Creek
Watershed Clematis
Vitalba Control Project

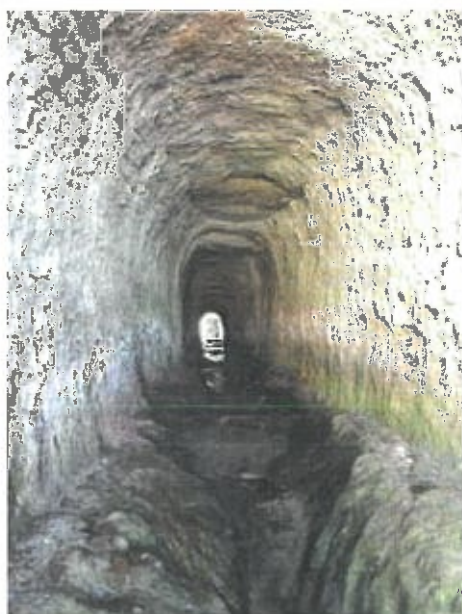
Figure 1-4. San Vicente Creek tunnel under Highway 1.

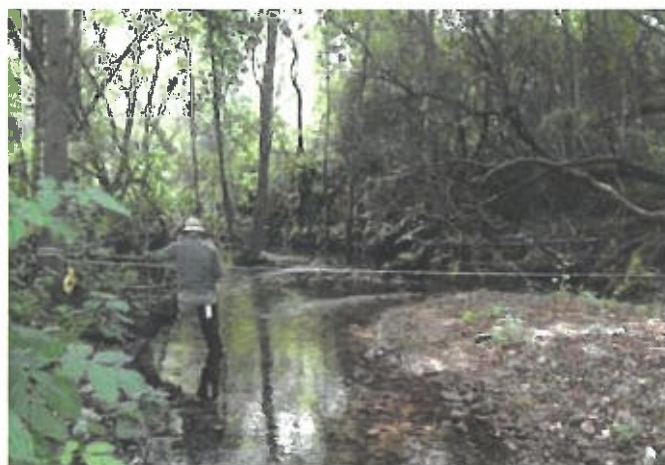
Figure 2-3: Synoptic low flow measurement made in July 2013 as a part of the watershed assessment project.

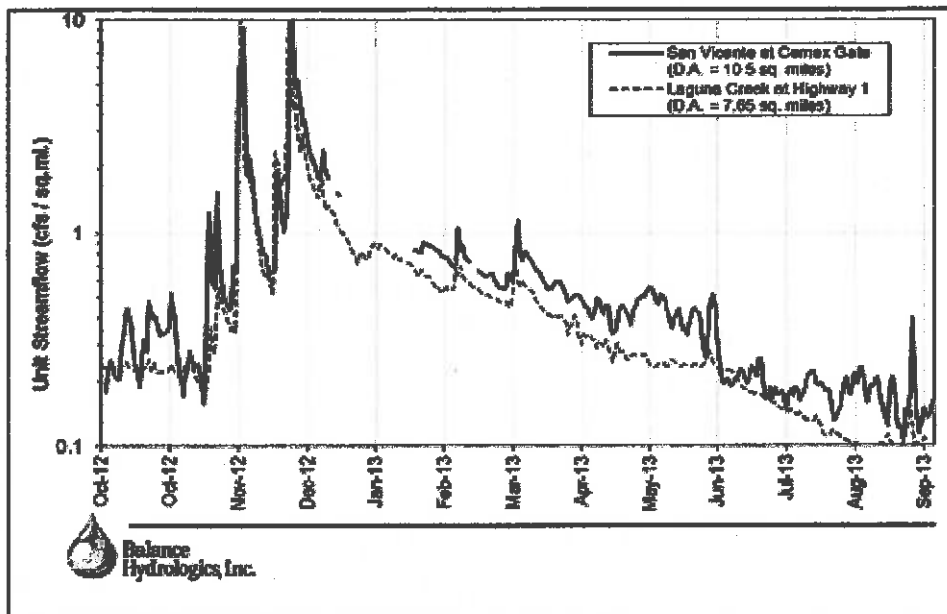
Figure 2-8. Unit streamflow for San Vicente at CEMEX Gate and Laguna Creek at Highway 1, WY2013. The flow record for Laguna Creek has been corrected for City of Santa Cruz water supply diversion. The San Vicente record however has not been corrected for upstream diversions, therefore in WY2013 San Vicente produced even more runoff per unit drainage area as measured at SVCG than what is depicted in Figure 2-8.

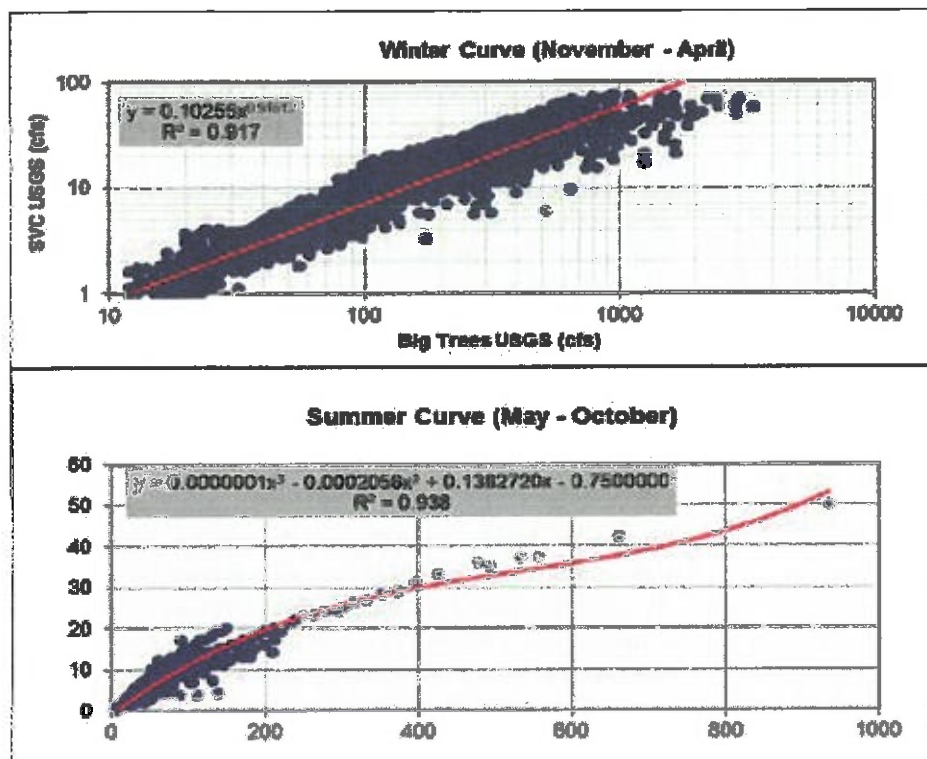
Figure 2-13. Regression models used to extend the USGS San Vicente record of streamflow using the USGS Big Trees gage on the San Lorenzo River.

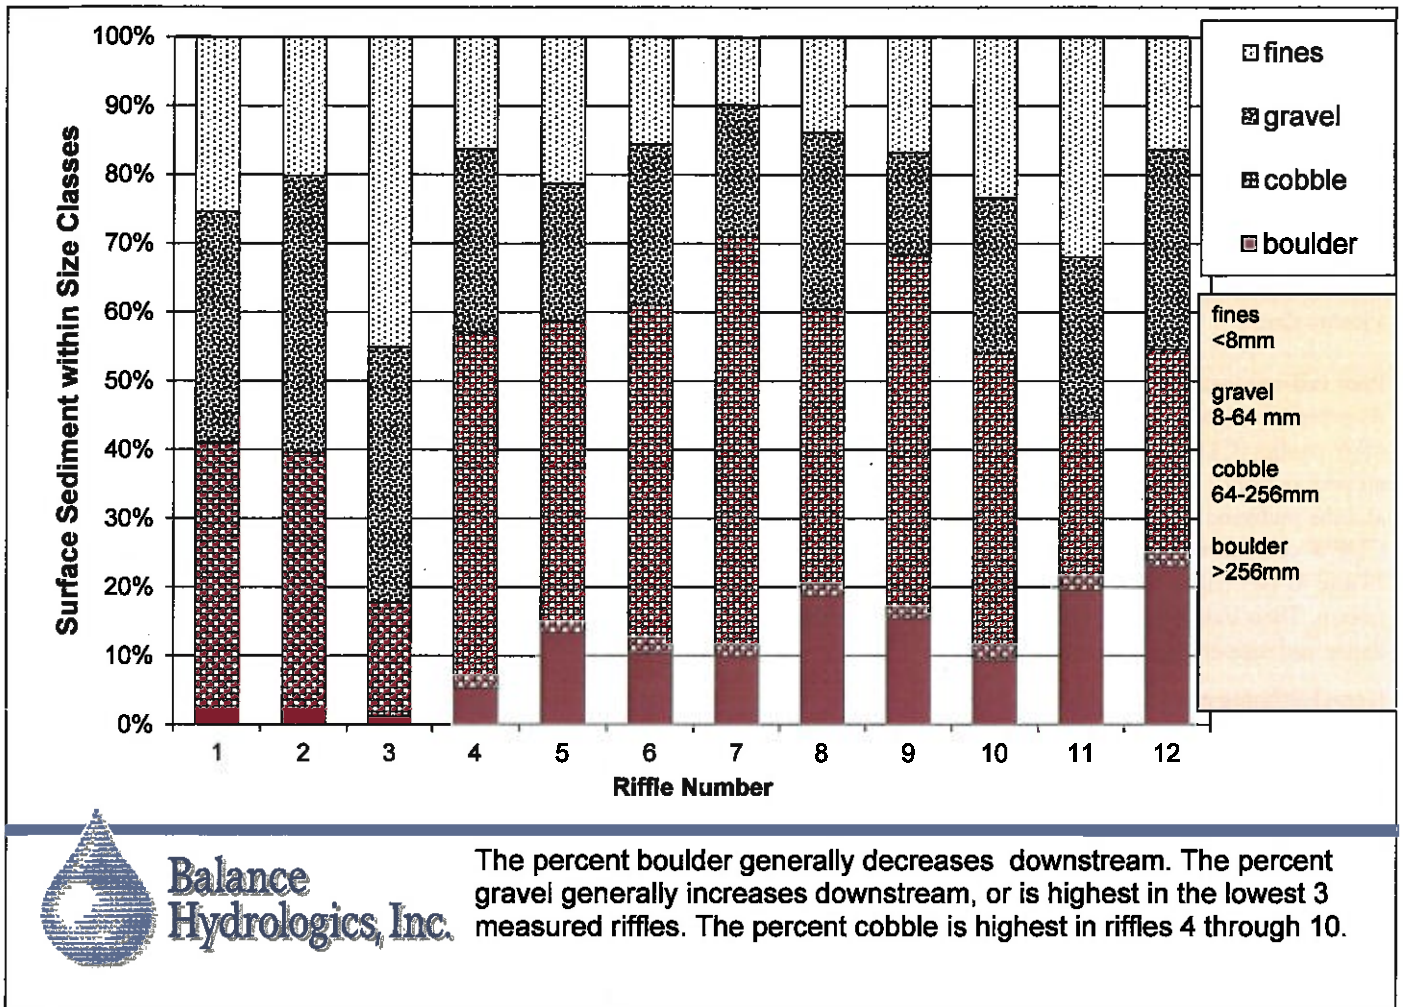
Figure 3-6. Riffle-surface texture measurements, San Vicente Creek July 2013.

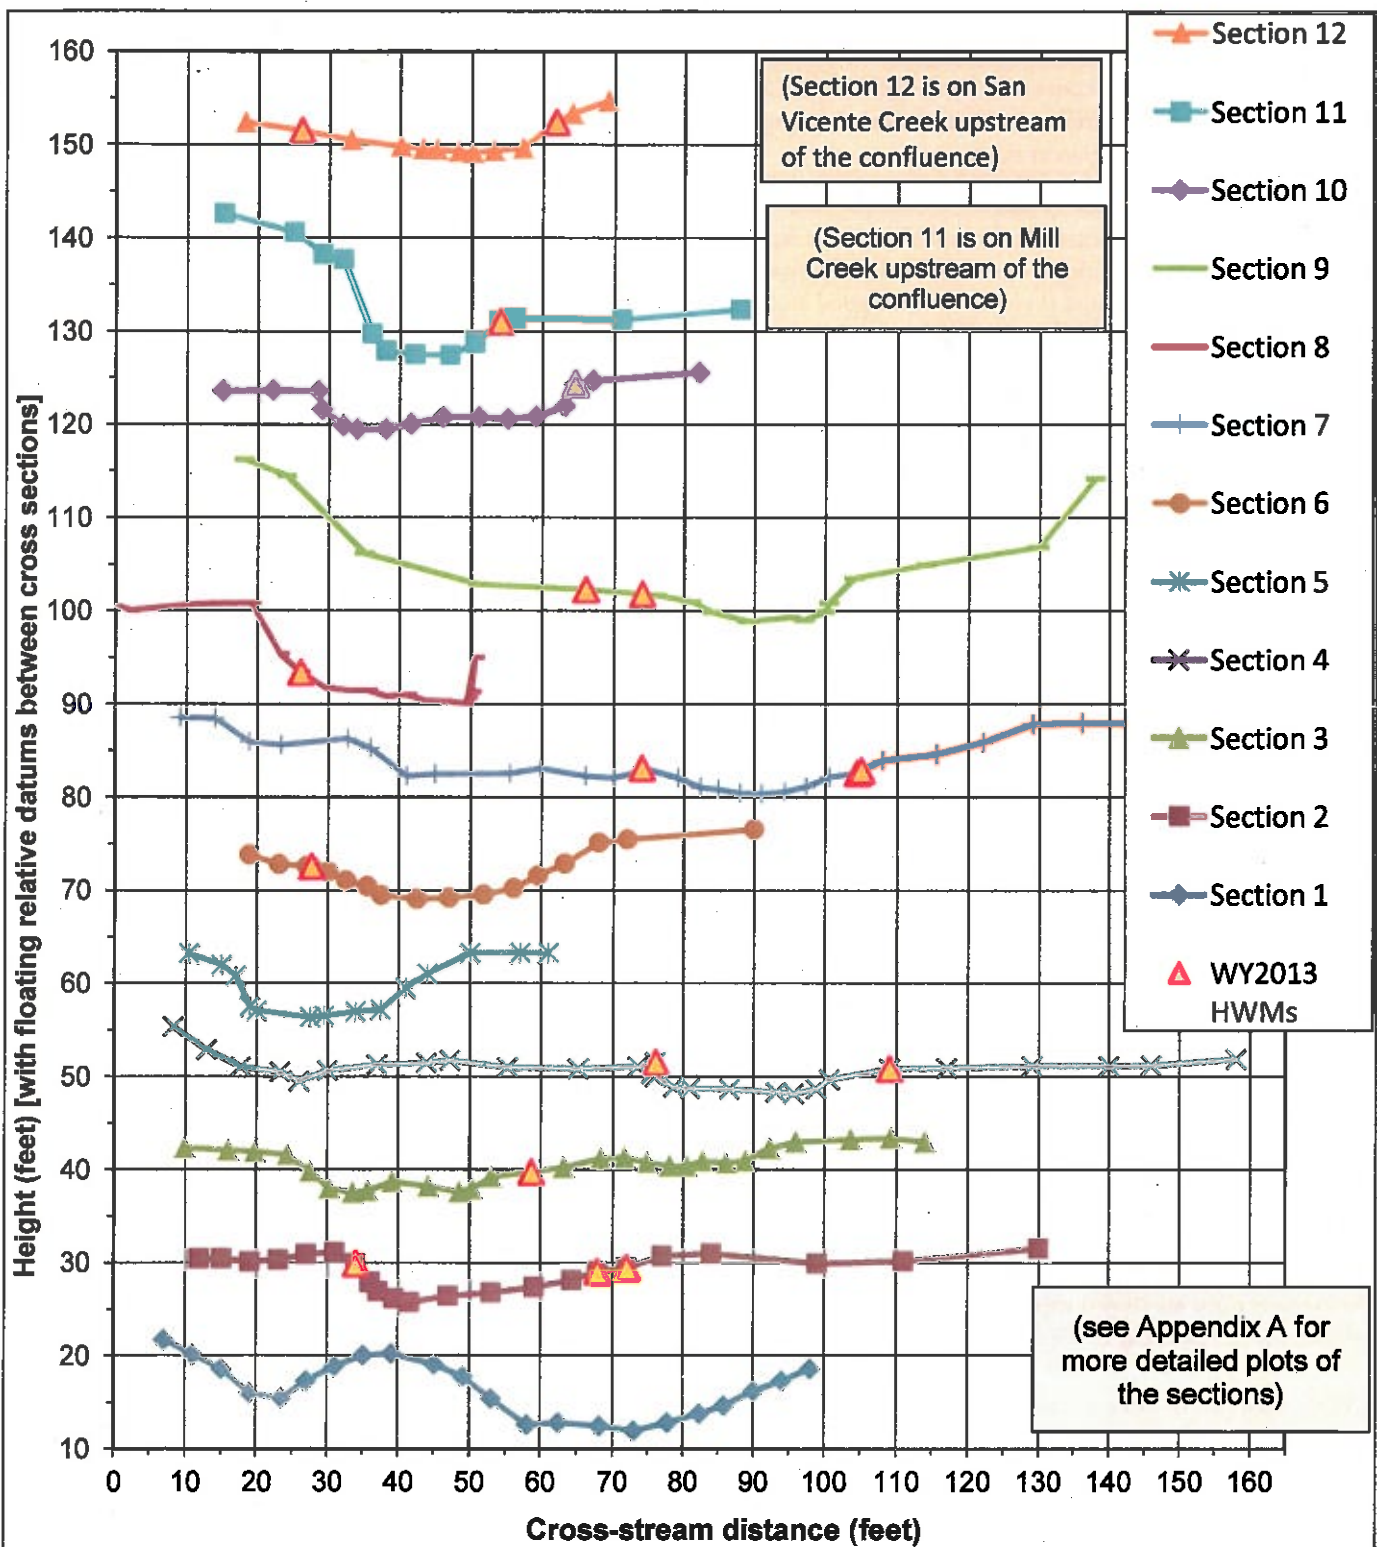
The cross-section surveys show varying degrees of floodplain connectivity. Well connected floodplains would ideally be inundated one or more times per year during most years. This frequency of inundation generally corresponds to a floodplain that is 2 to 2.5 feet above the channel bottom.

Figure 3-8. Cross-section survey measurements: San Vicente Creek, July 2013.

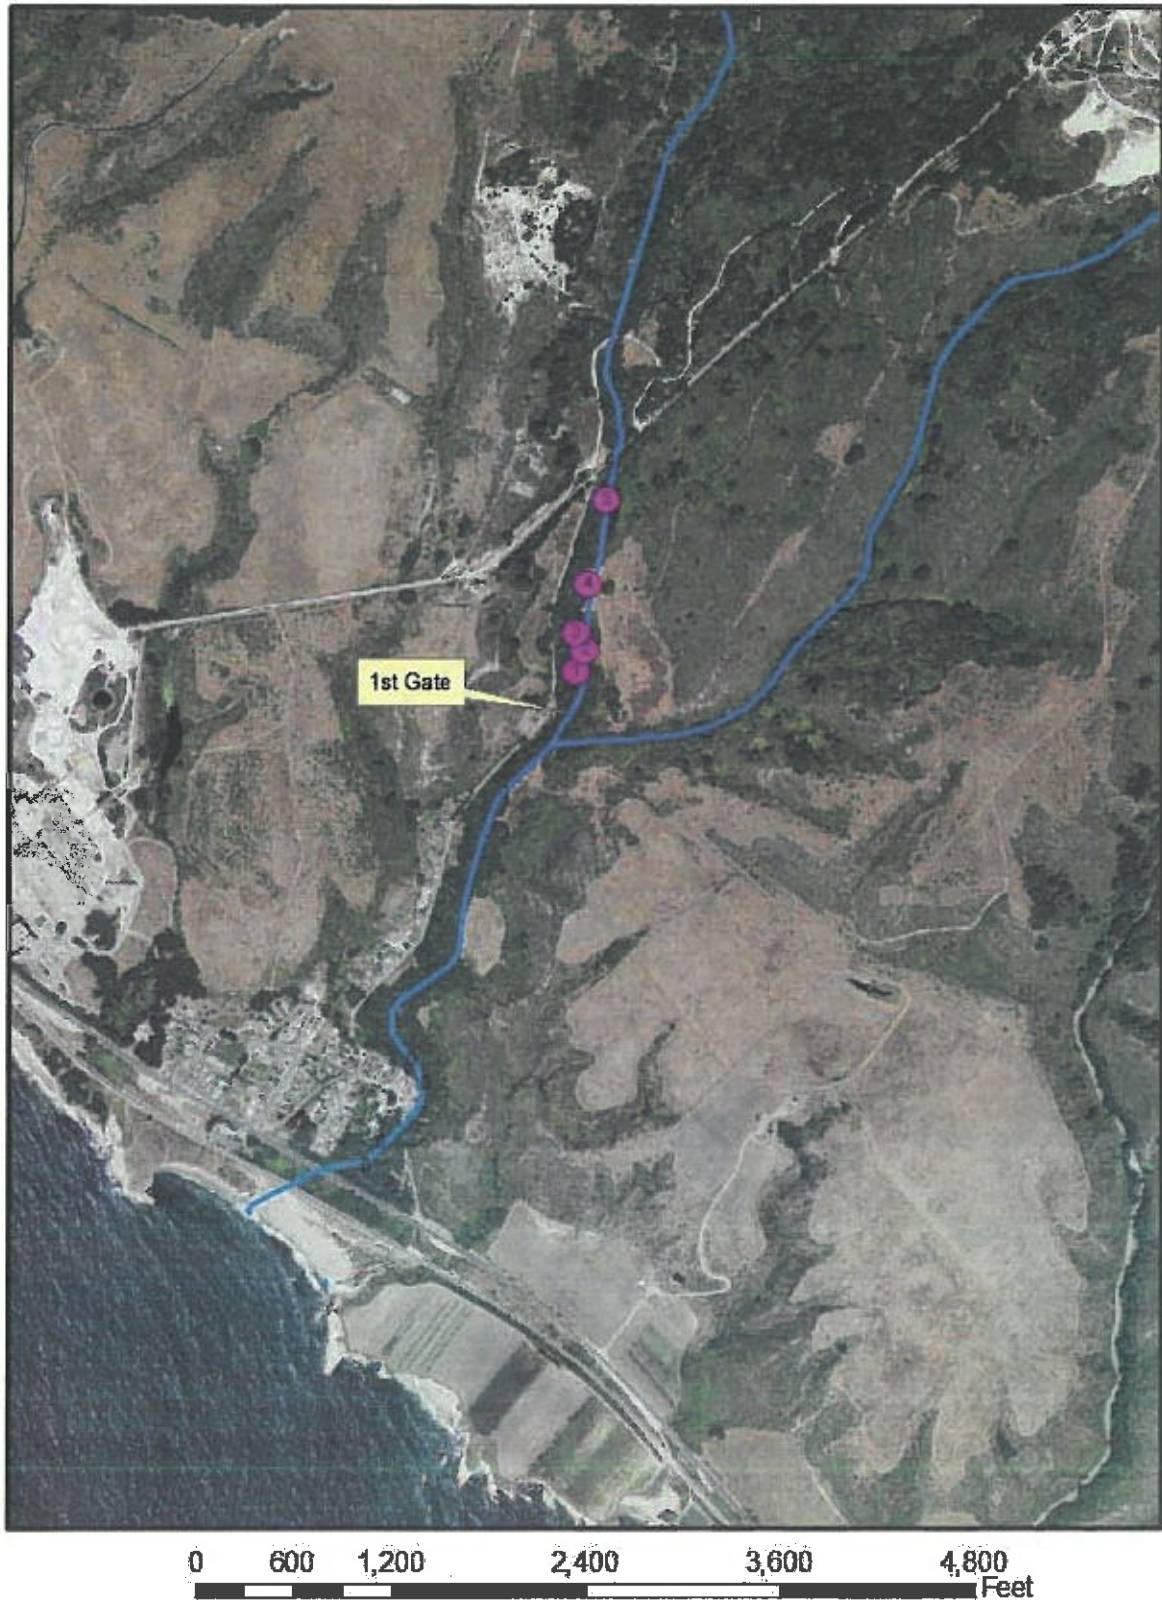
Figure 6-4 4. Cape Ivy Area Map
