Staff Report to the Zoning Administrator

Application Number: **10-0164**

Project Description: Proposal to demolish an existing 2,935 square foot two-story single-family dwelling and four existing accessory structures; to convert two existing accessory structures to an 1,136 square foot second unit with attached 623 square foot non-habitable storage structure and a 576 square foot non-habitable storage structure; to recognize an existing 240 square foot non-habitable storage structure; and to construct a replacement 3,445 square foot two-story, single-family dwelling and attached garage, a 640 square foot habitable accessory structure and 704 square foot carport.

Location: Project located on the southwest corner of Pine Flat Road and Martin Road (126 Martin Road)

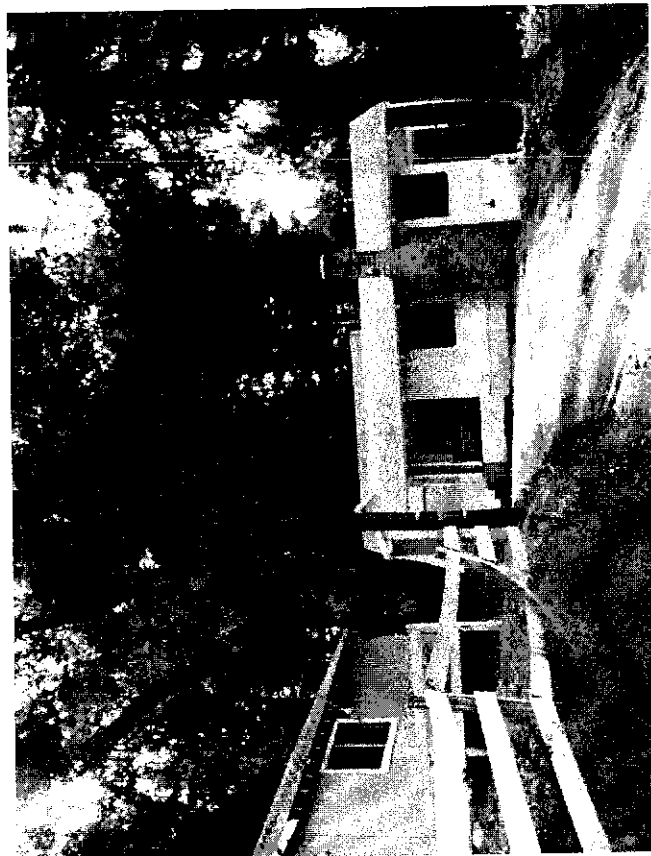
GARAGE TO BE REMOVED; EXISTING HOUSE TO BE REPLACED

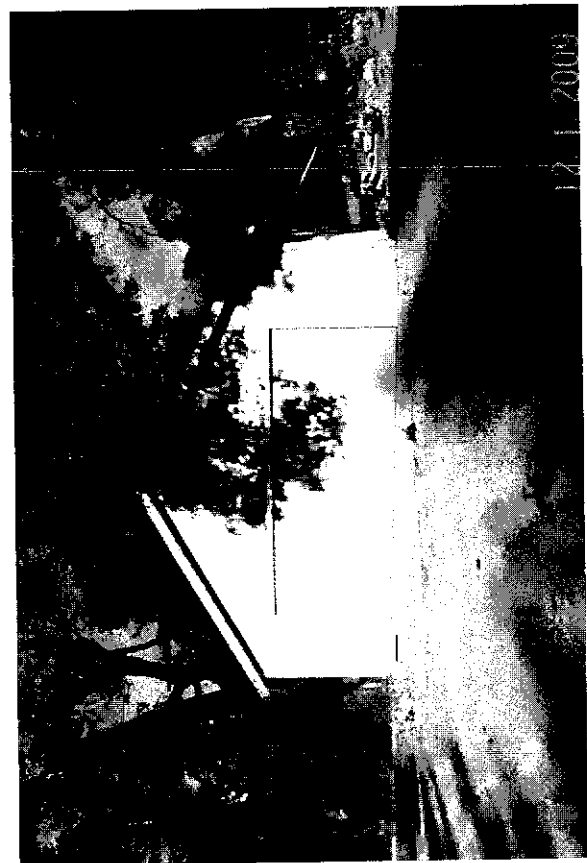
EXISTING GARAGE TO BE REMOVED

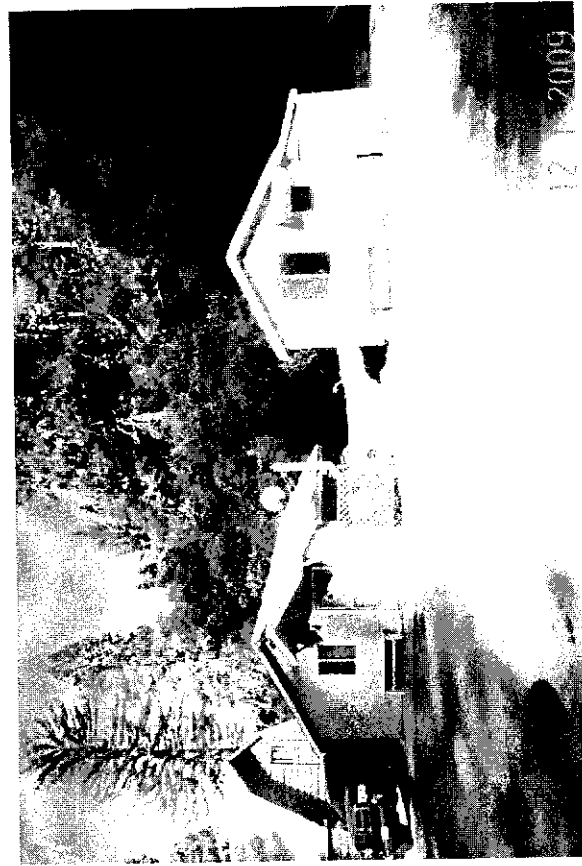
FUTURE STORAGE TO REMAIN (BLDNG 4); LAUNDRY ROOM TO REMAIN (BLD 5)

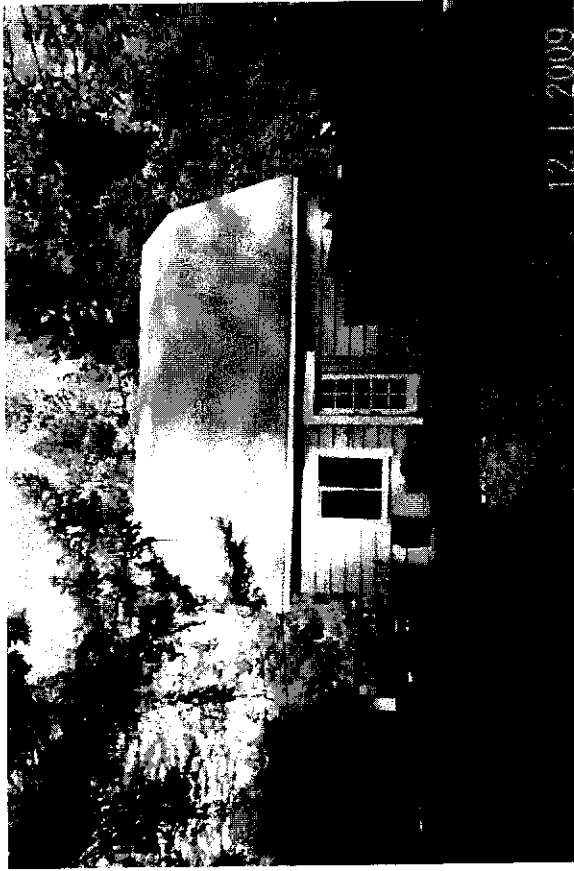
EXISTING STRUCTURE TO BE REMOVED & REPLACED WITH NEW HABITABLE
ACCESSORY STRUCTURE (BUILDING 3)

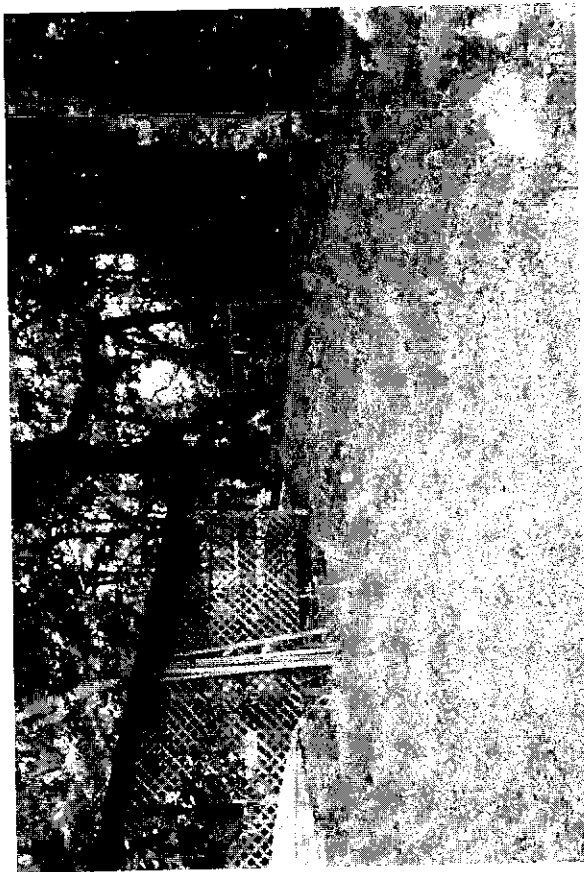
EXISTING CARPORT TO BE REMOVED
