COUNTY OF SANTA CRUZ

HISTORIC RESOURCES COMMISSION PLANNING DEPARTMENT

HISTORIC RESOURCE PRESERVATION PLAN REVIEW

Applicant:Heidi Spicer
Owner:Ayshe Tuncer and Mike Anderson
APN:041-021-41
Situs:8057 Valencia St., Aptos, CA
Location:The residence is located on the north side of Valencia St. approximately 200 feet east of Trout Gulch Rd.
Historic Name: None
Rating:..... NR3

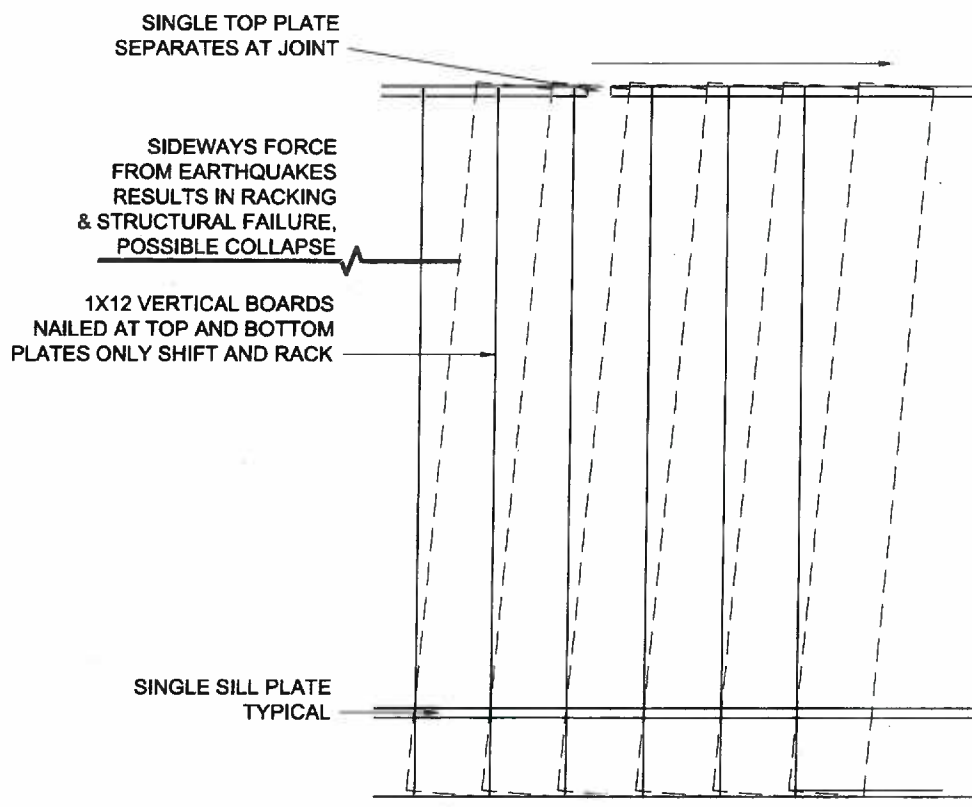
FIGURE D CONSTRUCTION W/ 1X12 VERTICAL SIDING $1/2" = 1'-0"$

The exterior vertical siding (1x12 boards) on the outside of the structure extends into the ground on the outside which explains the extensive rot and insect infestation extending far up the boards from grade. One can literally pull the boards apart, the wood being paper thin in places. The component supporting the roof – the exterior vertical siding - is for all intents and purposes non-existent for structural purposes. Any attempt to move the structure would very likely result in the structure collapsing under the weight of the roof. The rot is so extensive it requires virtually all of the exterior siding to be replaced. Keeping any of it will only spread the infestation to new construction. I refer you to the report by Leonard Willis, Structural Engineer. Completely new framing is required in order to create a structurally sound building suitable for safe occupancy. The rot and termite damage extends to floor framing members which are, in addition, improperly framed and are unsupported by any kind of functioning foundation. Even the roof rafters and sheathing are deeply eaten out by termites and require full replacement.
