COUNTY OF SANTA CRUZ

PLANNING DEPARTMENT

Subject: Review of Olive Springs Quarry Operating Under Mining Approval 88-0233 for Compliance with Conditions of Approval, and Minor Amendment to the Mining Plans

Olive Springs Quarry Mining Approval 88-0233 2011 Permit Review

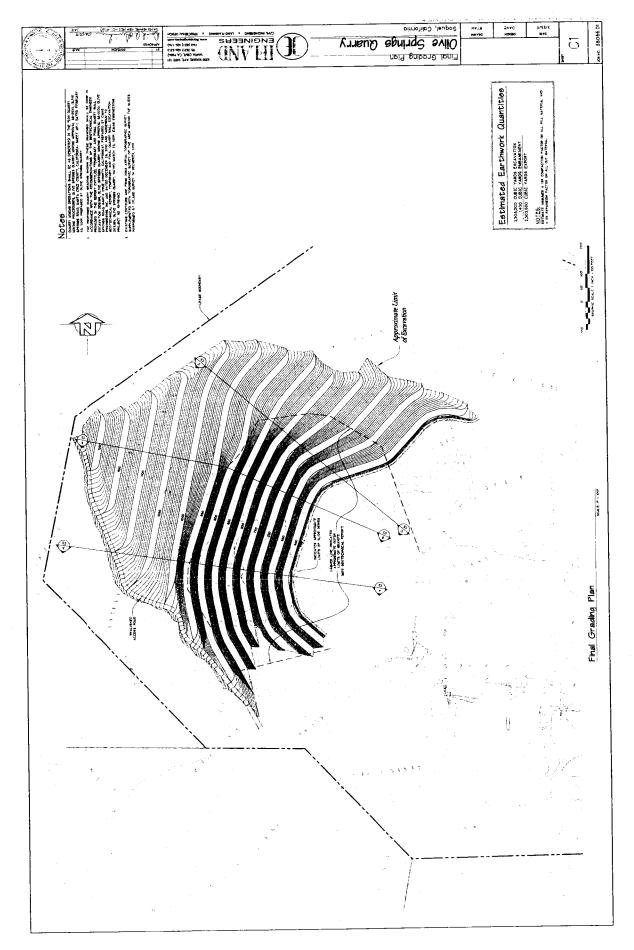
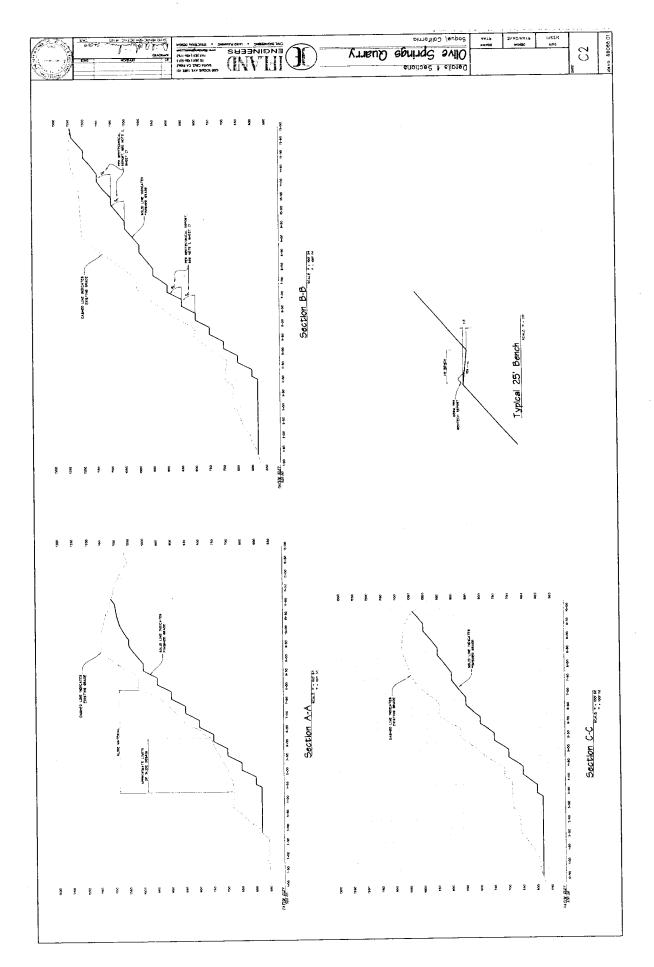
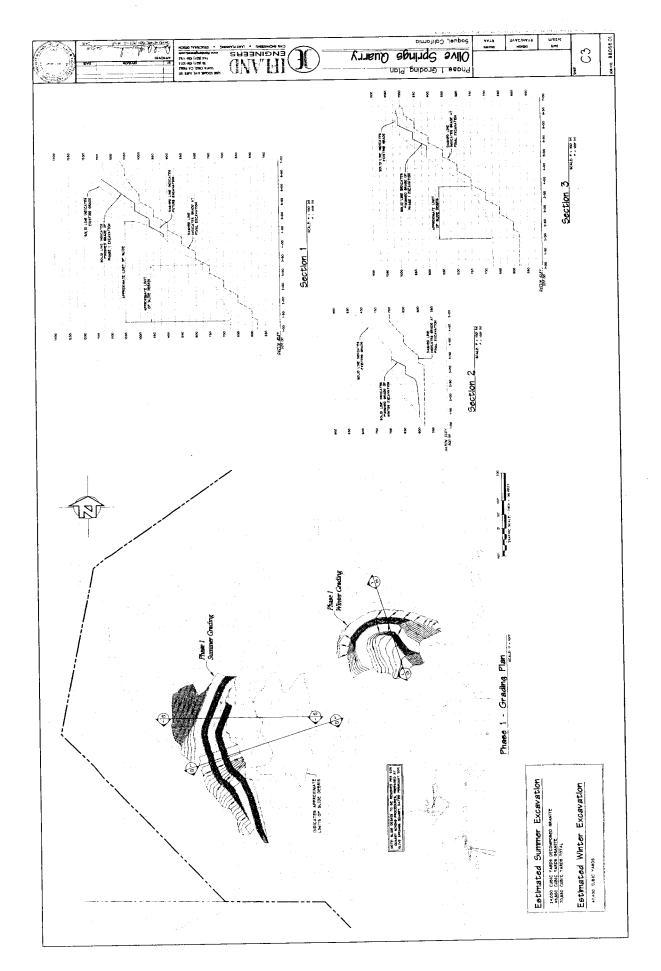
PROJECTED MINING LOCATIONS AND QUANTITIES FOR 2011:

- 1. APRIL 15TH TO OCTOBER 15TH, 2011:
- 1.1 EXCAVATION OF THE NORTHERN AND SOUTHERN FAILURE TALUS.
- 2. OCTOBER 15TH TO DECEMBER 31, 2011;
- 2.1 EXCAVATION OF THE MORTHERN PORTION OF THE DUARRY, STARTING AT AN ELEVATION OF 720 FEET FOR A TOTAL APPROXIMATELY VOLUME OF 47,400 CUBIC YARDS.
