Staff Report to the Zoning Administrator

Application Number: **141017**

Address: 2864 South Palisades Avenue, Santa Cruz

Project Description: Proposal to demolish an existing 2,352 square foot residential structure containing a single-family dwelling and a studio apartment/ADU, with a 252 square foot attached garage and to construct a replacement 2,384 square foot single-family dwelling with a 225 square foot attached garage and 256 square foot attached carport, construct a 5 foot high stucco wall and gate in the front, in the R-1-5-PP zone district. This requires a Coastal Development Permit and an Over-Height Fence Permit. This application also includes a Combined Soils/Geologic Report Review.

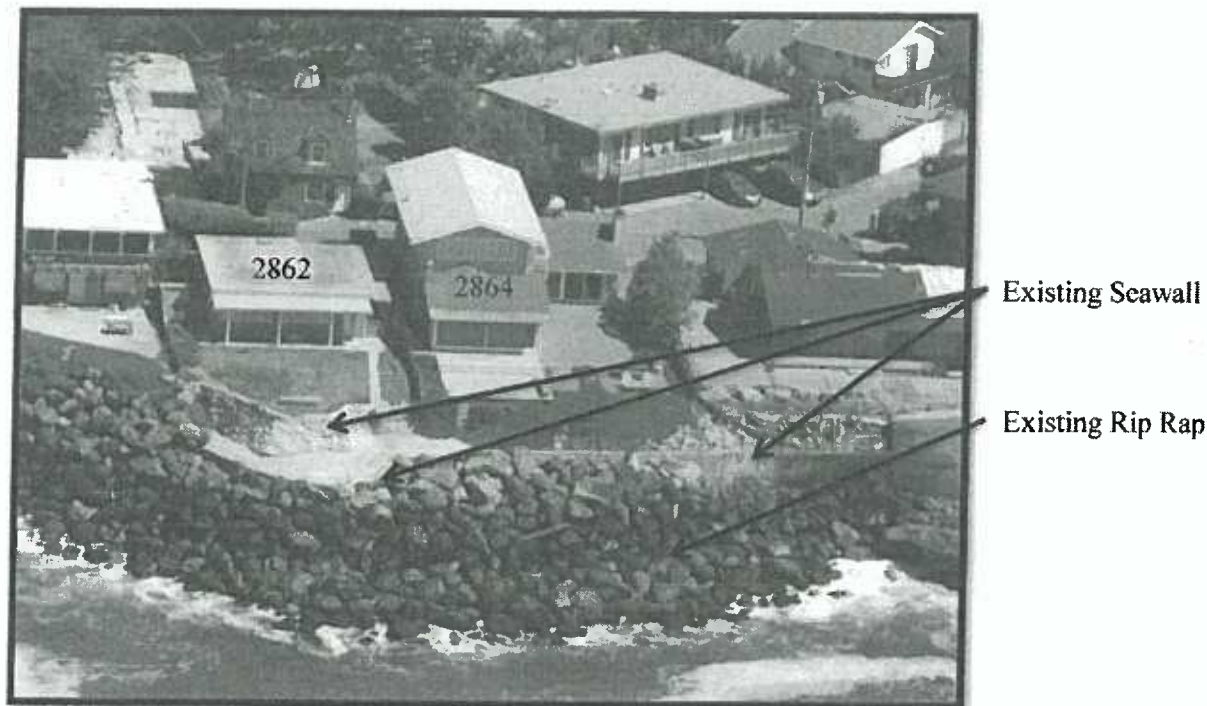
Figure 1

The coastal protection structure consists of a concrete seawall with a rip rap revetment that spans this parcel, the up coast parcel (2862 S. Palisades) and a portion of the down coast parcel as shown in **Figure 1**.
