Staff Report to the Zoning Administrator

Application Number: 181024

Applicant: Matson Britton Architects
Owner: Jim and Sue Vaudagna
APN: 043-095-14
Site Address: 379 Beach Drive, Aptos

Project Description: The proposed project includes demolition of an existing three-story single-family dwelling and construction of a new three-story replacement single-family dwelling. The project includes excavation of the toe of the coastal bluff, construction of several coastal bluff stabilization features including two retaining walls (9 and 11-feet high respectively) in the rear yard, as well as a 10-foot high geobrug debris flow fence located 30-40 feet upslope from the proposed home. Requires a Coastal Development Permit and Variance approval to reduce the minimum 20 foot front yard setback to 10 feet, to increase the maximum height of 28 feet to 32.5 feet, to increase the maximum number of stories from two to three and to increase the allowed 50% floor area ratio to approximately 60%.

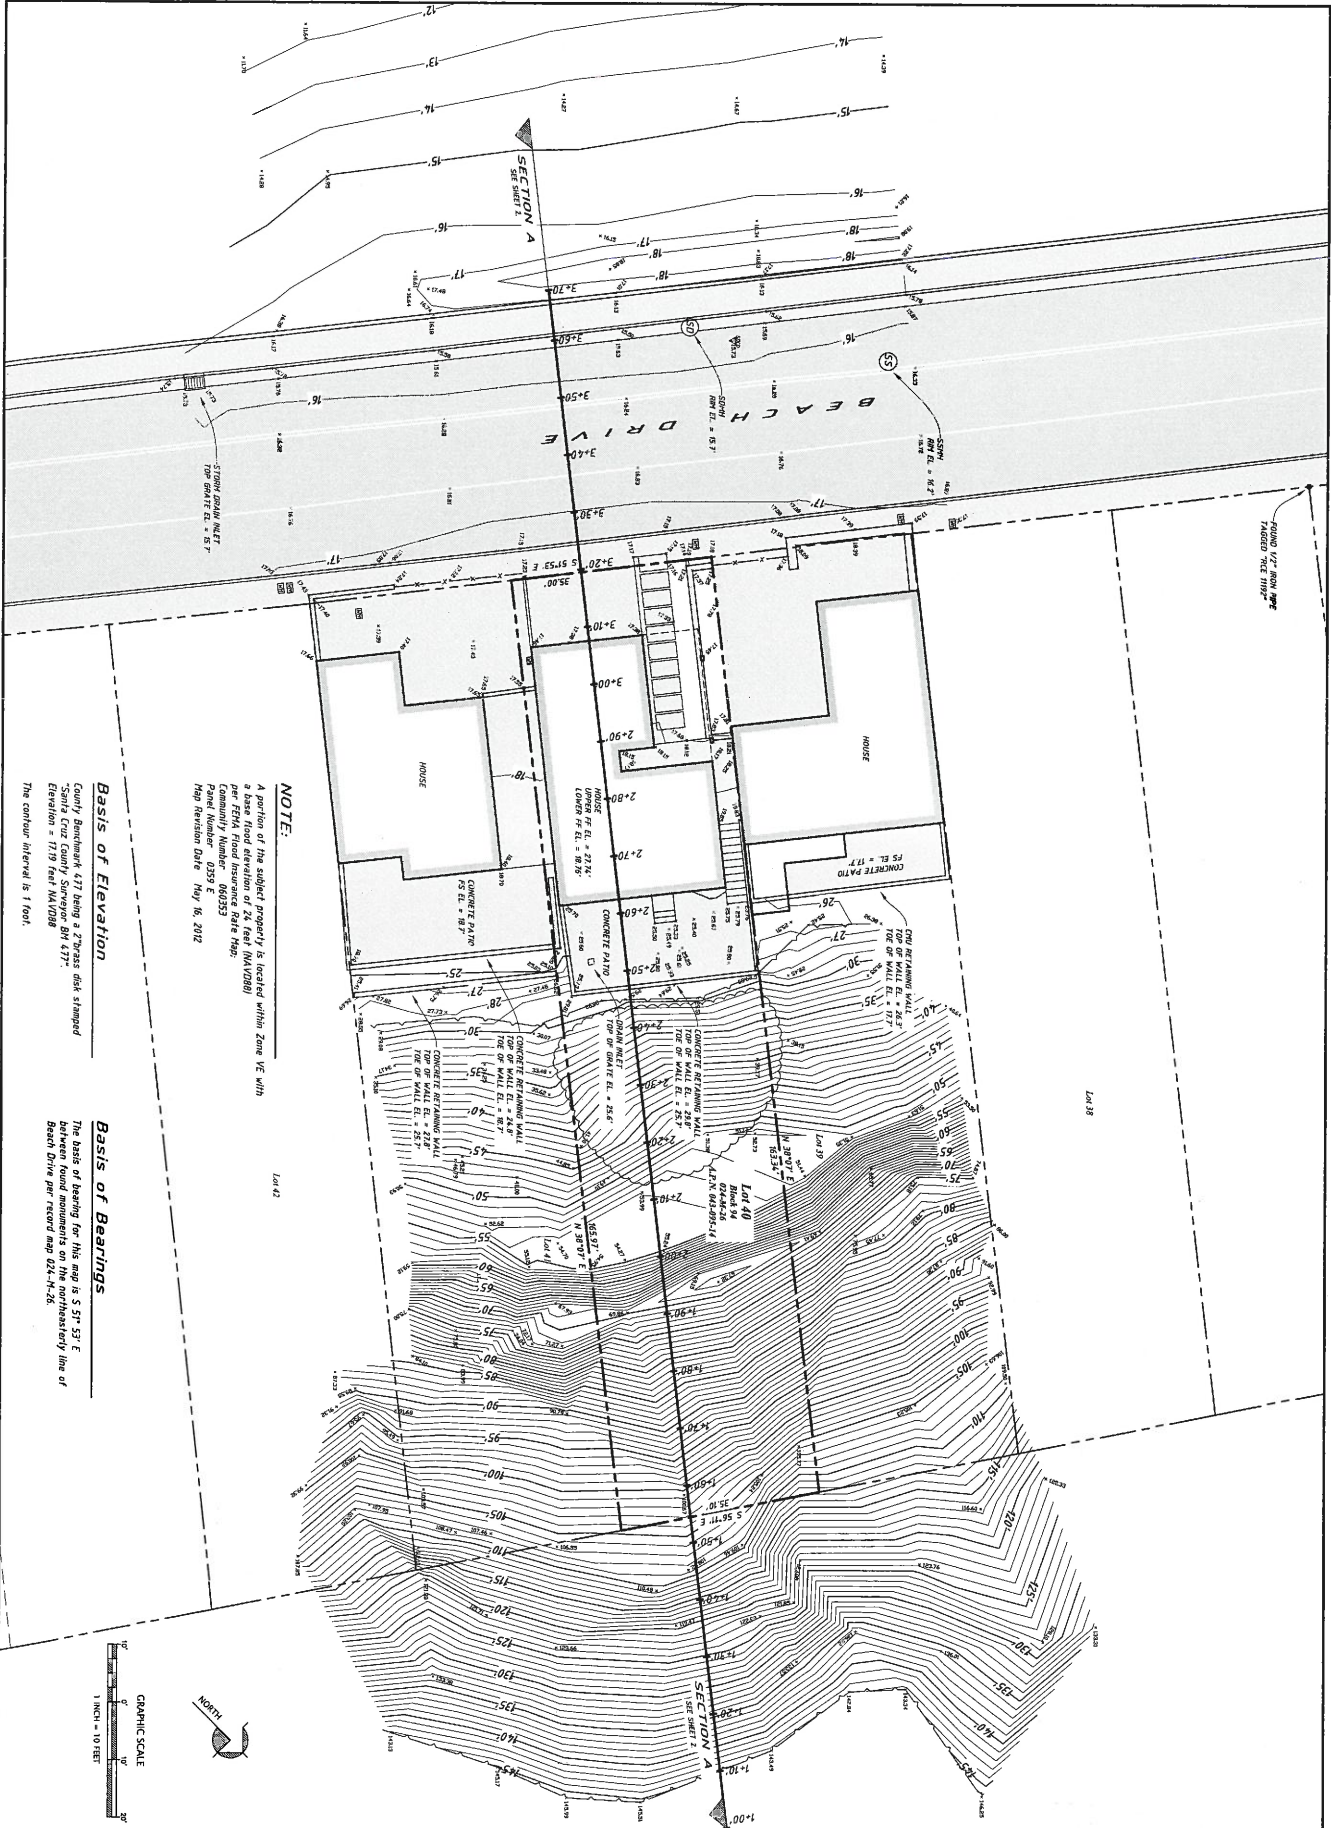
NOTE:
A portion of the subject property is located within Zone VE with a base flood elevation of 24 feet (NAVD83) per FEMA Flood Insurance Rate Map; Flood Insurance Rate Map Panel Number 0359 E Map Revision Date May 16, 2012

Basis of Elevation
County Benchmark 427 being a 272225.66 stamped Santa Cruz County Survey 4/14/73. Elevation = 1719 feet NAVD83
The contour interval is 1 foot.

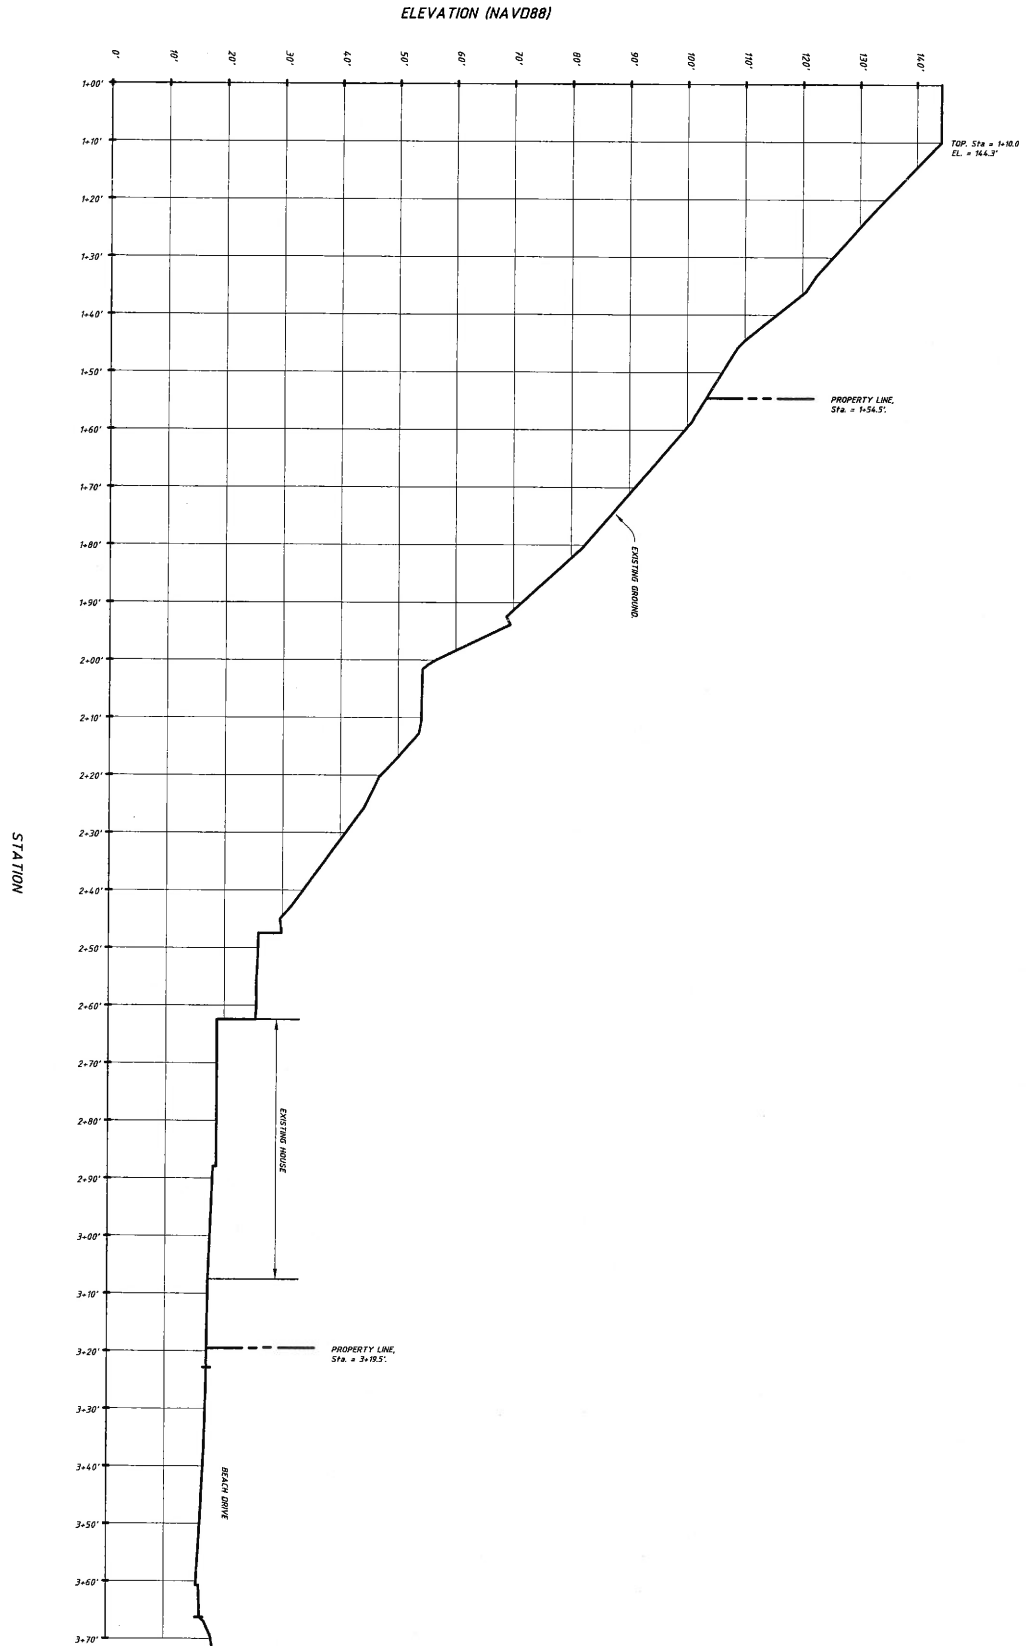
A.P.N. 043-095-16		Topographic Map, The Lands Of:		HANAGAN LAND SURVEYING, INC.		REVISION		
DATE 5-10-2017		DESIGN		305-C SOQUEL AVE., SANTA CRUZ, CA 95062		APPROVED		
SCALE 1" = 10'		DRAWN N. Pasquini		PHONE 831-460-3450		Paul Hanagan LS 7797		
SHEET SU-2		OF 2 SHEETS		17023

SEE SHEET 1.
SECTION A
HORZ. SCALE: 1" = 10'
VERT. SCALE: 1" = 10'

Basis of Elevation
County Benchmark 437 below a 379245 disk stamped
Santa Cruz County Surveyor SN 437.
Elevation = 1719 feet NAVD83
The contour interval is 1 foot

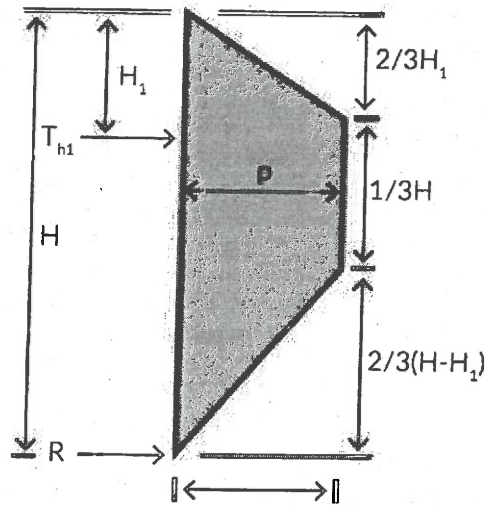
Walls with one level
of ground anchors

$$p = \frac{\text{TOTAL LOAD}}{2/3H} \approx K_A \gamma H$$

**Apparent Earth Pressure Diagram
for Tie Back Walls**
379 Beach Drive, Aptos, California

60. If tiebacks are required, tieback retaining walls should be designed for apparent lateral earth pressure. The appropriate apparent earth pressure diagram will depend on the location of the tieback anchors with respect to the vertical wall face. Refer to the Apparent Earth Pressure Diagram, Figure 9, in Appendix A for details. If tie backs are not used the active equivalent fluid pressures provided in the previous section should be used. Please note that these earth pressure diagrams assume fully drained conditions. If fully drained conditions are not provided behind the wall, an additional hydrostatic load of 62.4 psf/ft should be included in the wall design.

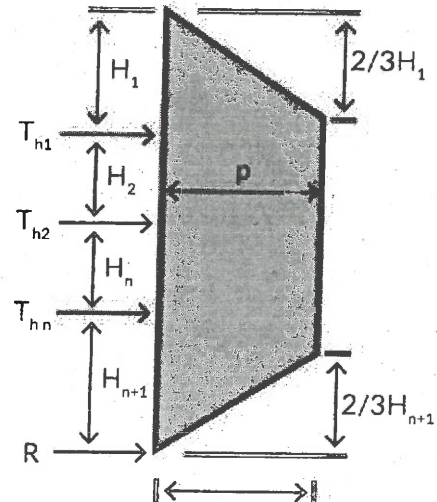
Walls with multiple levels
of ground anchors

$$p = \frac{\text{TOTAL LOAD}}{H - 1/3H_1 - 1/3H_{n+1}}$$

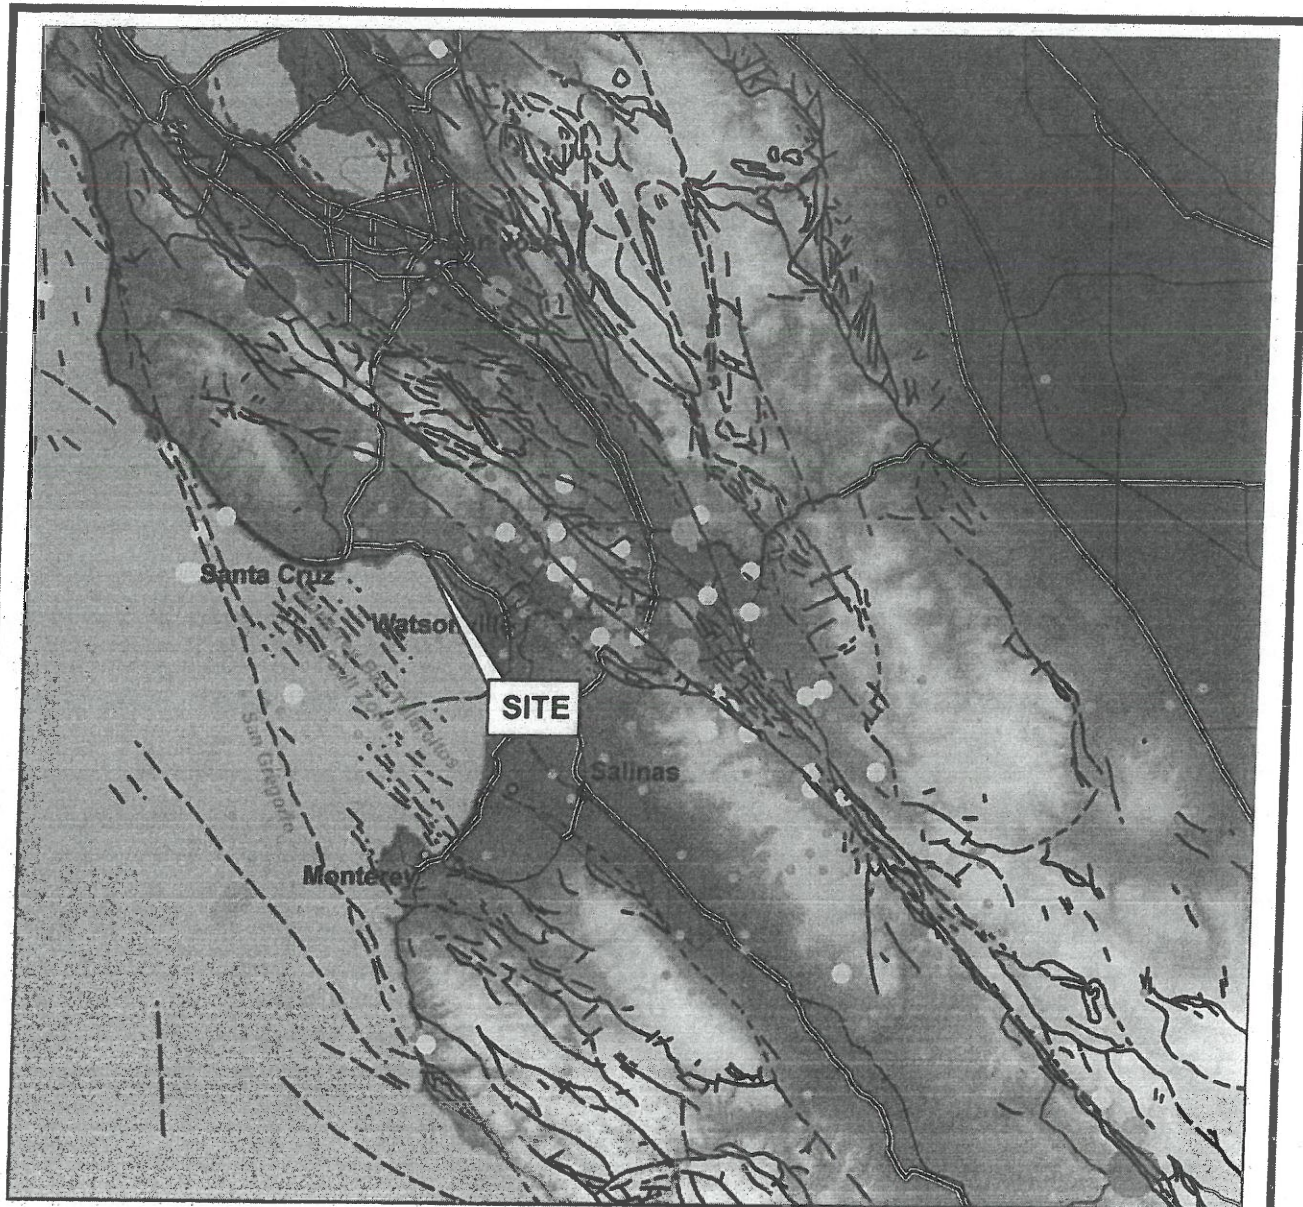
Regional Seismicity Map
Lands Of Vaudagna
379 Beach Drive
Aptos, California

Seismicity Information: Magnitude 4 and greater earthquakes, compiled from various sources, 1769 to 2000; available at www.consrv.cagov/CGS/rghm/quakes/cgs2000_fnl.txt

Fault Information: Jennings, C.W., 1977, Geologic map of California: California Department of Conservation, Division of Mines and Geology, scale 1:750,000

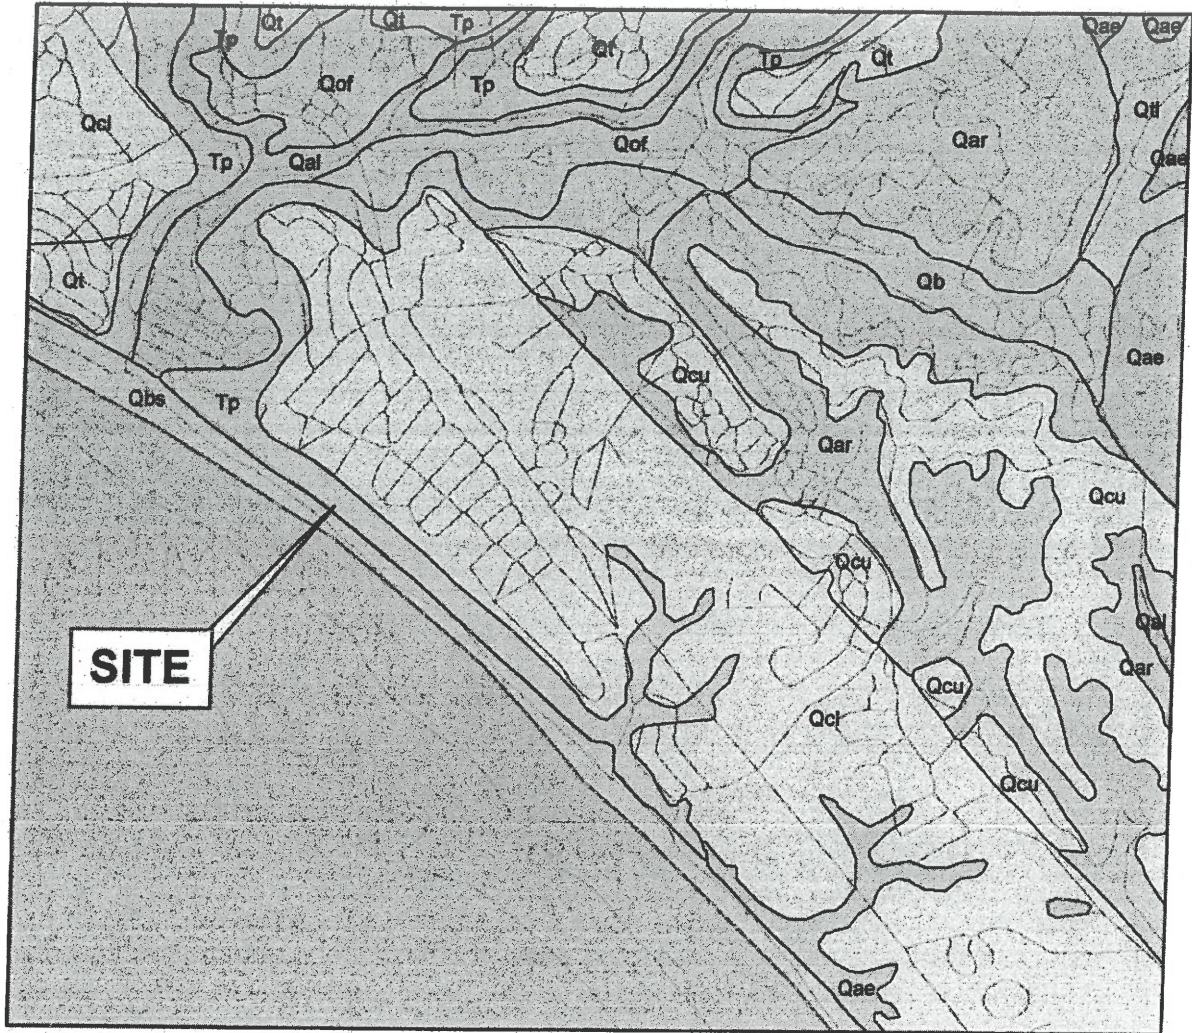
BASE MAP: Brabb, E.E., 1997, Geologic map of Santa Cruz County, California: a digital database: U.S. Geological Survey, Open-File Report 97-489, scale 1:62,500.

Brabb (1997, Figure 4; see also Plates 1 and 2) has mapped the subject property as being underlain by Purisima Formation bedrock, which is partially consistent with our findings. Based upon the data procured from our outcrop mapping and the small-diameter borings advanced by PCEI, the southwestern end of the property (the portion proposed for development) is underlain by about 16 to 22 ½ feet of relatively looser, well sorted, well rounded, fine-grained sand to coarse pebbly-sand. The package of relatively looser sand can be further subdivided into a separate layer of beach sand that is least 16 feet thick at the southwestern property line (see Plate 2). The two formations must interfinger with one another somewhere underneath the existing residence, based upon the results of the borings and the nature of the development of the colluvial wedge at the base of the bluff over geological time.

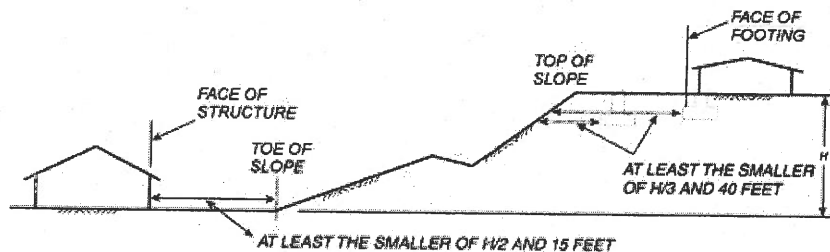
FIGURE 1808.7.1

1808.7.1 Building clearance from ascending slopes

In general, buildings below slopes shall be set a sufficient distance from the slope to provide protection from slope drainage, erosion and shallow failures. Except as provided in Section 1808.7.5 and Figure 1808.7.1, the following criteria will be assumed to provide this protection. Where the existing slope is steeper than one unit vertical in one unit horizontal (100-percent slope), the toe of the slope shall be assumed to be at the intersection of a horizontal plane drawn from the top of the foundation and a plane drawn tangent to the slope at an angle of 45 degrees (0.79 rad) to the horizontal. Where a retaining wall is constructed at the toe of the slope, the height of the slope shall be measured from the top of the wall to the top of the slope.

FOUNDATION CLEARANCES FROM SLOPES

incorrect code section. Code section 1808.7.2 actually applies to foundation setbacks from descending slope surfaces which is not applicable to this project in our opinion. In any event, Section 1808.7.1 of the 2016 California Building Code is as follows (highlighting added by us):

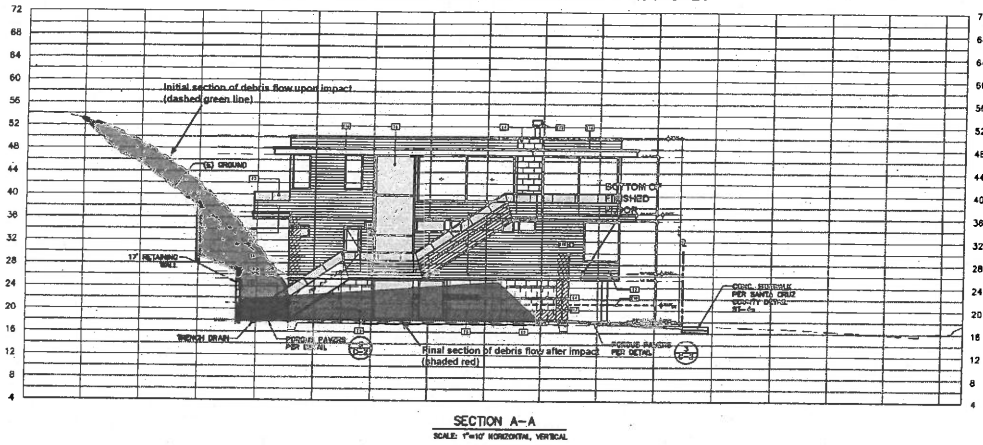
SCENARIO ONE
DEBRIS FLOW WITH NO IMPACT OR CATCHMENT STRUCTURES

PARAMETERS TAKEN FROM GEOBRUGG SHALLSLIDE ONLINE TOOL
AND PACIFIC CREST ENGINEERING SLOPE STABILITY ANALYSIS

Width of starting volume = 9 meters (29.5 feet)
Total starting volume of shallow landslide = 176 cubic meters (230 cubic yards)
Density of shallow landslide material = 2100 kilograms per cubic meter (131 pounds per cubic foot)
Distance from breakout zone to barrier location = 10 meters (33 feet)
Spreading angle of starting volume = 5 degrees
Additional width at impact section on each side of starting width = 1 meter (3.3 feet)
Width of shallow landslide at impact point = 11 meters (36 feet)
Maximum speed of shallow landslide at impact section = 7.8 meters per second (25 feet per second)
Travel time of landslide front between starting zone and impact section = 1.32 seconds
Peak discharge = 134 cubic meters per second (175 cubic yards per second)
Flow height = 1.63 meters (5.3 feet)
System height of the filled barrier = 2.63 meters (8.6 feet)
Slope angle = 70%
Inclination of retained material behind the barrier = 15%

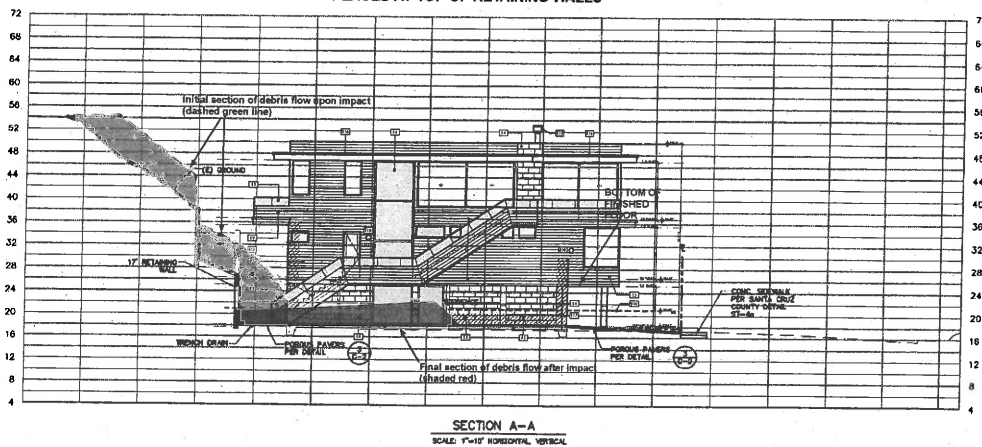
SCENARIO TWO
DEBRIS FLOW WITH IMPACT WALLS
PLACED AT TOP OF RETAINING WALLS

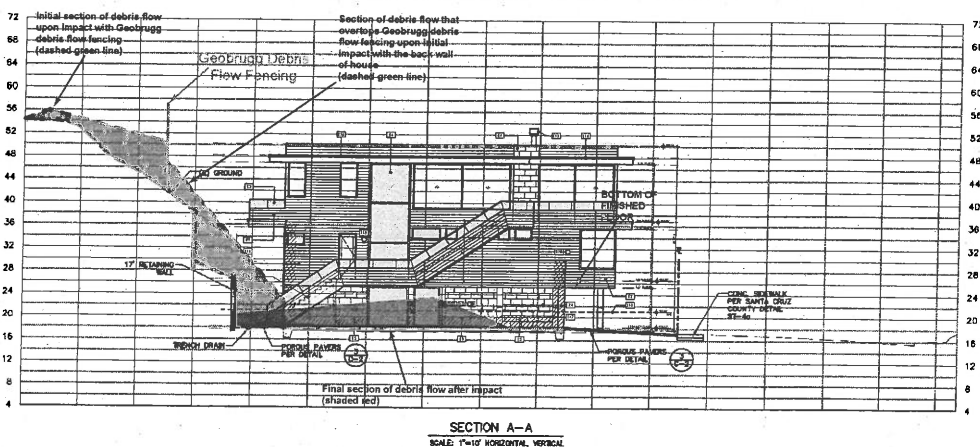
SCENARIO THREE
DEBRIS FLOW WITH ONLY GEOBRUGG DEBRIS FLOW FENCING

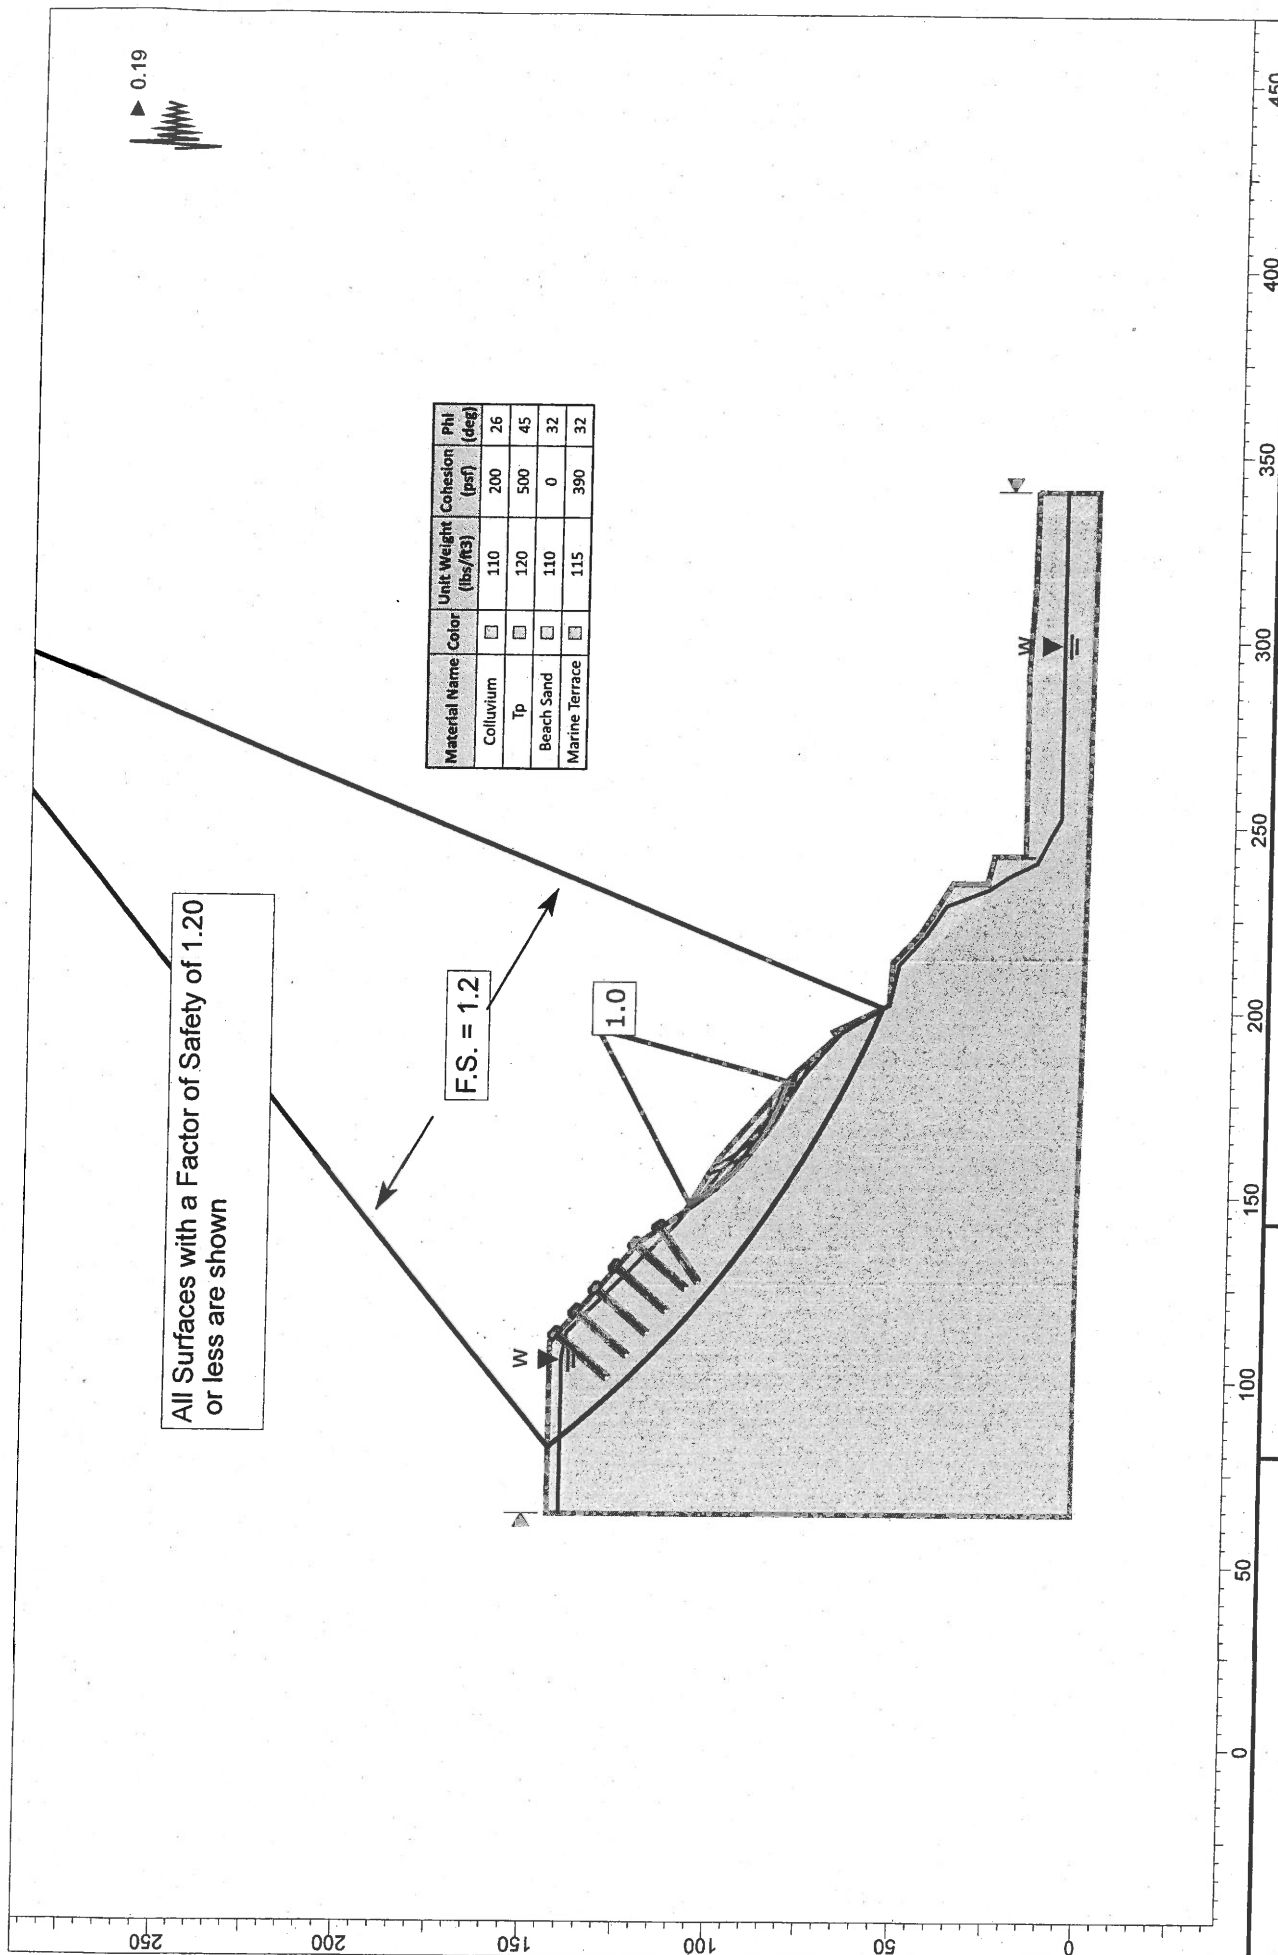
Figure No: 1
 Project No. 1738

Date: 8/26/2019
 File Name: Vau 6d seism circ 19b.slm

Seismic Analysis
 379 Beach Drive
 Aptos, California

Attachments:
Figure 1 – Seismic Analysis
