# County of Santa Cruz <sup>0027</sup>

### **Approve Construction Grant Application to California Board of Corrections for Renovation of Juvenile Hall Facility**

## 2. PROJECT NEED

#### 4. SCOPE OF WORK AND IMPACT

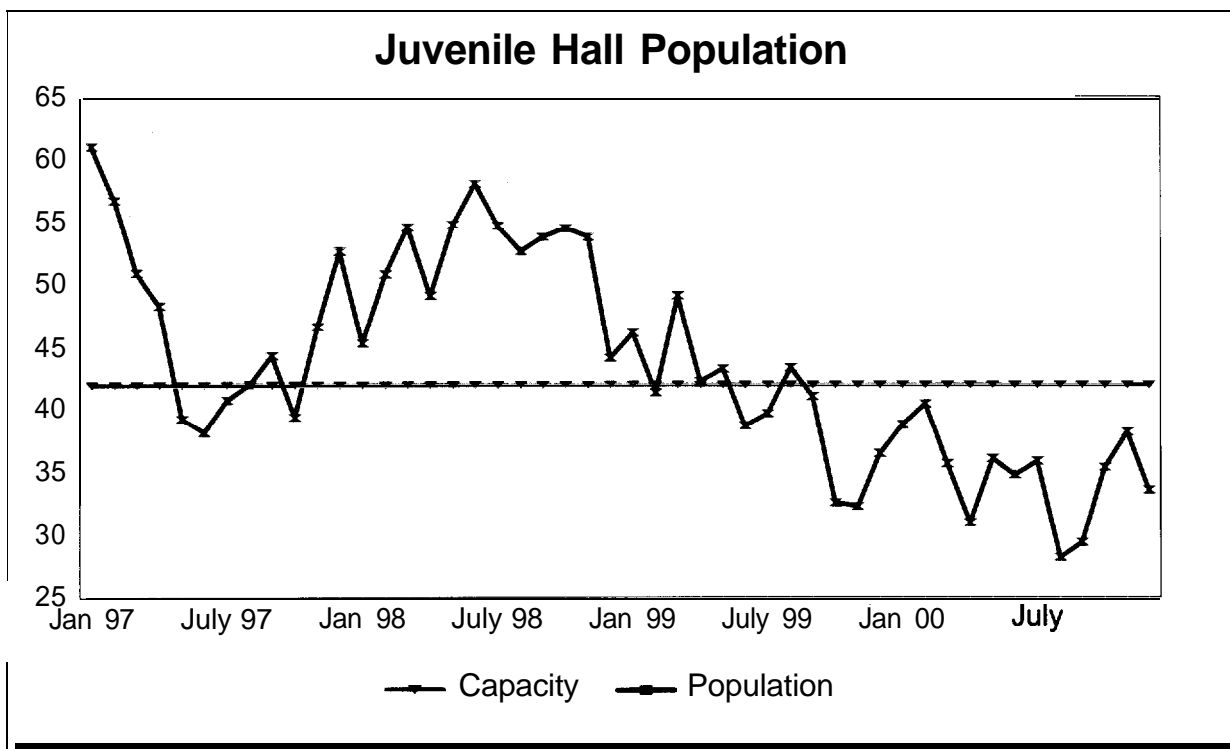
Santa Cruz County Probation Department  
 Juvenile Hall  
 Average Daily Population  
 January 1997 through January 2001

July	Aug	Sept	Oct	Nov	Dec	Jan	Feb	Mar	Apr	May	June	Ave
1996/97							61.1	56.8	51.0	48.4	39.3	38.2	49.1
1997-98	40.8	42.1	44.4	39.4	46.7	52.7	45.4	50.9	54.6	49.2	54.8	58.1	48.3
1998-99	54.7	52.7	53.8	54.5	53.8	44.2	46.2	41.4	49.2	42.3	43.3	38.7	47.9
1999-200	39.7	43.4	41.1	32.6	32.3	36.5	38.8	40.5	35.7	31.0	36.1	34.8	36.9
2000-01	35.9	28.2	29.4	35.4	38.2	33.6	36.7	0.0	0.0	0.0	0.0	0.0
