THE EVOLUTION OF THE APPLE BARN

APTOS VILLEGE PLAN

Historic Barn Relocation:

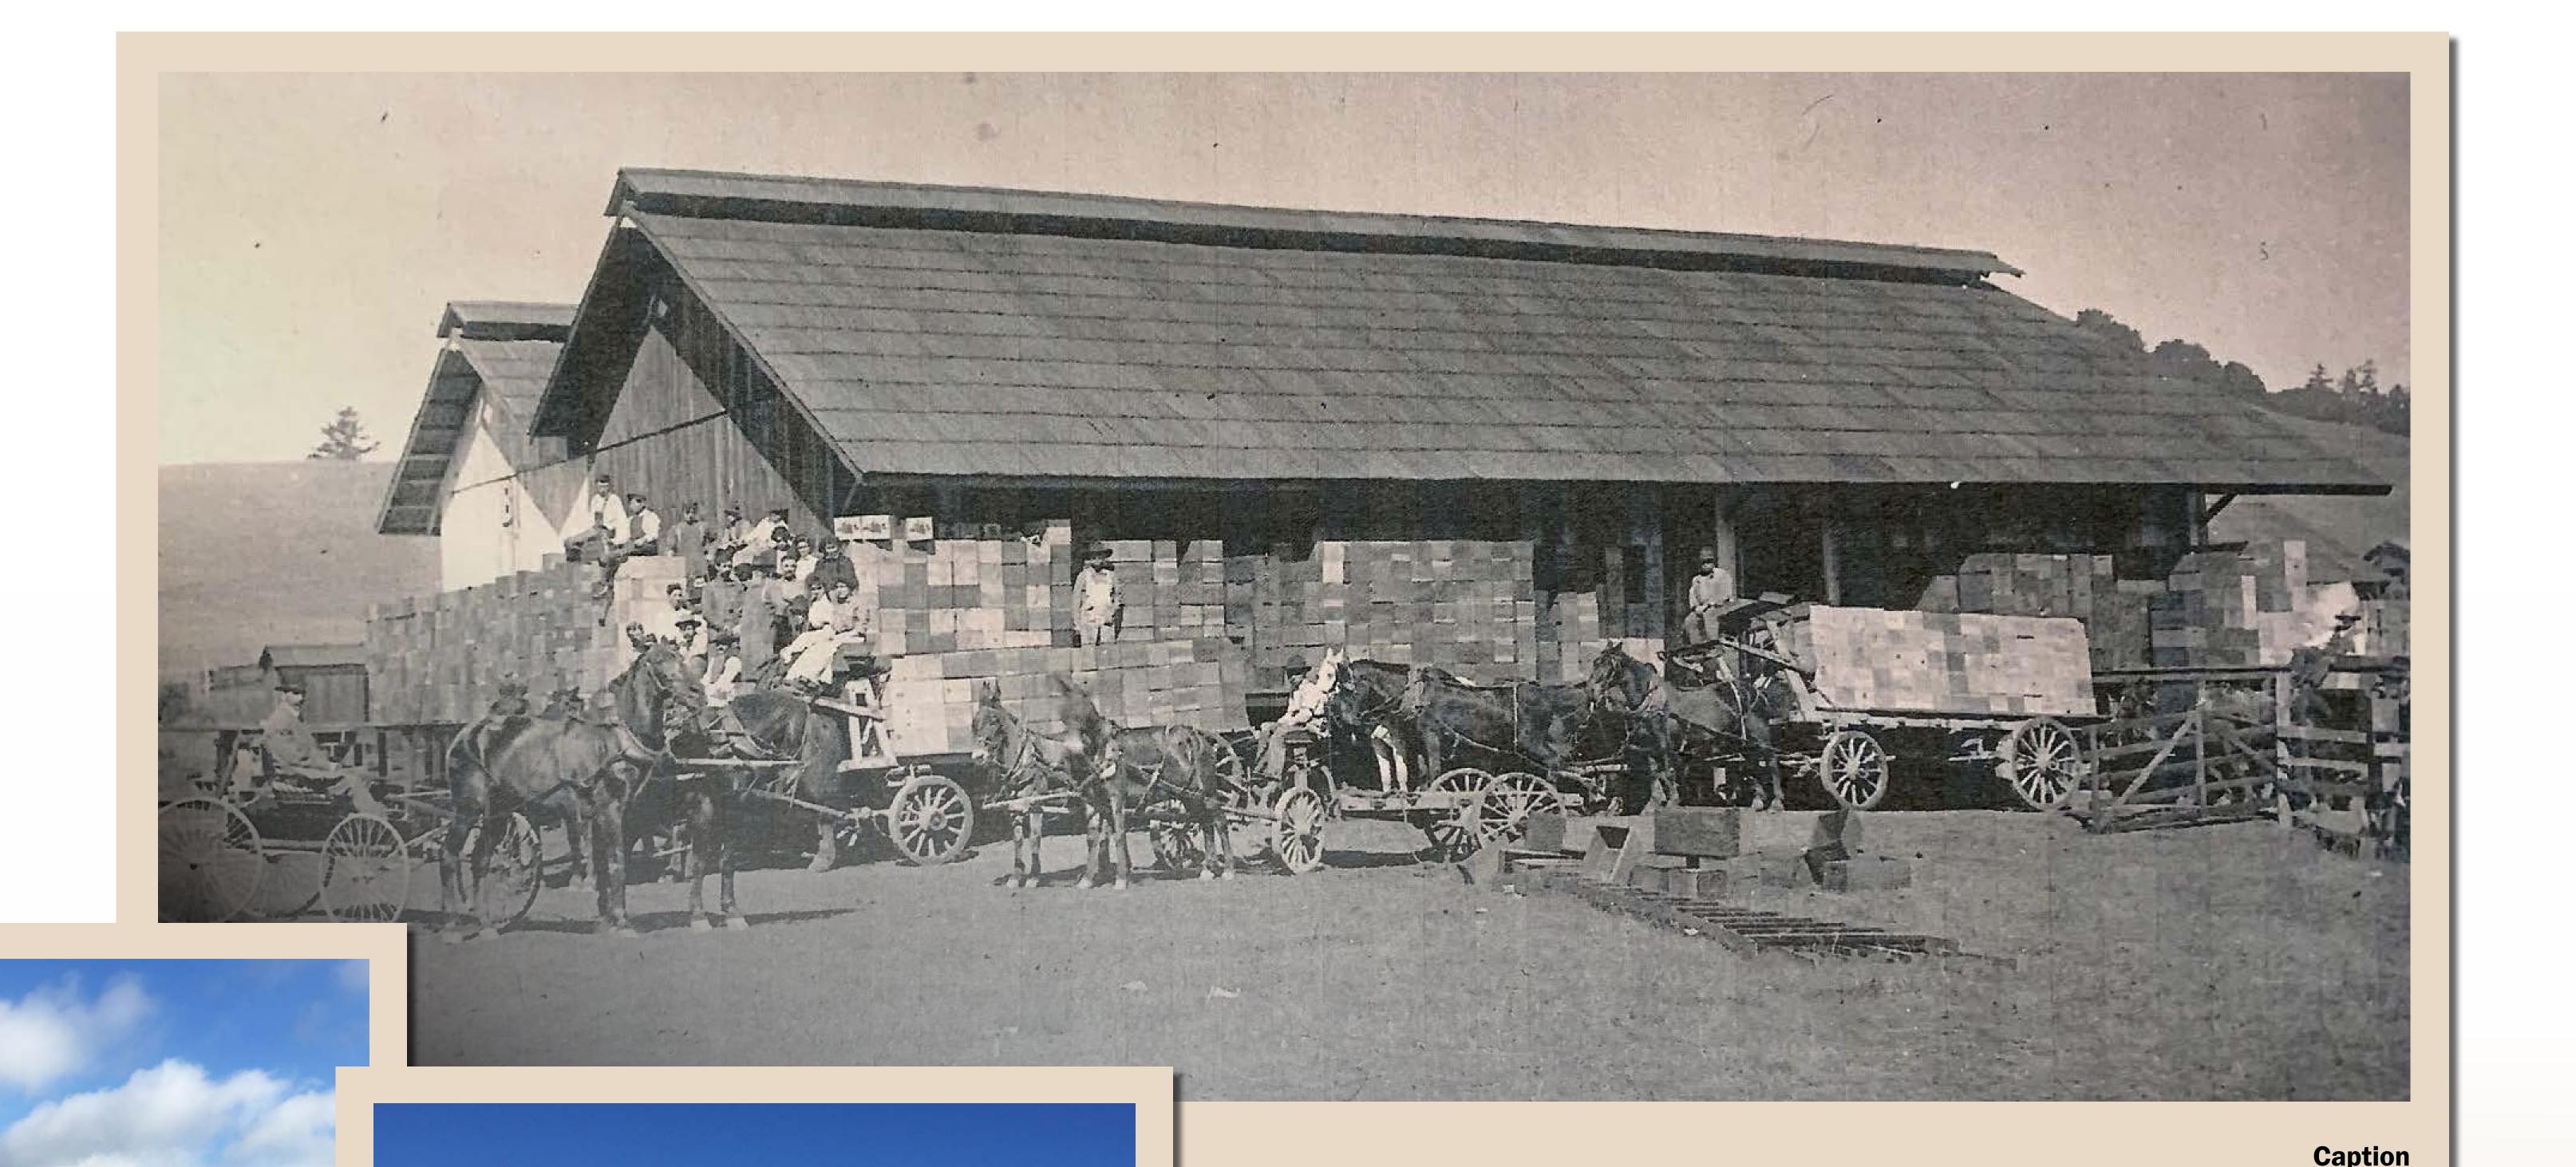
Kelly Brothers House Movers lifted and moved the Apple Barn to its new location in 2016.

The Hihn Apple Barn was relocated in 2016 by Kelly Brothers House Movers. The building was separated at one of its joints to create two parts, and long steel girders were installed underneath it so the building could be lifted and moved. The barn was raised on jacks and carefully wheeled to its new location on rollers. The barn was moved an estimated 250 feet and rotated 160 degrees.
