## **Staff Report to the Zoning Administrator**

**Application Number: 211316**

**Project Description:** Proposal to construct an approximately 110 linear foot pin pier retaining wall, on-site with an existing single-family dwelling.

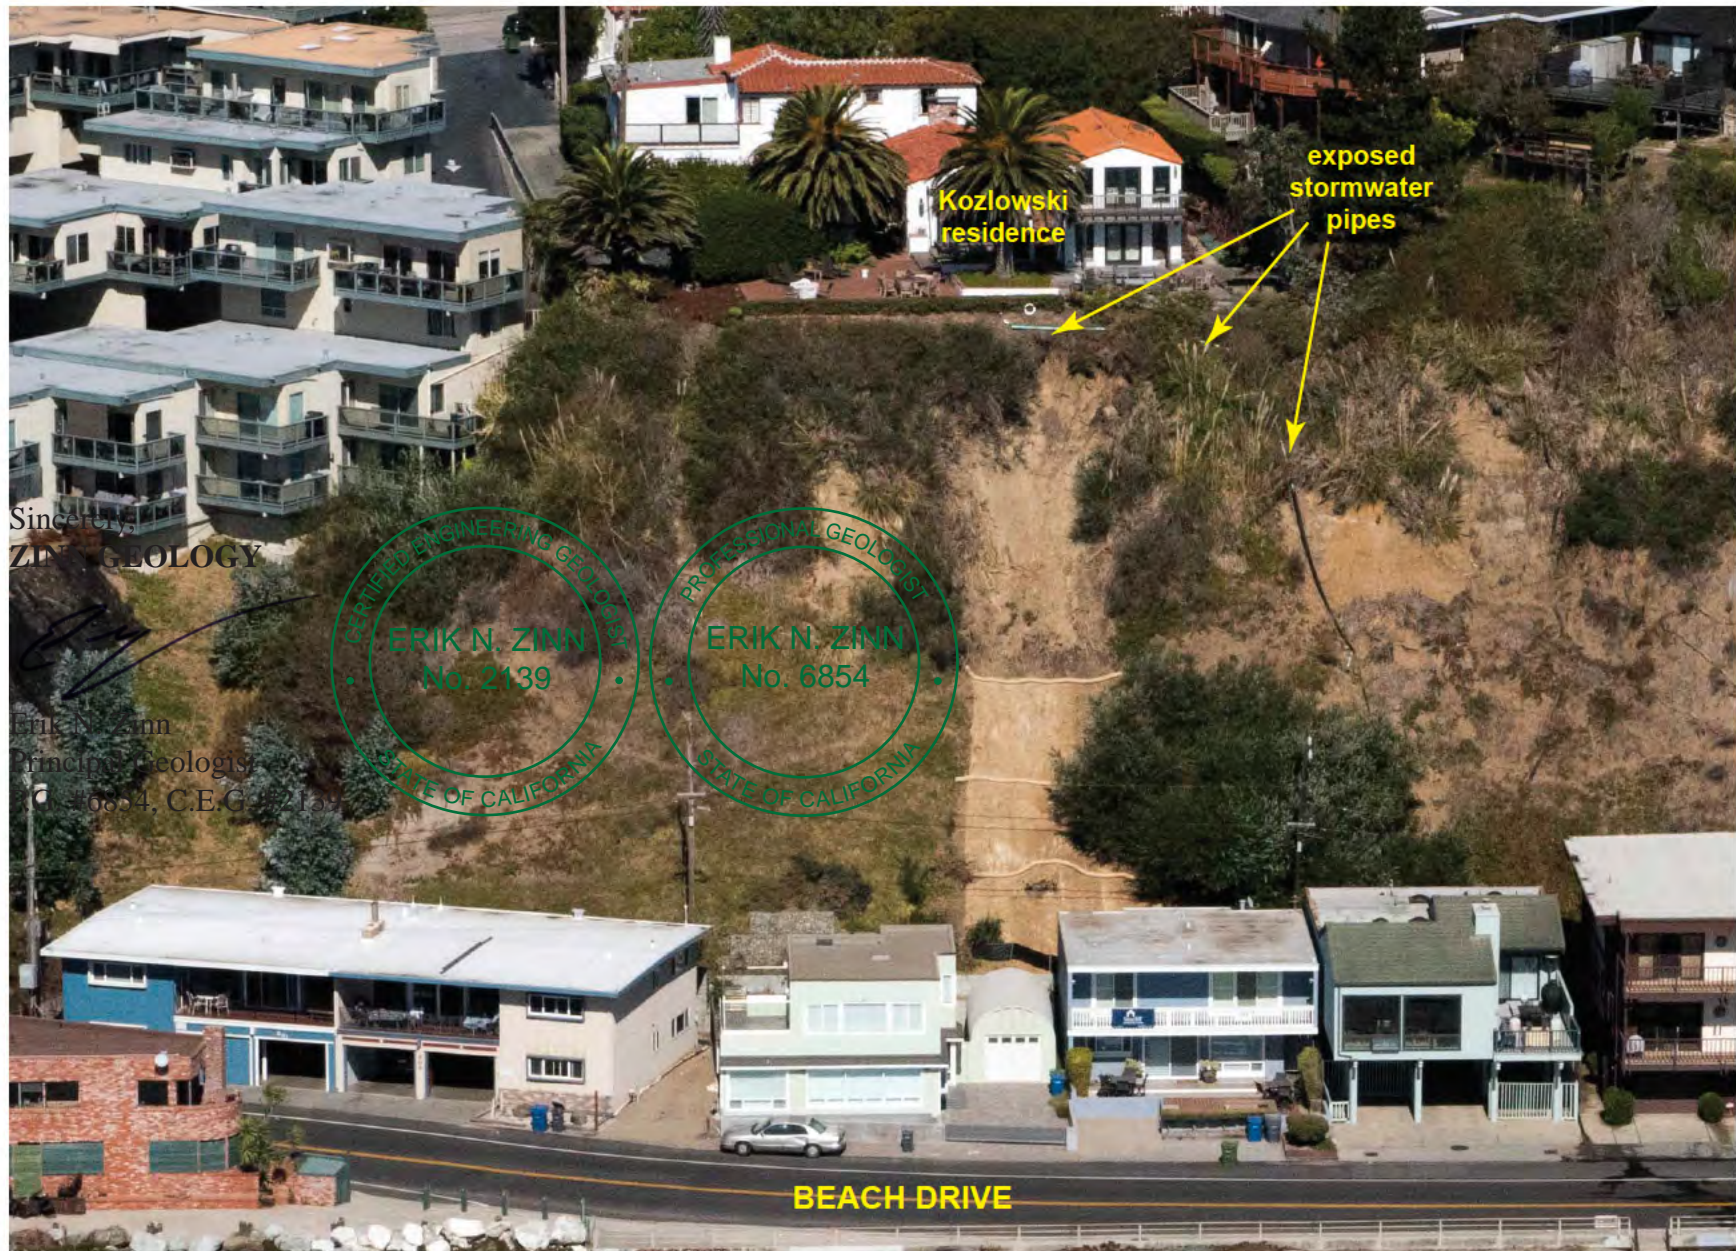
# FIGURE 1 - 2019 PHOTO

SOURCE: digitally excerpted from oblique aerial photo archives owned and maintained by California Coastal Records Project; <https://www.californiacoastline.org/>
