Staff Report to the Zoning Administrator

Application Number: **07-0617**

Project Description:

Proposal to (1) remove concrete rip-rap from a drainage swale and remediate the damage, and to (2) recognize the placement of concrete rip-rap and drainage system in a second drainage swale area to repair severe gully erosion and conduct appropriate remediation. Requires a Coastal Permit, a Grading Permit, a Riparian Exception and an Environmental Assessment.

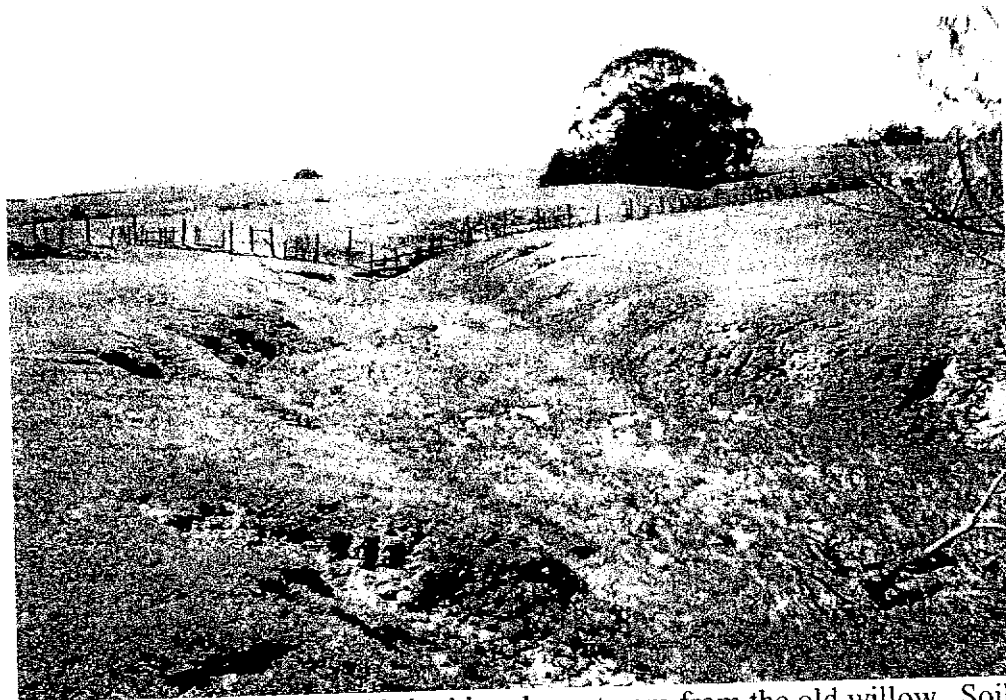
FIGURE 1. The lower fill site in 2000, looking downstream from the old willow. Soil has since eroded from the channel bed, therefore the repaired channel bottom will be lower than it was in 2000. The banks will be rounded and the channel bottom will be flat, as in this photograph.

According to the project geotechnical engineer the concrete rip-rap at the lower site can be removed and the channel restored to a pre-construction condition. The channel restoration will be protected from erosion through flattening the flow line, placement of erosion control fabric and establishment of vegetation in the channel. A check dam immediately downstream of the project site will contain any sediment movement which occurs during the first winter after restoration and thereafter. The restored channel area will be fenced to exclude cattle. A road crossing culvert immediately upstream of the channel restoration will be improved with inlet and outlet protection to prevent erosion and dissipate energy of winter flows before reaching the restoration site.

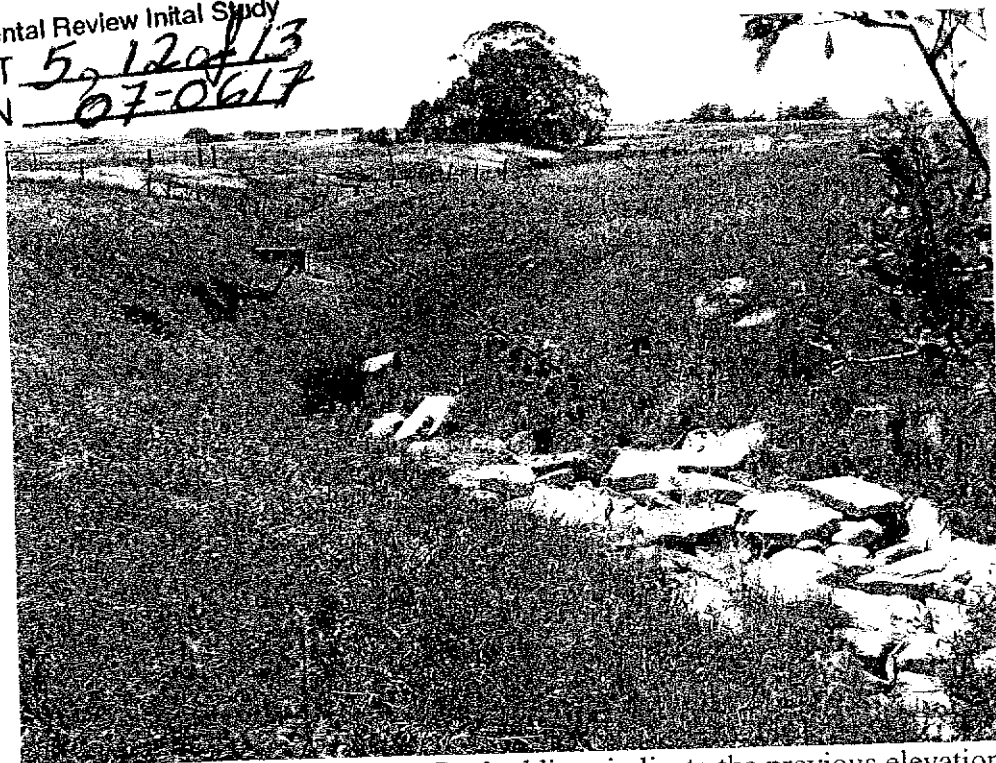
FIGURE 2. The same site, May 1, 2008. Dashed lines indicate the previous elevation of the channel bottom.

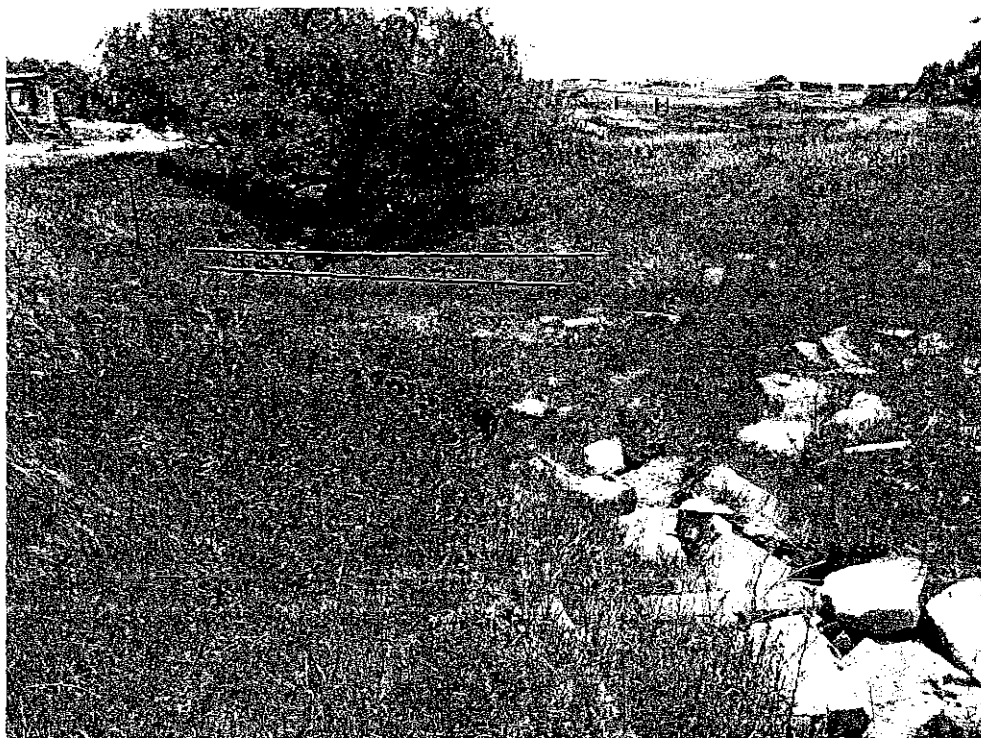
FIGURE 3. View of part of the channel upstream from the willow. Note the broad grassy flat area where the willow has captured sediment. The brown lump in the center of the picture is a remnant of the previous channel bottom.

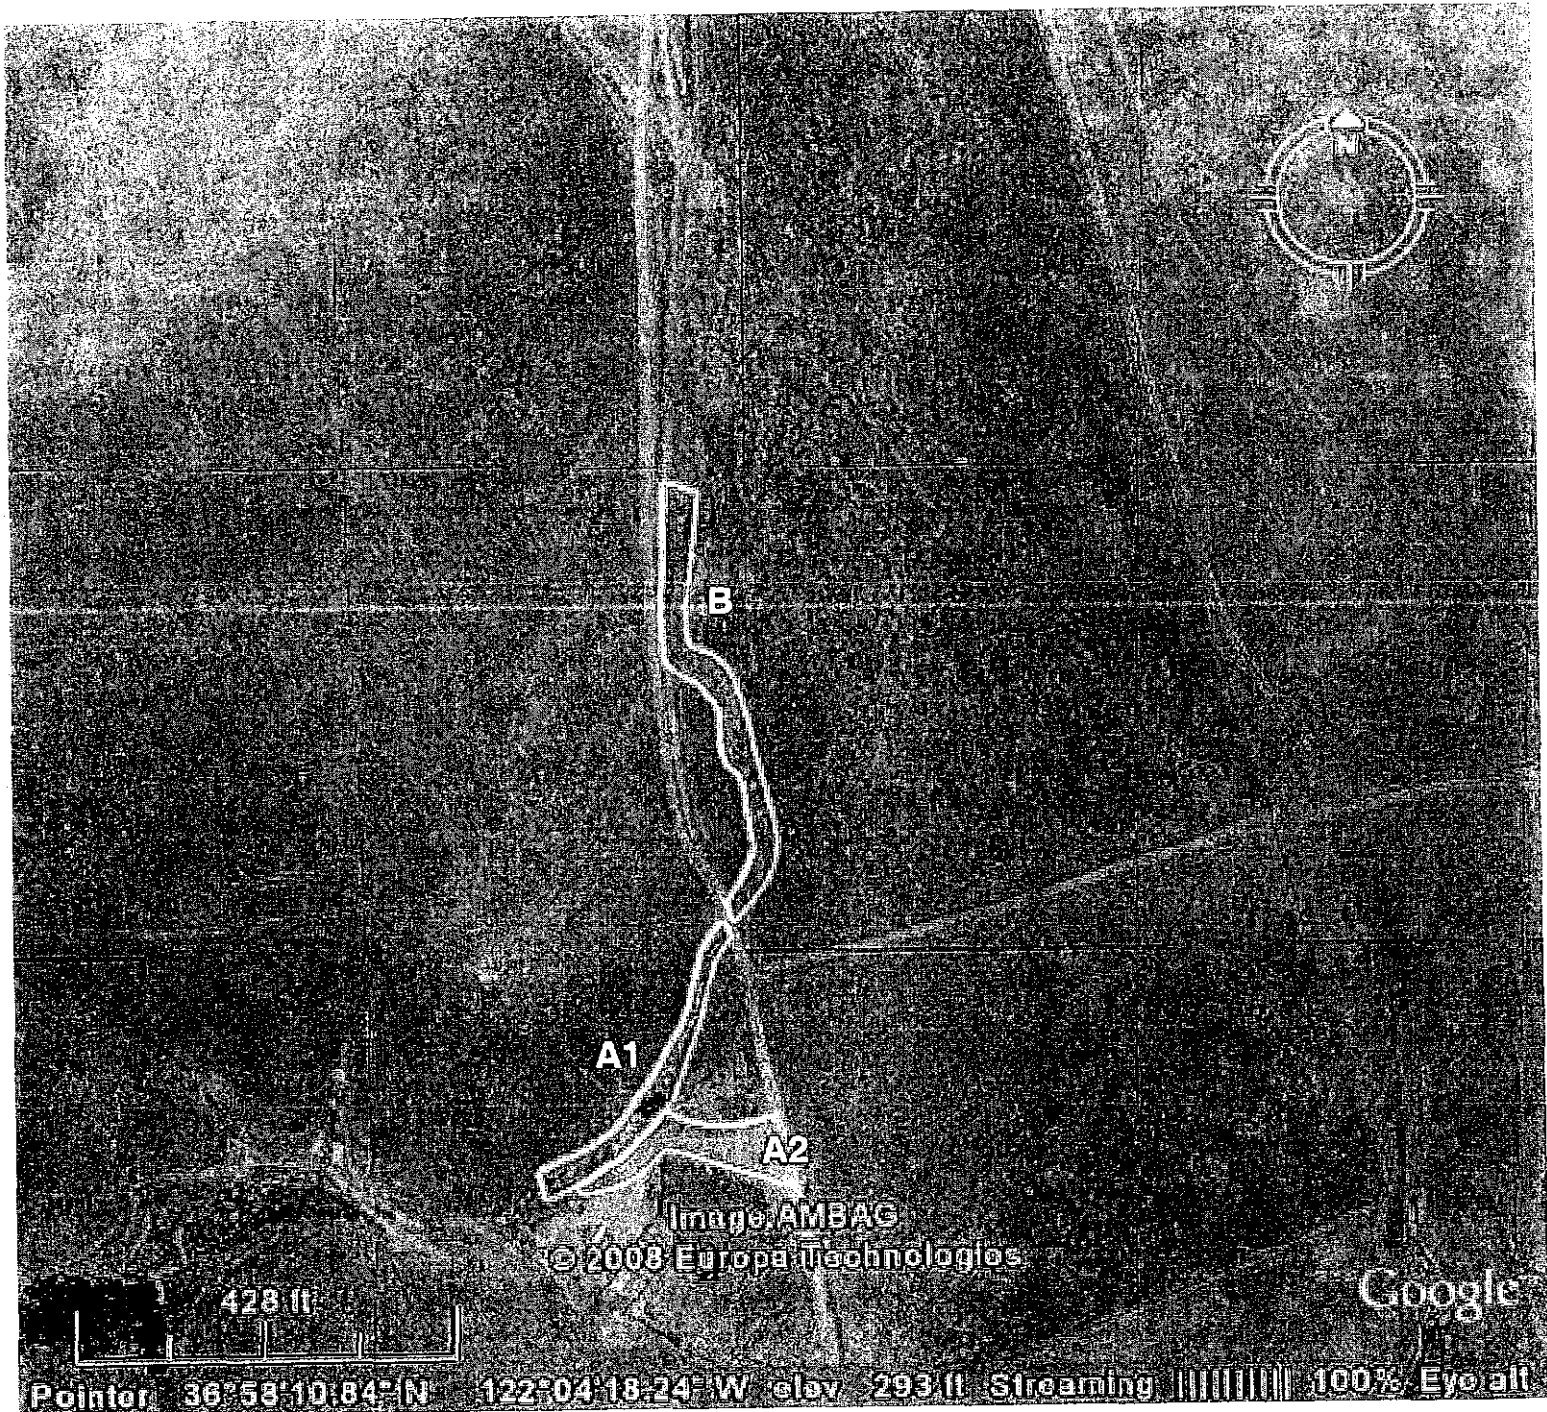
Figure 1

A1: Lower Fill Site _ Work Area

A2: Lower Fill Site _ Access Route

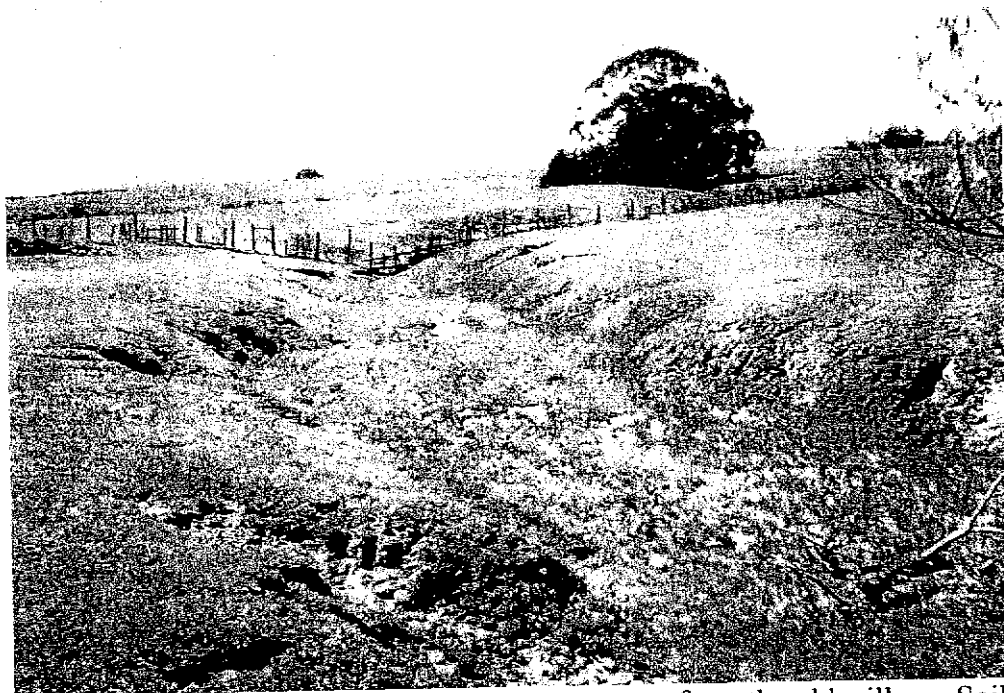
FIGURE 1. The lower fill site in 2000, looking downstream from the old willow. Soil has since eroded from the channel bed, therefore the repaired channel bottom will be lower than it was in 2000. The banks will be rounded and the channel bottom will be flat, as in this photograph.

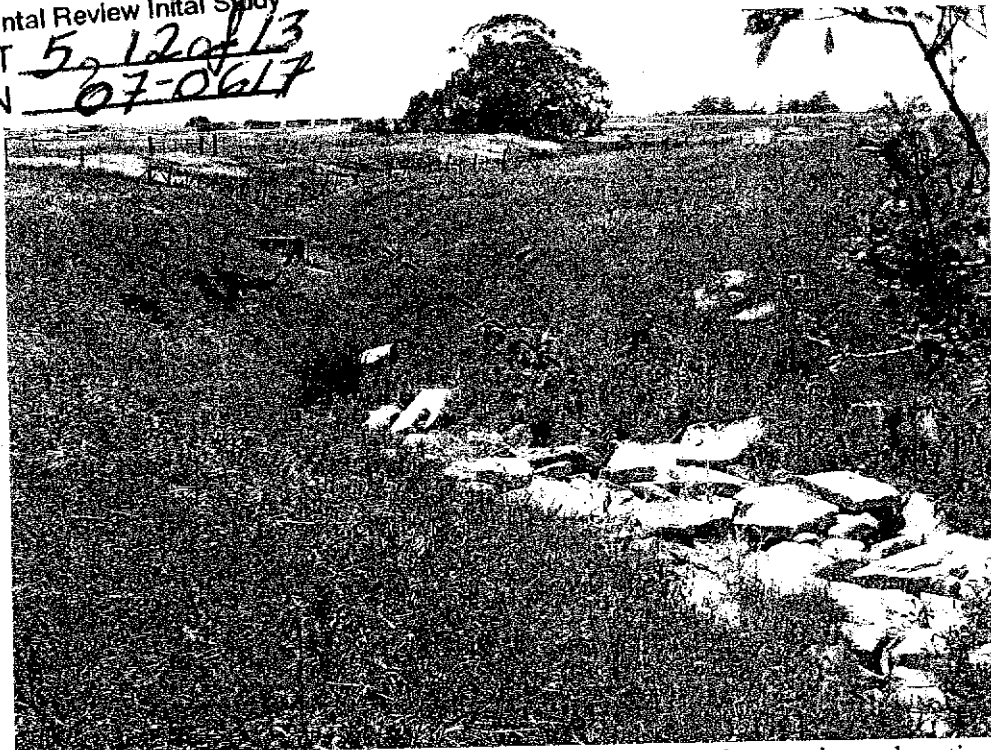
FIGURE 2. The same site, May 1, 2008. Dashed lines indicate the previous elevation of the channel bottom.

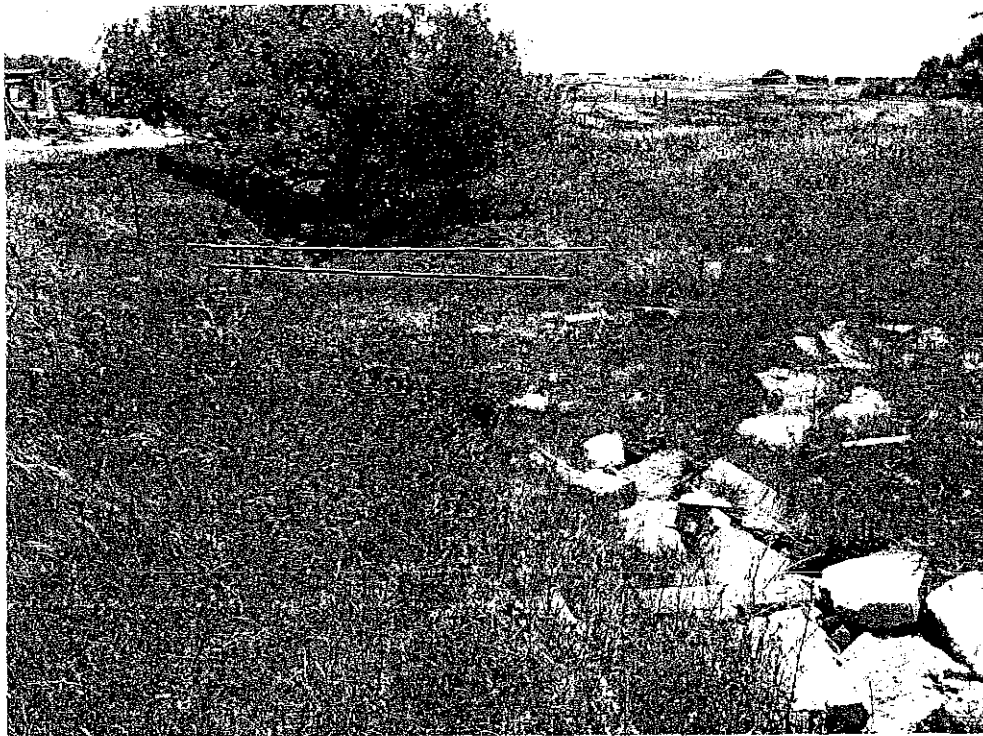
FIGURE 3. View of part of the channel upstream from the willow. Note the broad grassy flat area where the willow has captured sediment. The brown lump in the center of the picture is a remnant of the previous channel bottom.
